Smoke Test Report

March 13, 2020

Re: 2019 Brantford Storm Sewer Smoke Testing
(Support Information for North East Flood Remediation Study)

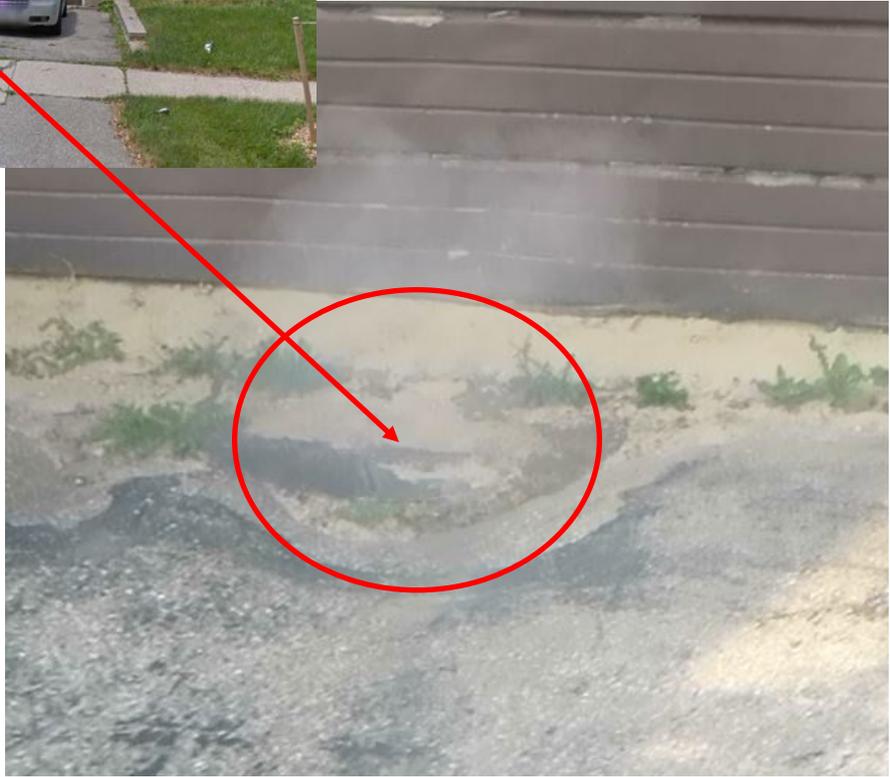
Location: [REDACTED]

Defect Description: Reverse grade driveway drain is directly connected to the storm sewer as evidenced by visible smoke at the surface drain in the driveway during smoke testing of the storm sewer system.

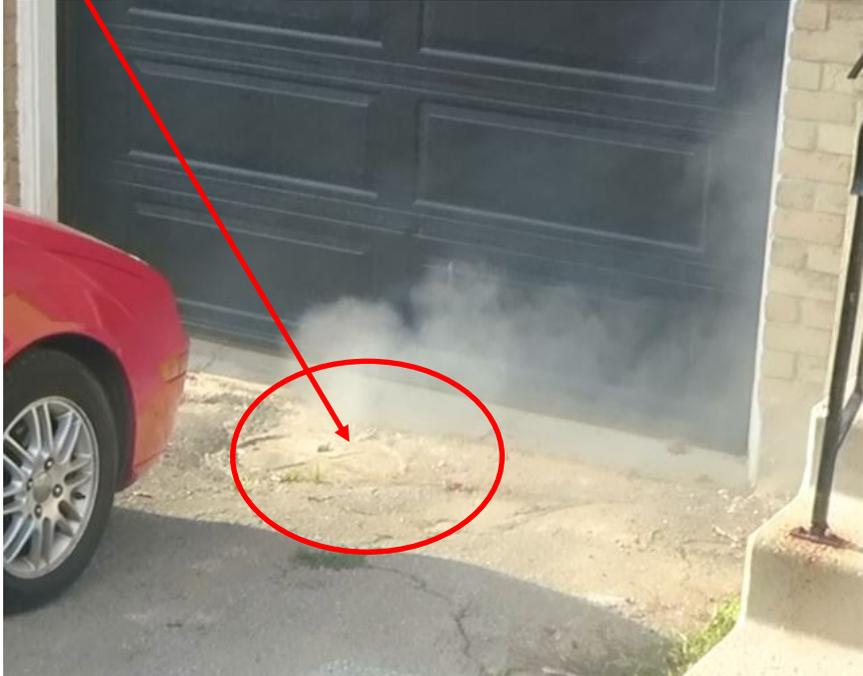
Defect Description: Reverse grade driveway drain is directly connected to the storm sewer as evidenced by visible smoke at the surface drain in the driveway during smoke testing of the storm sewer system.

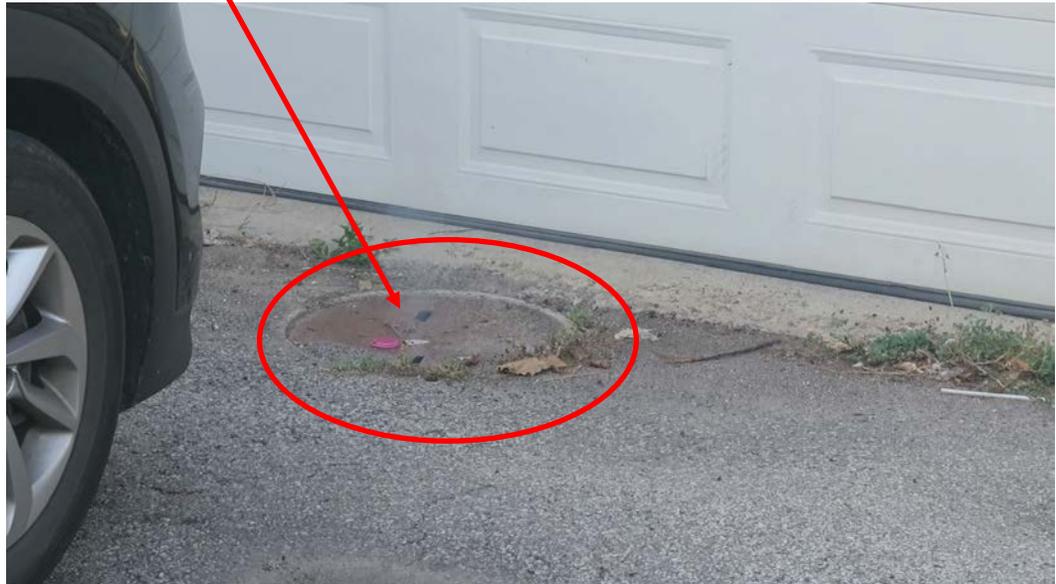
Location: [REDACTED]

Defect Description: Reverse grade driveway drain is directly connected to the storm sewer as evidenced by visible smoke at the surface drain in the driveway during smoke testing of the storm sewer system.

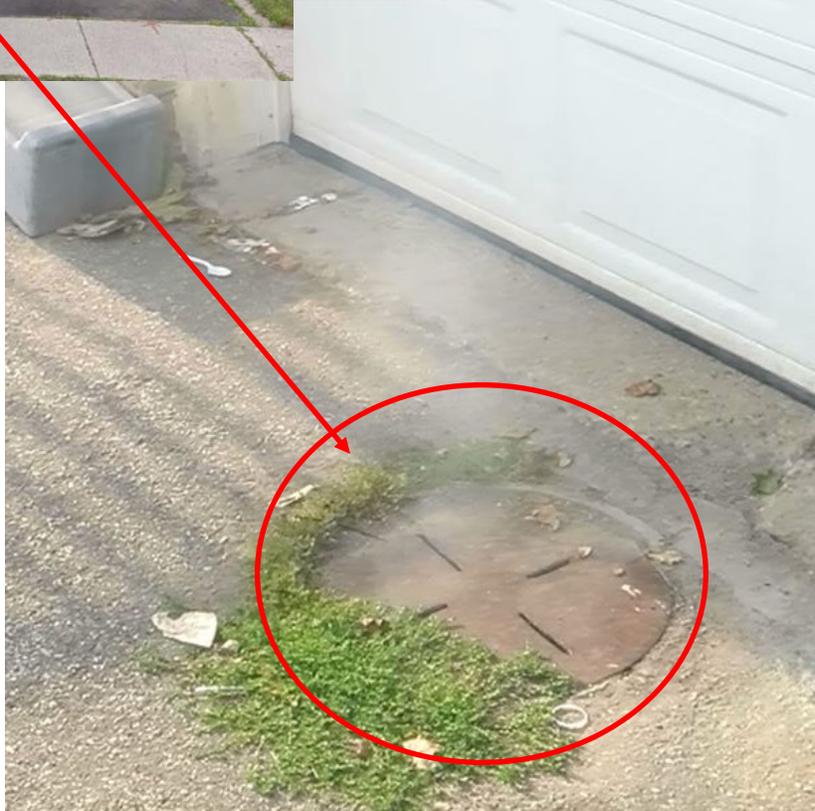
Location: [REDACTED]

Defect Description: Reverse grade driveway drain is directly connected to the storm sewer as evidenced by visible smoke at the surface drain in the driveway during smoke testing of the storm sewer system.

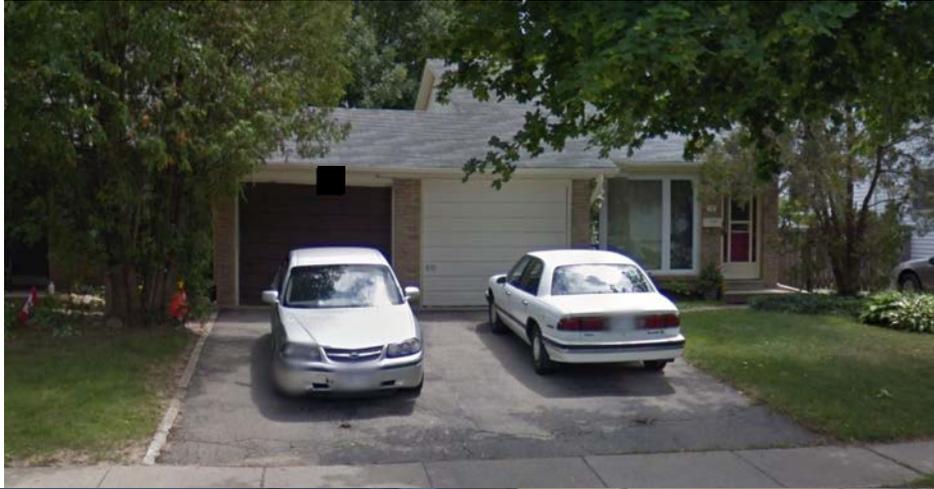
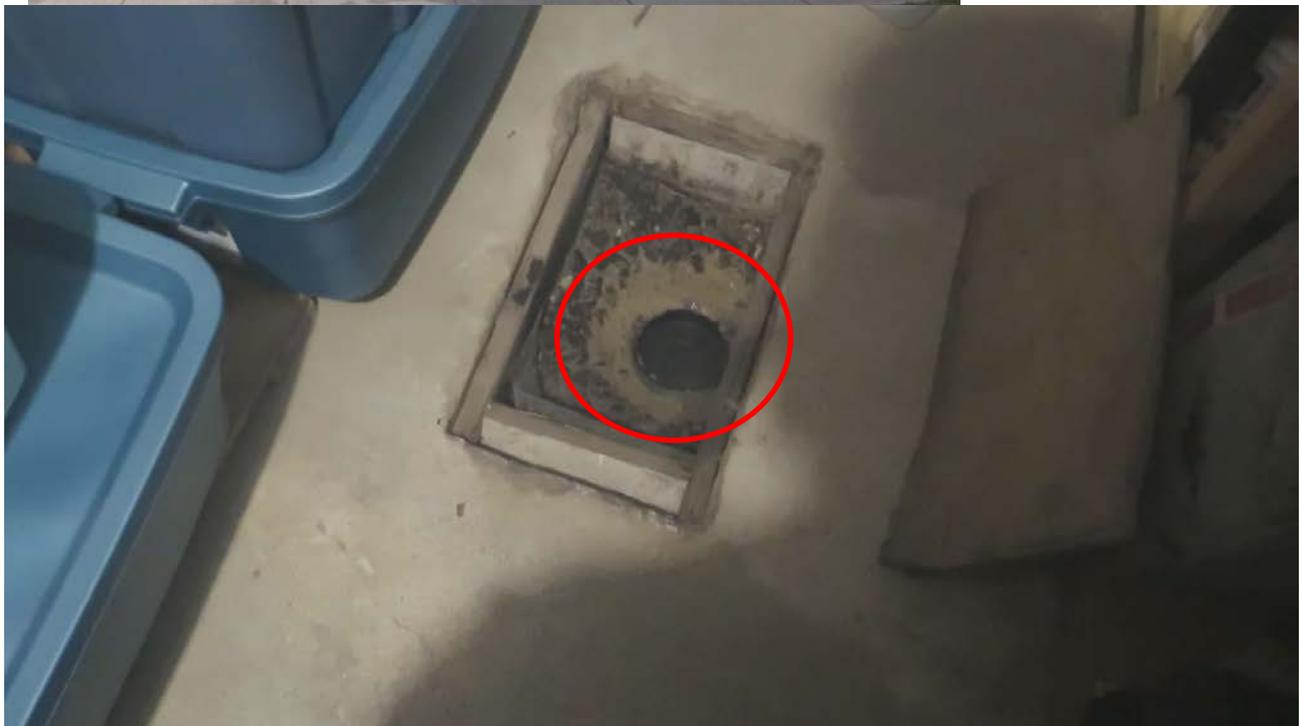
Location: [REDACTED].

Defect Description: A sump pit in the basement is connected to the storm sewer via the weeping tiles and storm lateral. This smoked during our storm testing filling the basement with smoke. A definite connection to the storm sewer through this source.

TQI found smoke emanating from sump pits which were connected to the storm sewer laterals. Most of these sump pits were actual pits in the concrete floor but some were simply a 100 mm pipe access to the weepers and storm sewer. Some residents informed us that when their basement was flooded, the water came from these “pits”.

From this information and our smoke testing results, it appears that when the storm sewer surcharges it backs up the storm laterals and floods basements through these “sump pits”. Simply plugging these pits could also create another problem. With the sump “pits” plugged hydrostatic uplift could occur and heave basement floors.

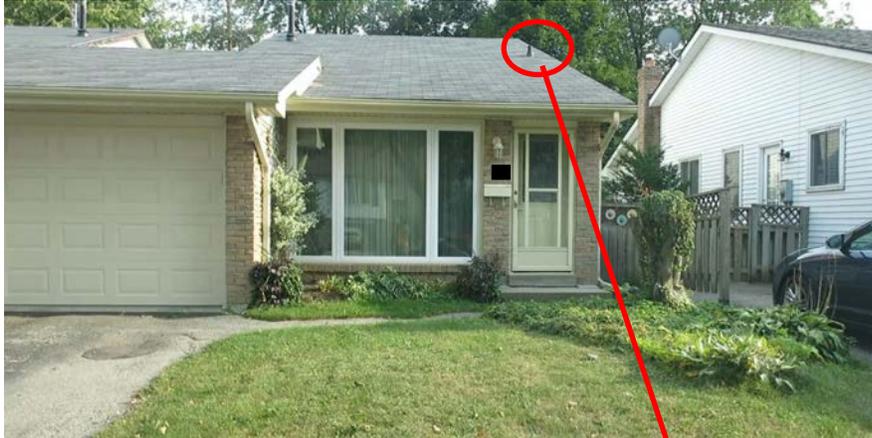
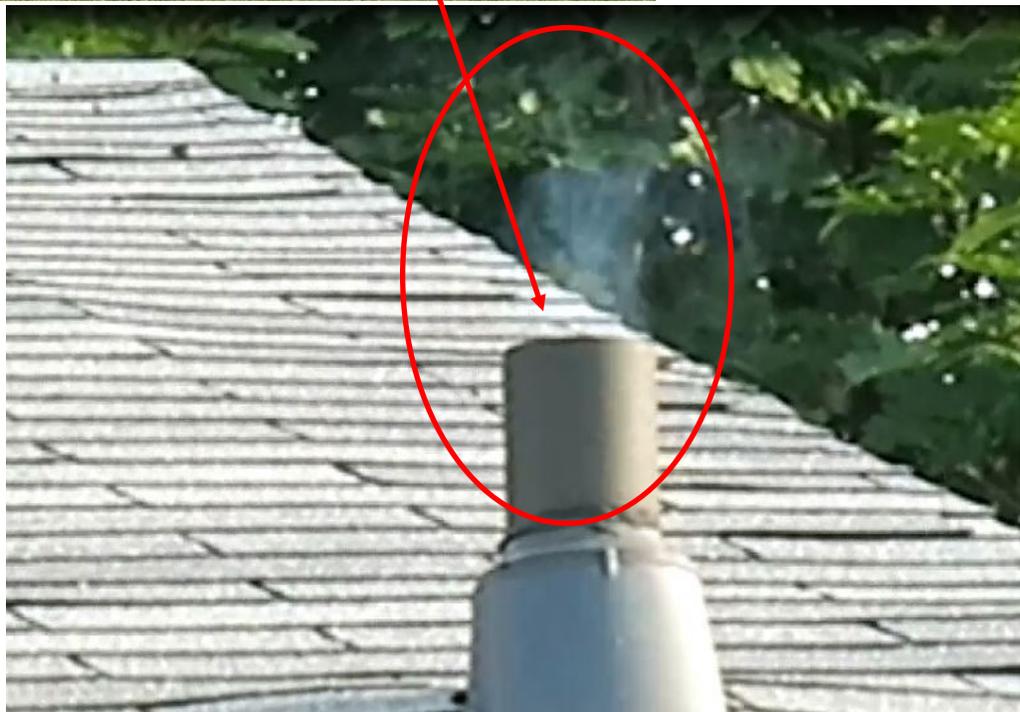
Location: [REDACTED]

Defect Description: Smoke was seen from the plumbing vent during the storm testing indicating a connection with the storm sewer system. Sanitary smoke testing or dye testing is recommended to confirm the plumbing interconnection. As well, the basement sump pit was connected via a lateral to the storm sewer establishing a definite connection of weeping tiles to the storm sewer.

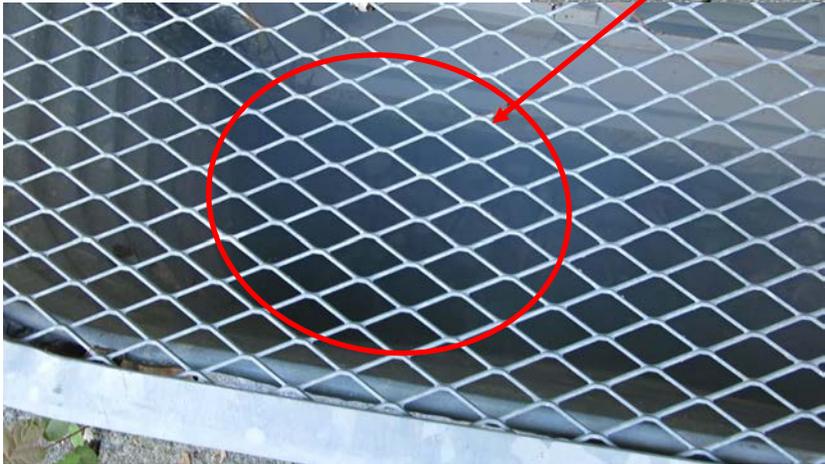
Defect Description: Window well connection to the storm sewer was observed. This is evidence of weeping tile (foundation drain) connection to the storm sewer. Ensure positive drainage (grading) away from the house.

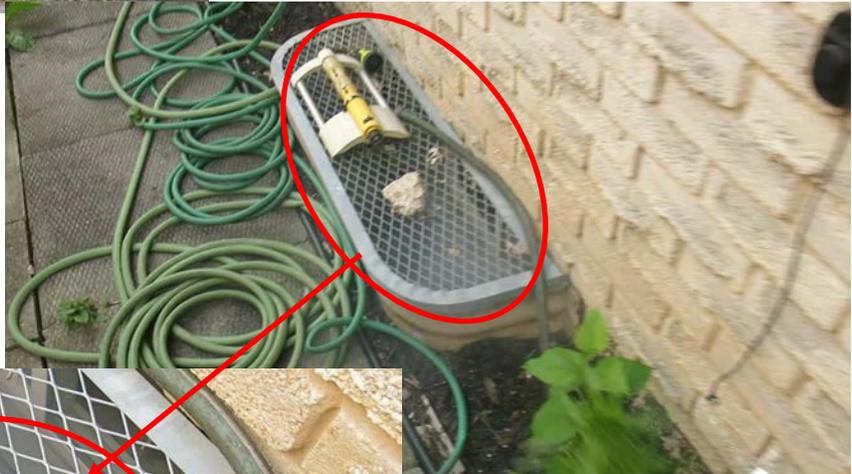
Defect Description: Window well connection to the storm sewer was observed. This is evidence of weeping tile (foundation drain) connection to the storm sewer. Ensure positive drainage (grading) away from the house.

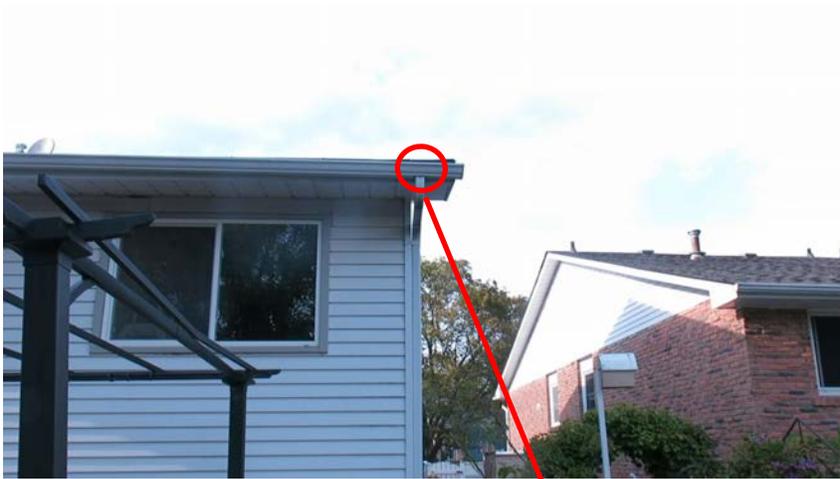
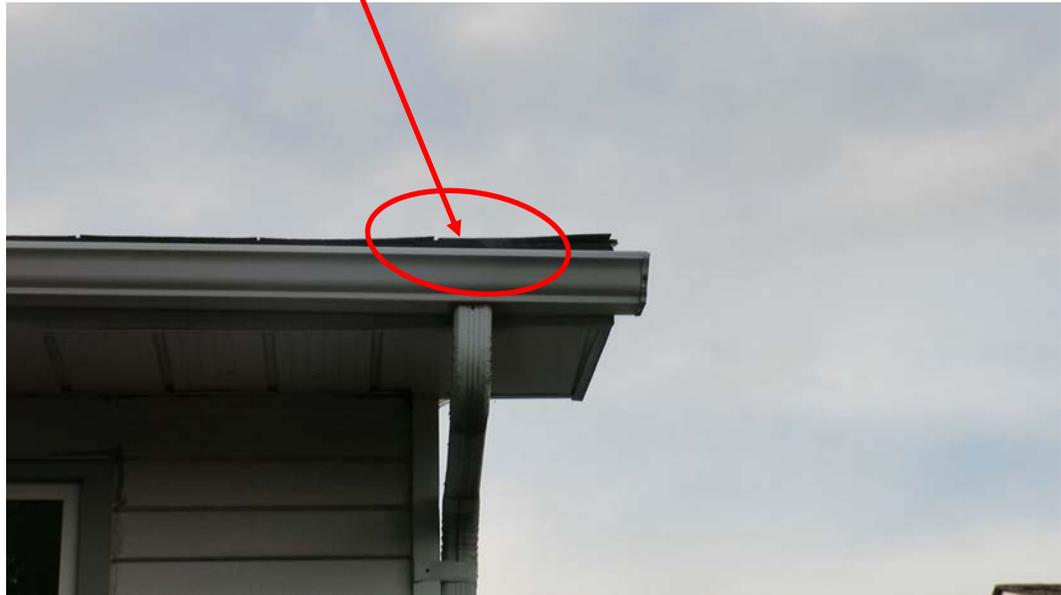
Defect Description: Downspout is connected to the storm sewer. Requires disconnection and discharge to the surface with positive drainage 1 m away from the building foundation wall to prevent sewer inflow via the weeping tiles.

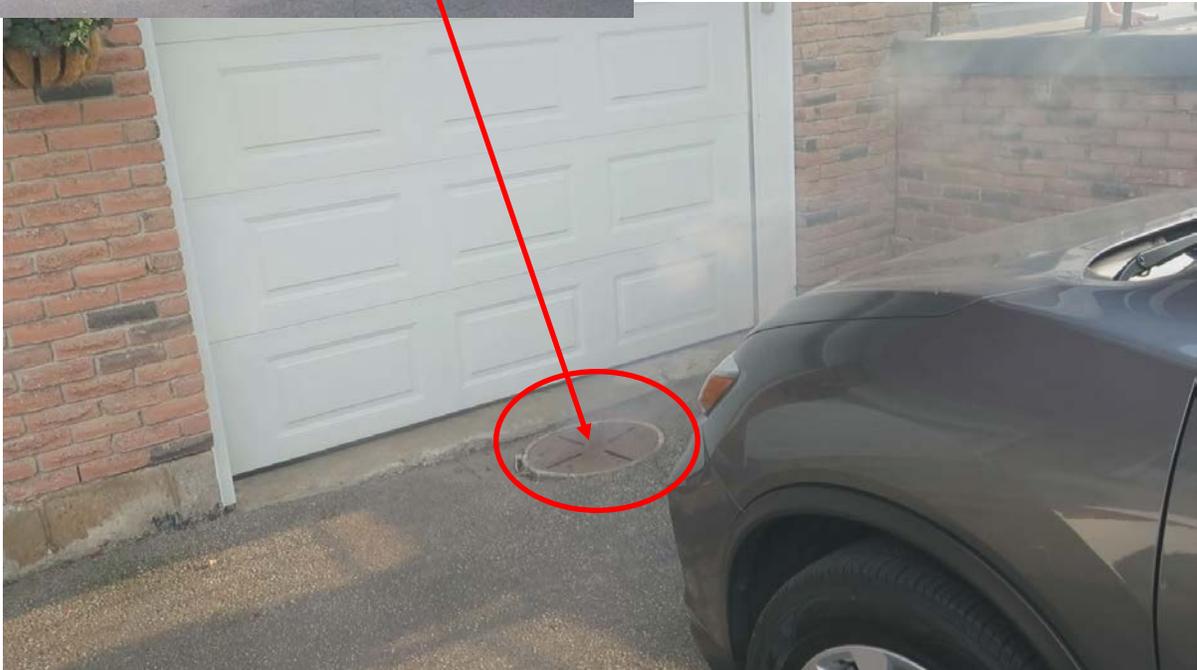
Defect Description: Reverse grade driveway drain is directly connected to the storm sewer as evidenced by visible smoke at the surface drain in the driveway during smoke testing of the storm sewer system.

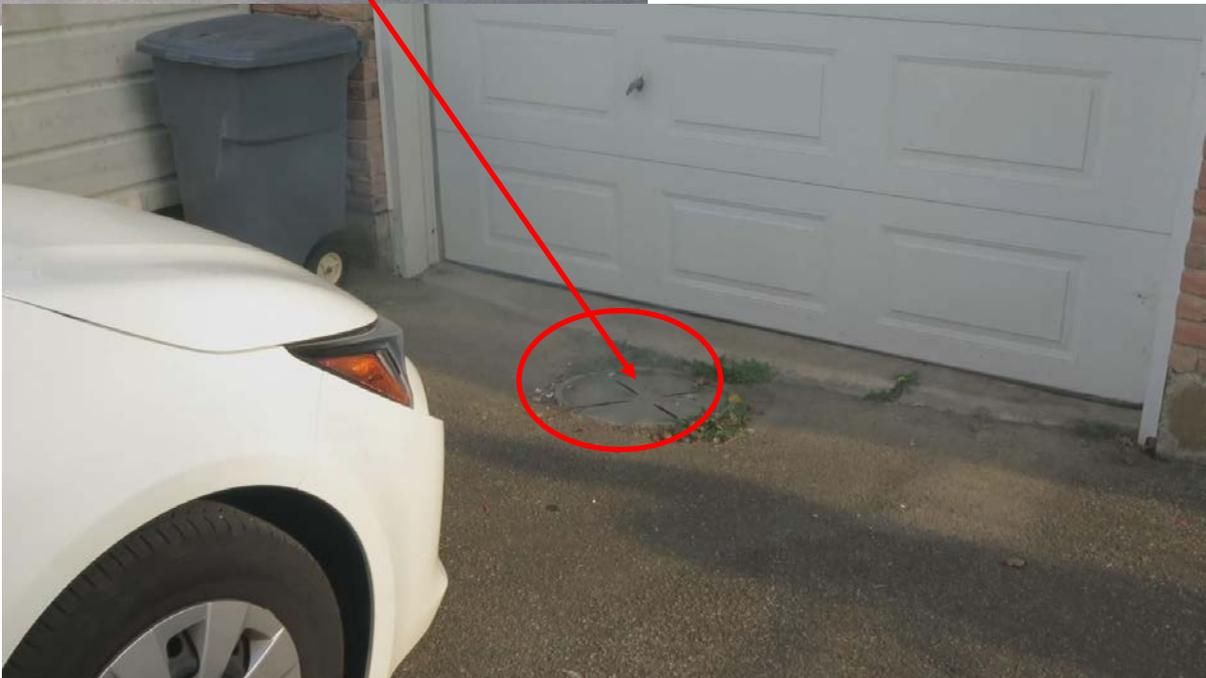
Defect Description: Reverse grade driveway drain is directly connected to the storm sewer as evidenced by visible smoke at the surface drain in the driveway during smoke testing of the storm sewer system.

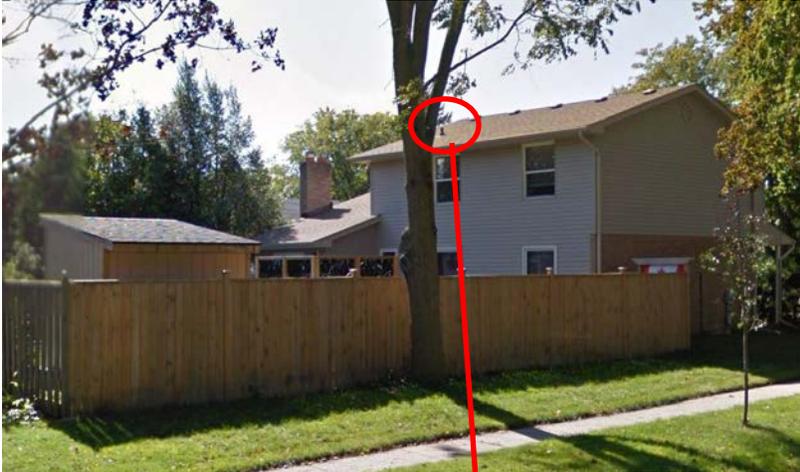
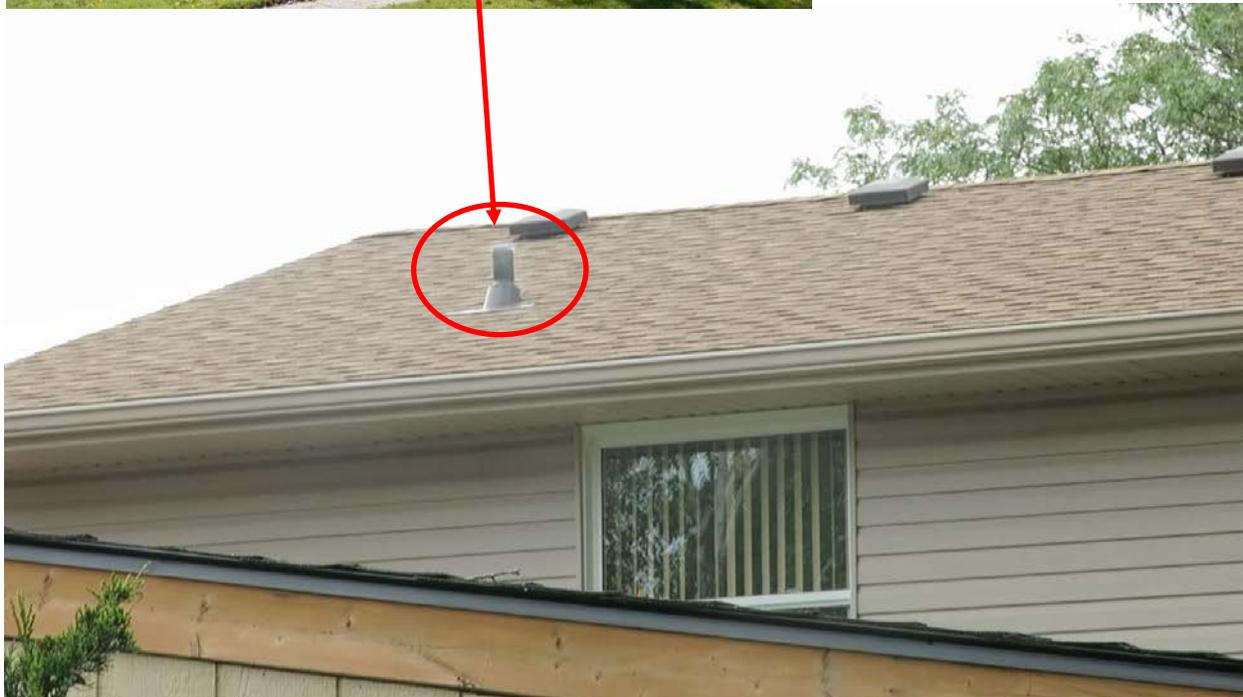
Defect Description: Smoke was seen from the plumbing vent during storm smoke testing indicating a connection with the storm sewer system. Sanitary sewer smoke testing or dye testing is recommended to confirm connection of the plumbing to the storm sewer prior to any corrective action.

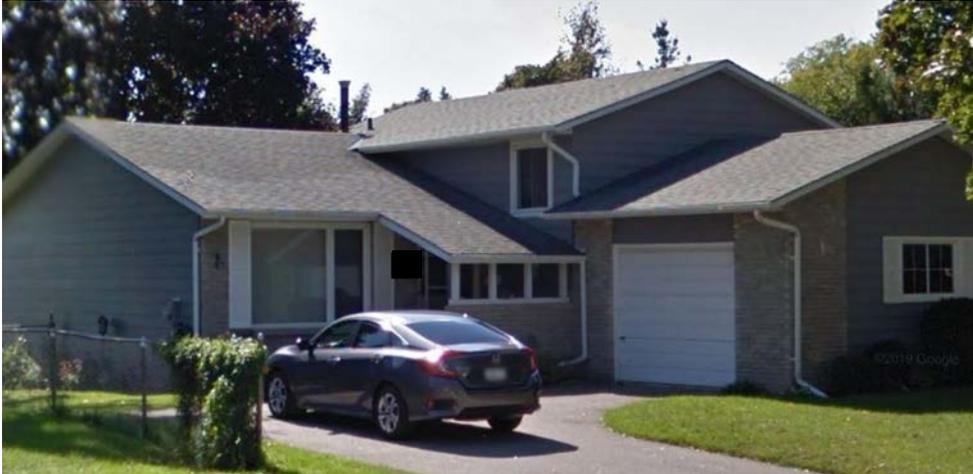
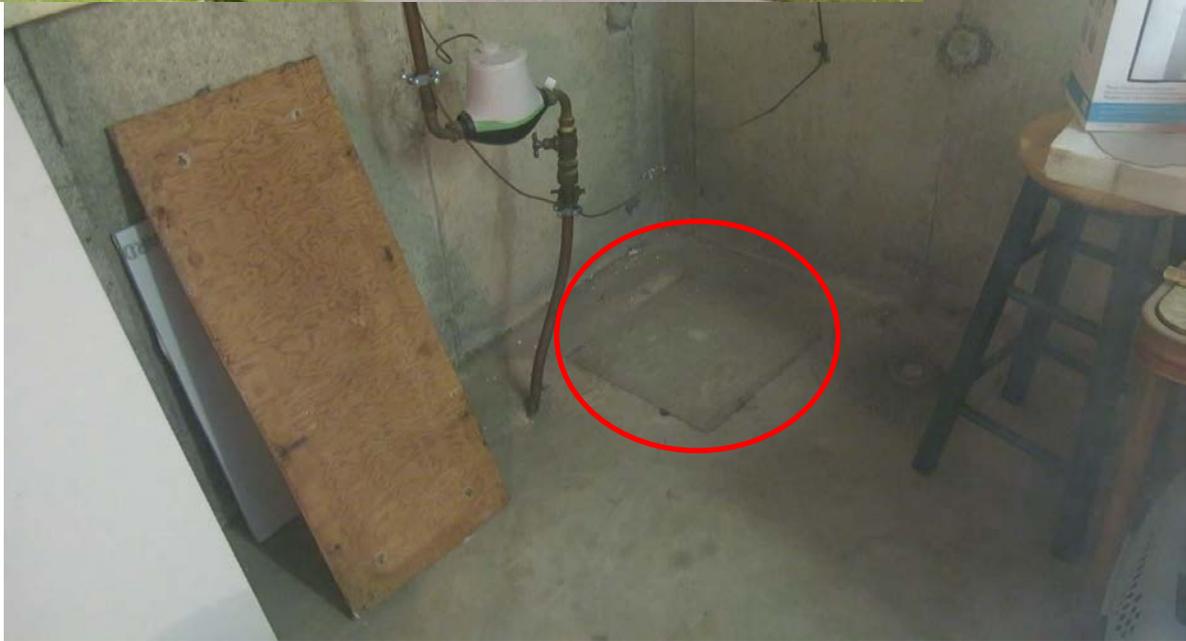
Defect Description: A sump pit in the basement is connected to the storm sewer via the weeping tiles and storm lateral. This smoked during our storm testing filling the basement with smoke. A definite connection to the storm sewer through this source.

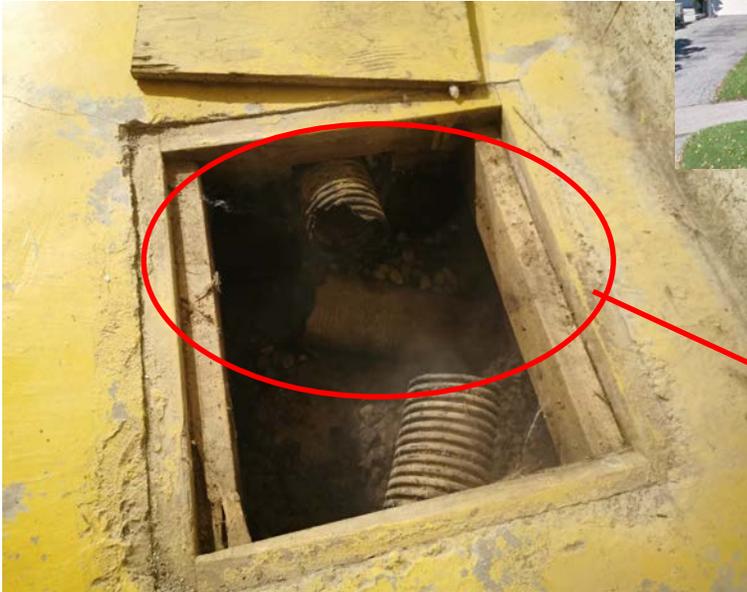
Defect Description: A sump pit in the basement is connected to the storm sewer via the weeping tiles and storm lateral. This smoked during our storm testing filling the basement with smoke. A definite connection to the storm sewer through this source.

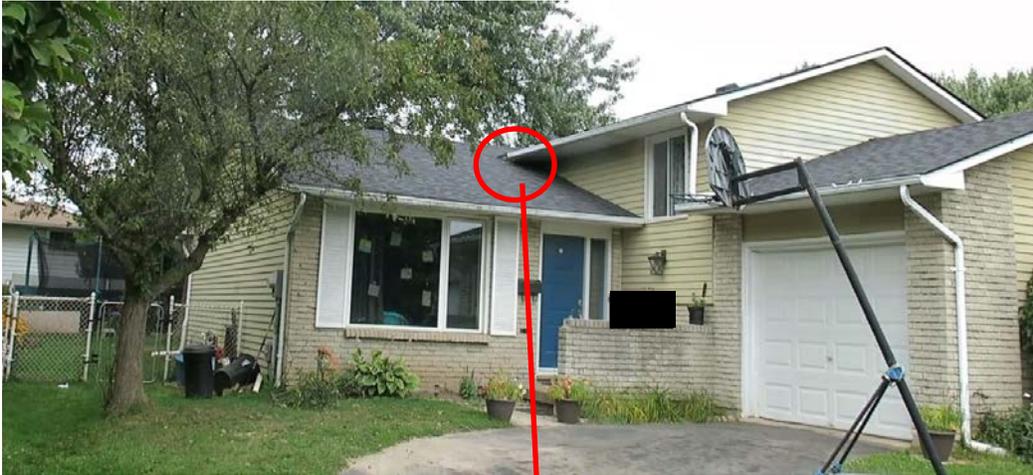
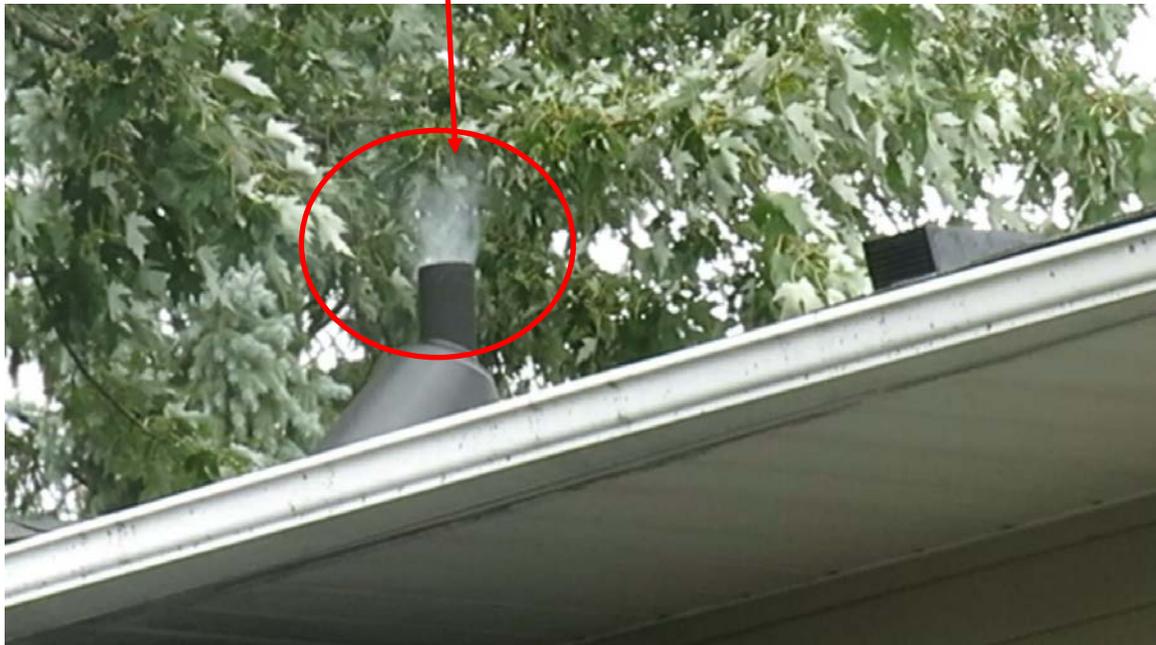
Defect Description: Smoke was seen from the plumbing vent during storm smoke testing indicating a connection with the storm sewer system. Sanitary sewer smoke testing or dye testing is recommended to confirm connection of the plumbing to the storm sewer prior to any corrective action.

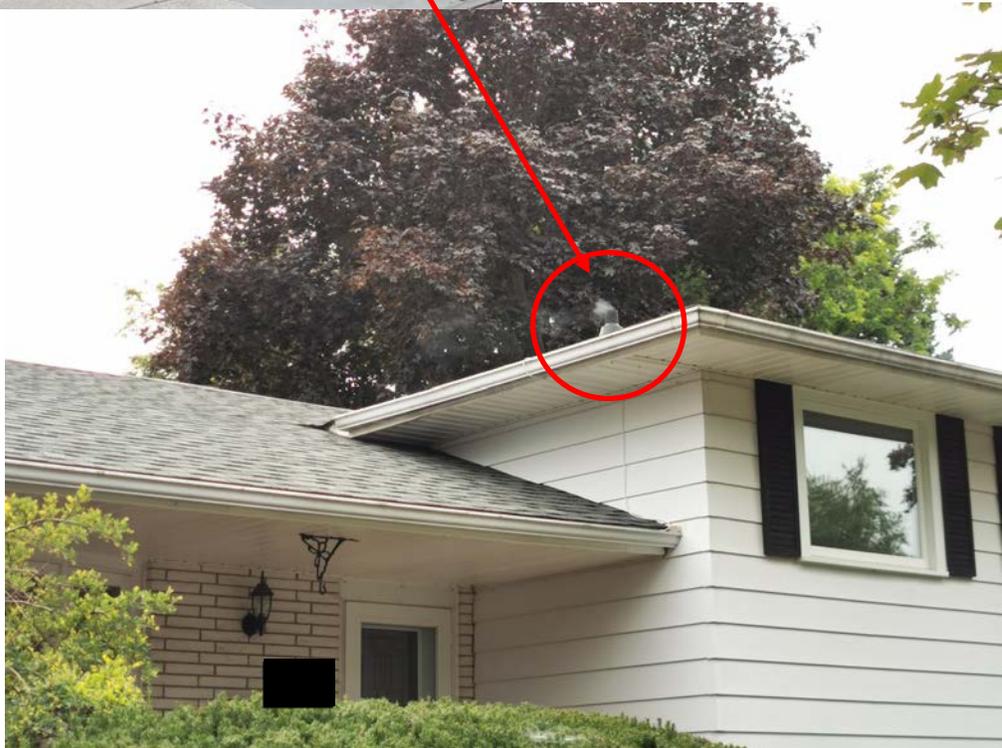
Defect Description: Smoke was seen from the plumbing vent during storm smoke testing indicating a connection with the storm sewer system. Sanitary sewer smoke testing or dye testing is recommended to confirm connection of the plumbing to the storm sewer prior to any corrective action.

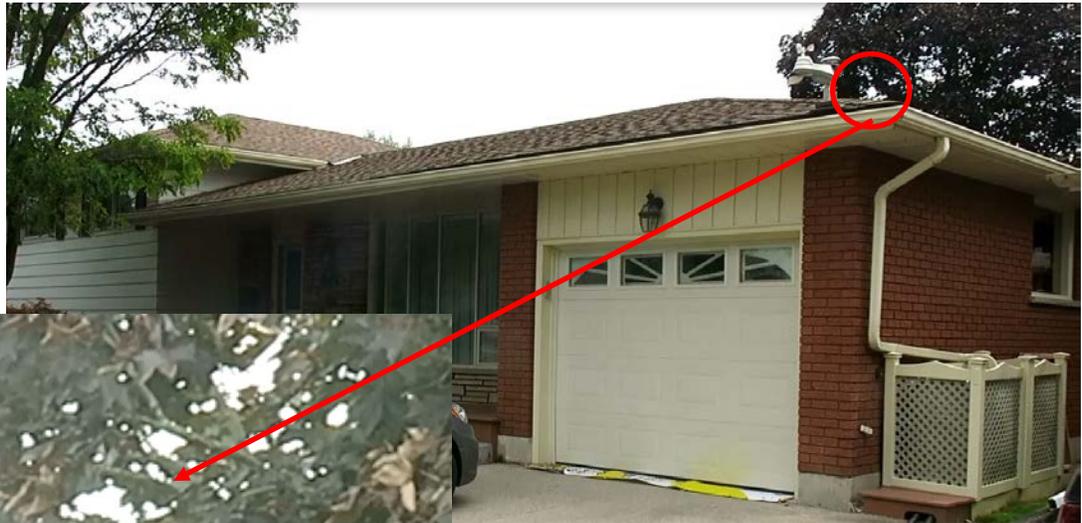
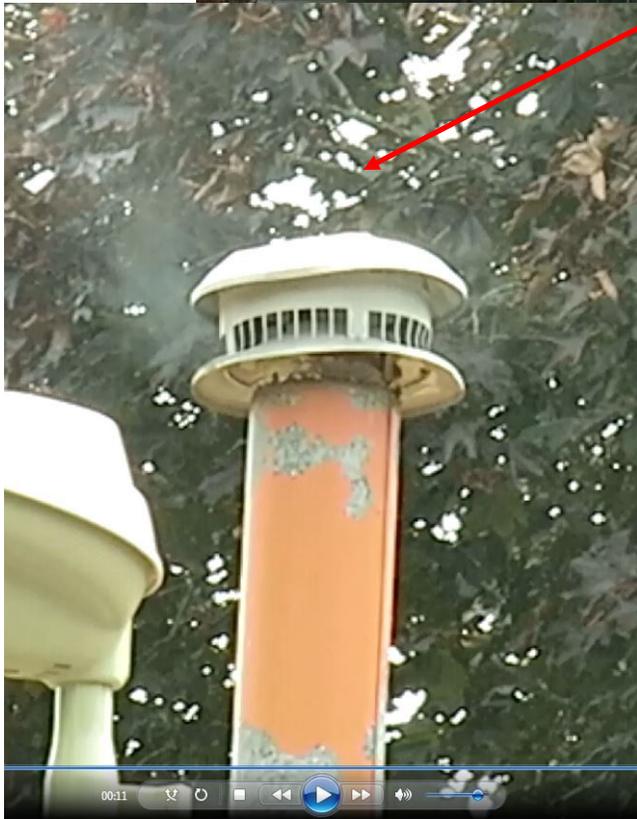
Defect Description: Smoke was seen from the roof (plumbing vent?) during storm smoke testing indicating a connection with the storm sewer system. Sanitary sewer smoke testing or dye testing is recommended to confirm connection of the plumbing to the storm sewer prior to any corrective action.

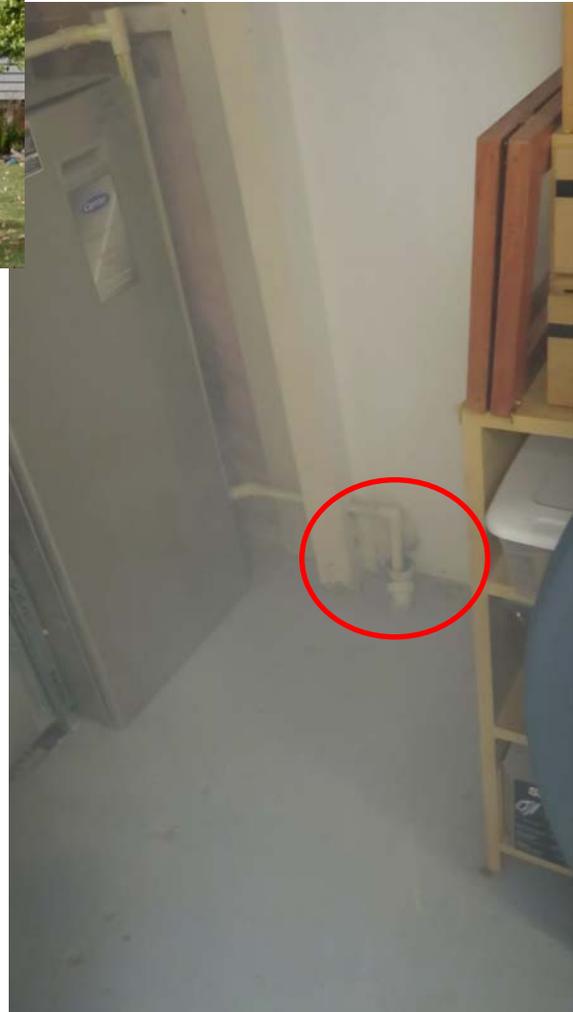
Defect Description: Drains to likely old sump pit that is under concrete.

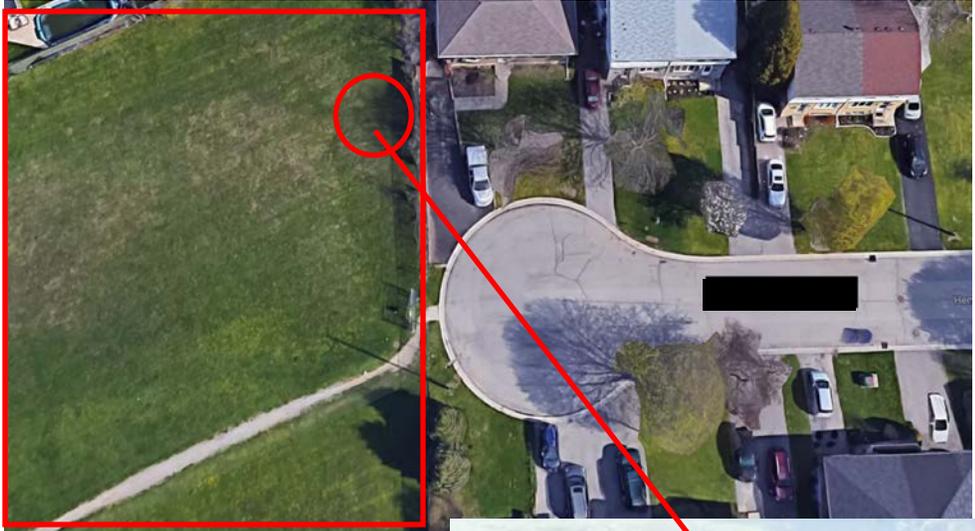
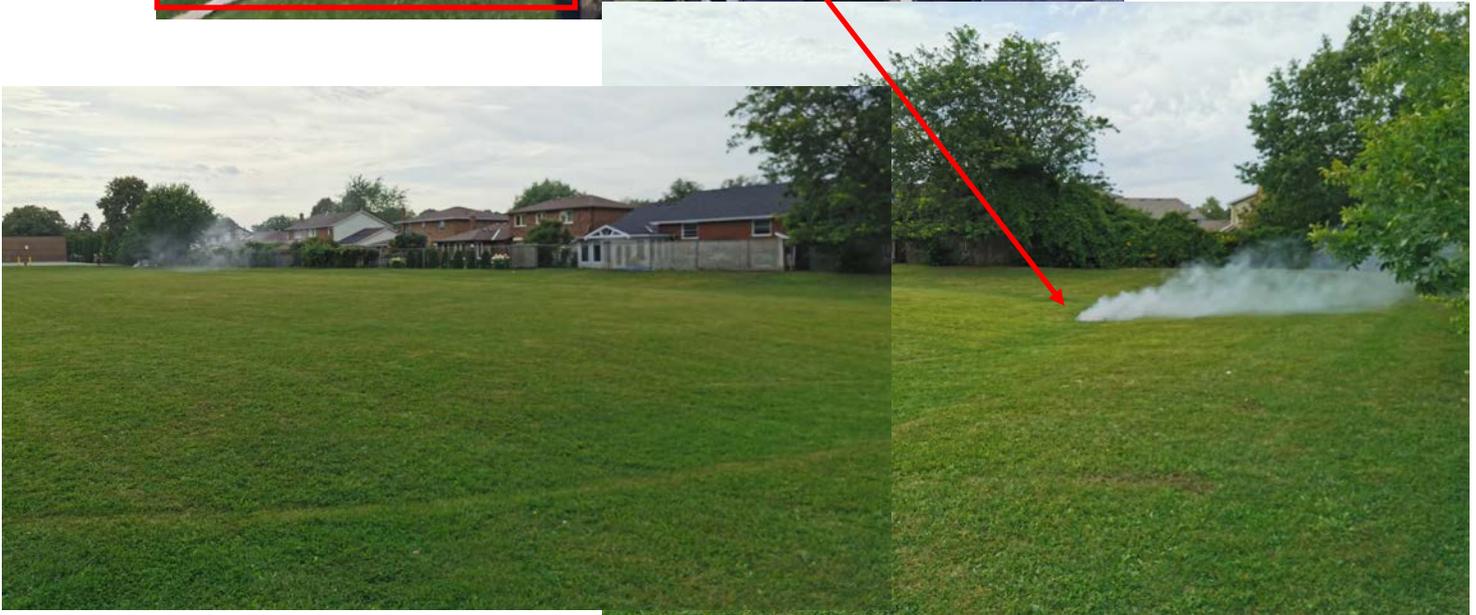
Defect Description: The park ditch Inlet CB's are connected to the storm sewer on Hemlock Ct. Surface water from the park during rain events is directed to the storm sewer on Hemlock Ct utilizing capacity.

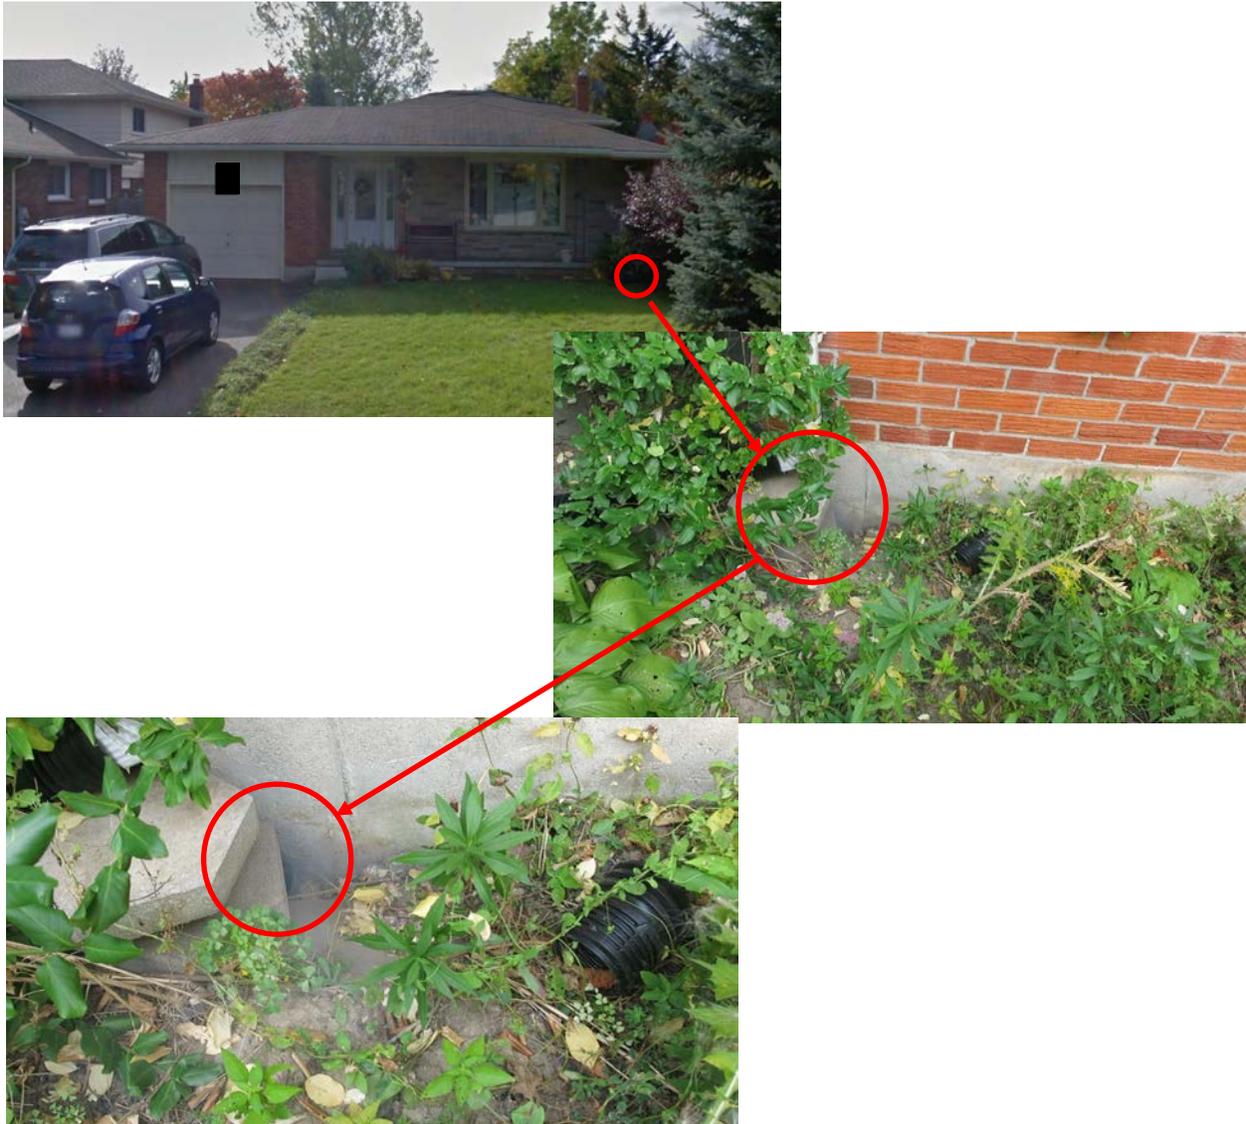
Improperly Disconnected Downspout with connection to Storm System

Defect Description: Downspout is connected to the storm sewer. This repair requires capping the former downspout connection to the storm sewer. Any downspout discharge to be directed to the surface with positive drainage 1 m away from the building foundation wall to prevent sewer inflow via the weeping tiles.

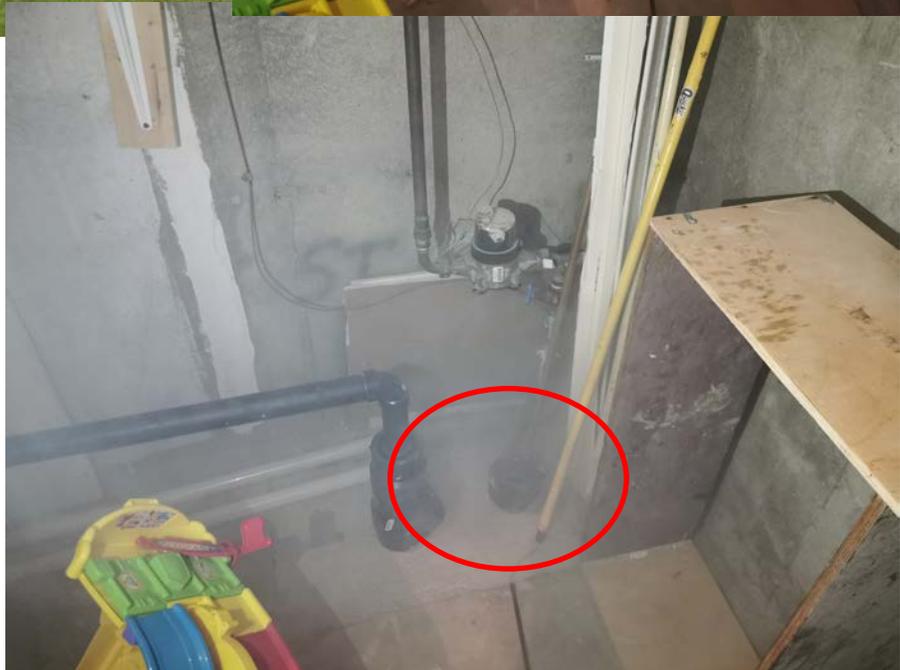
Defect Description: A sump pit in the basement is connected to the storm sewer via the weeping tiles and storm lateral. This smoked during our storm testing filling the basement with smoke. A definite connection to the storm sewer through this source.

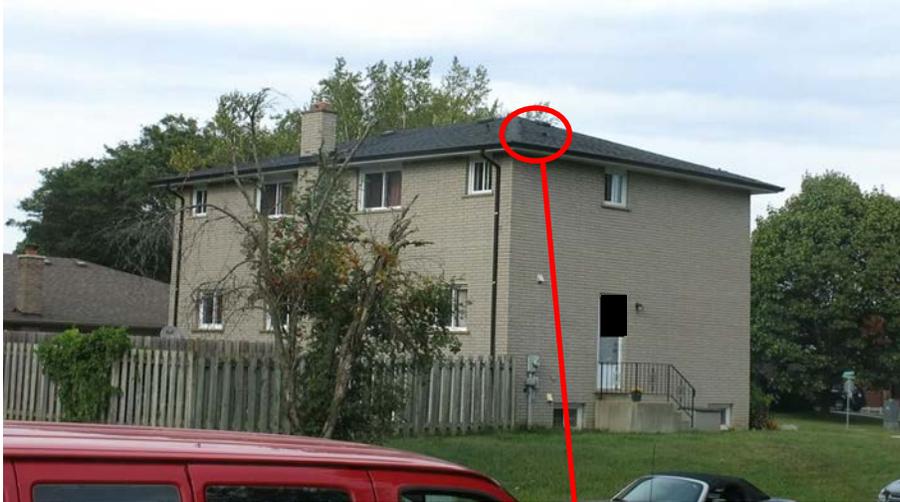
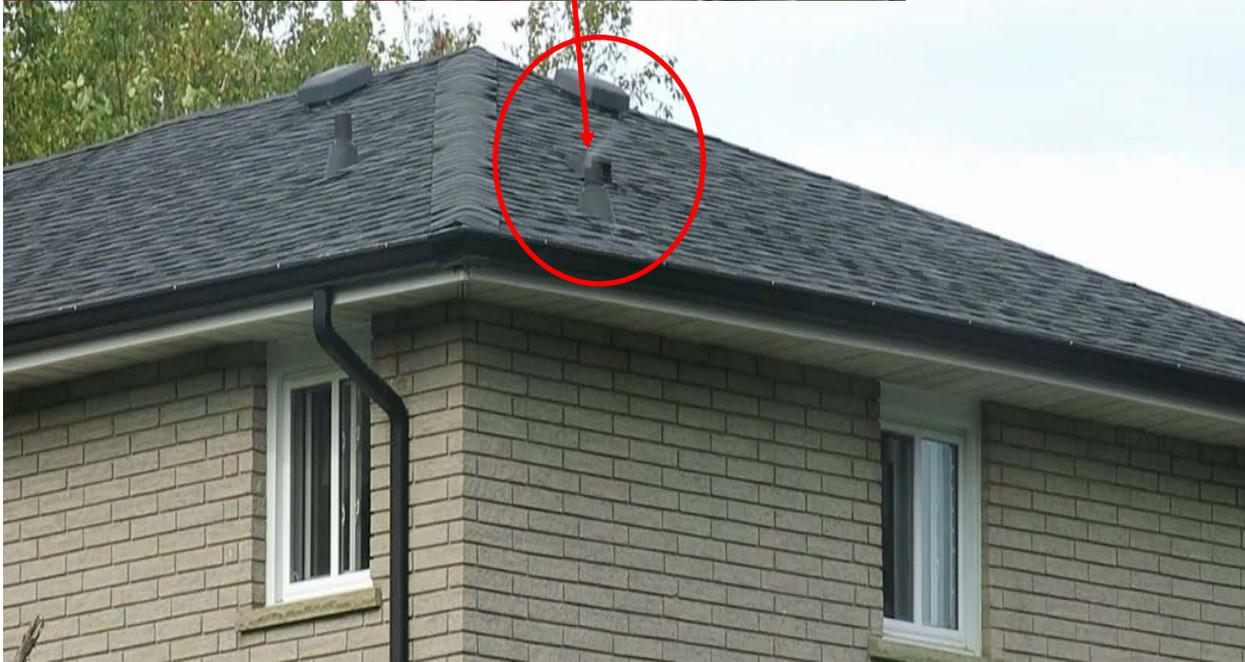
Defect Description: Smoke was seen from the plumbing vent during storm smoke testing indicating a connection with the storm sewer system. Sanitary sewer smoke testing or dye testing is recommended to confirm connection of the plumbing to the storm sewer prior to any corrective action.

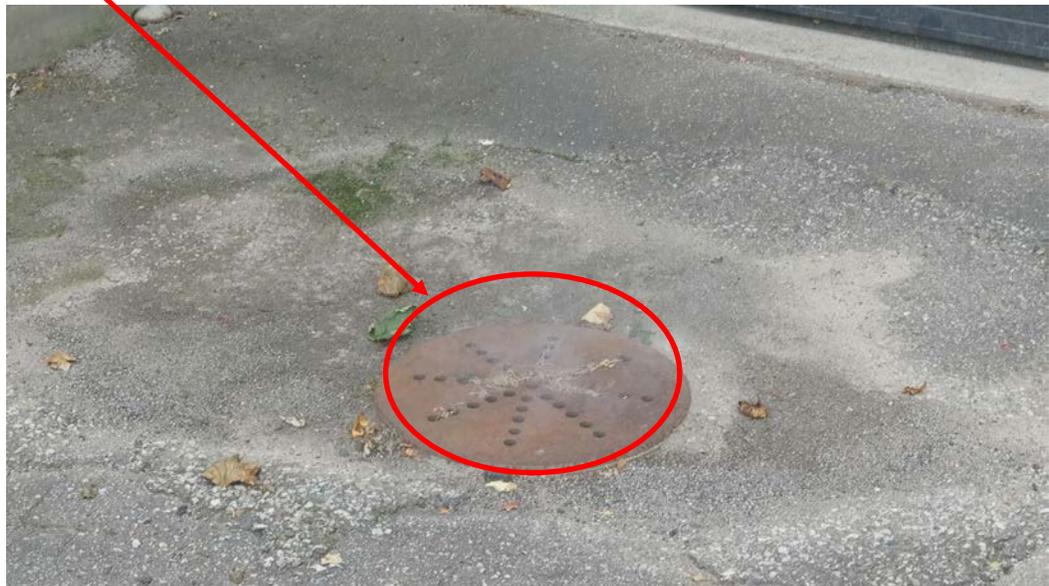
Defect Description: Reverse grade driveway drain is directly connected to the storm sewer as evidenced by visible smoke at the surface drain in the reverse grade driveway during smoke testing of the storm sewer system.

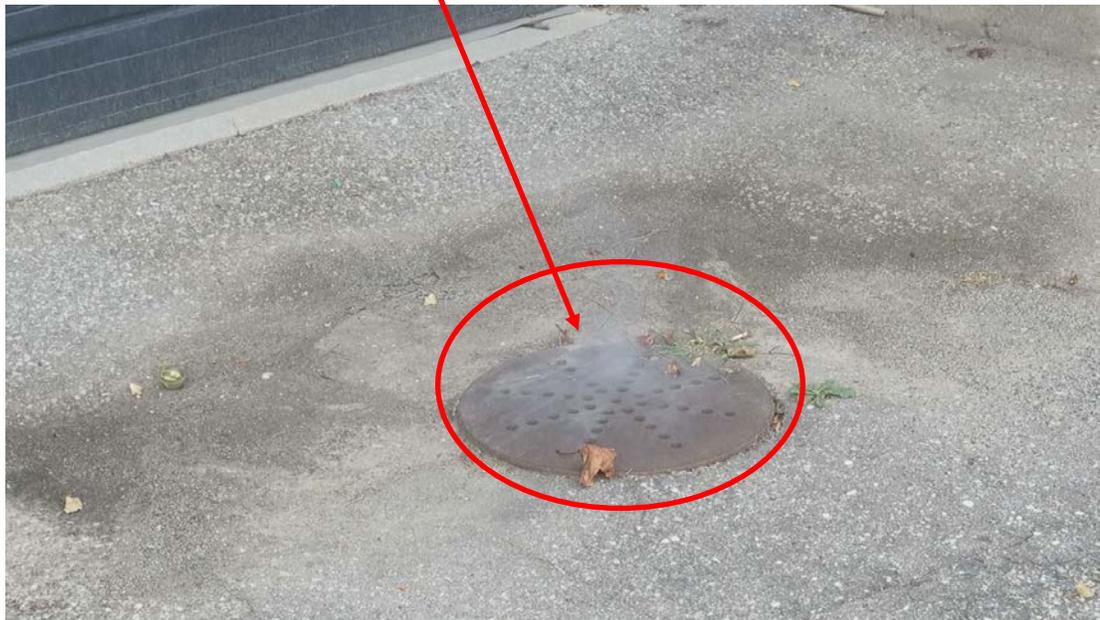
Defect Description: Reverse grade driveway drain is directly connected to the storm sewer as evidenced by visible smoke at the surface drain in the reverse grade driveway during smoke testing of the storm sewer system.
