Smoke Test Report

March 13, 2020

Re: 2019 Brantford Storm Sewer Smoke Testing
(Support Information for North East Flood Remediation Study)

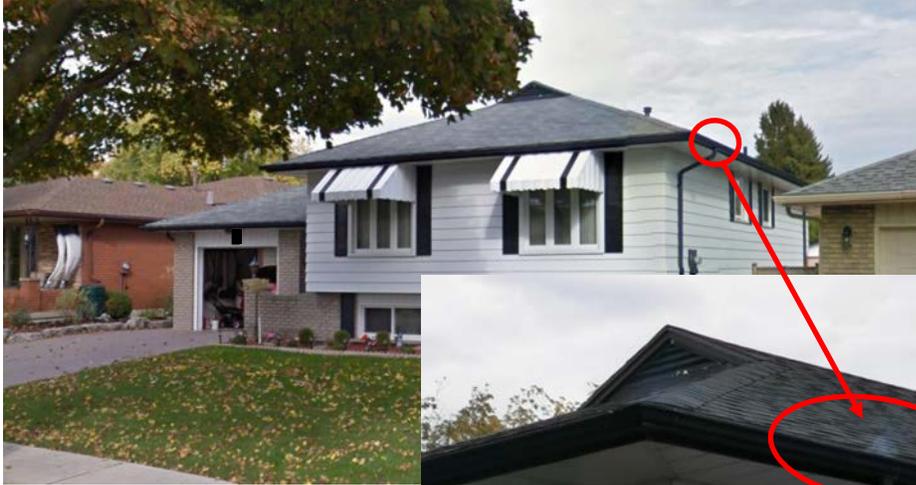
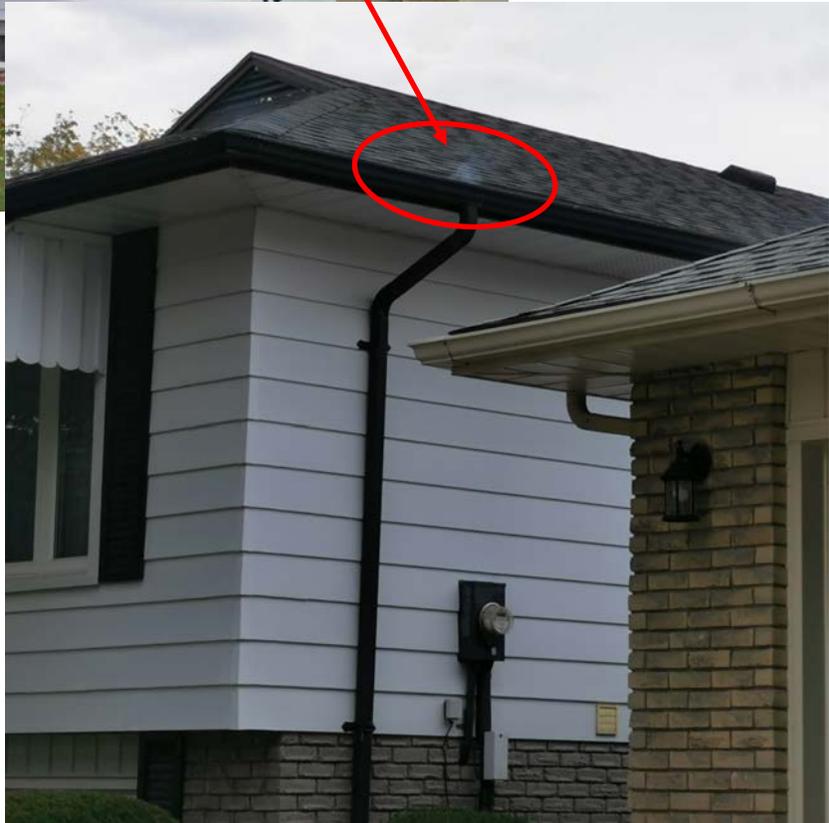
Defect Description: Downspout is connected to the storm sewer. Requires disconnection and discharge to the surface with positive drainage 1 m away from the building foundation wall to prevent sewer inflow via the weeping tiles.

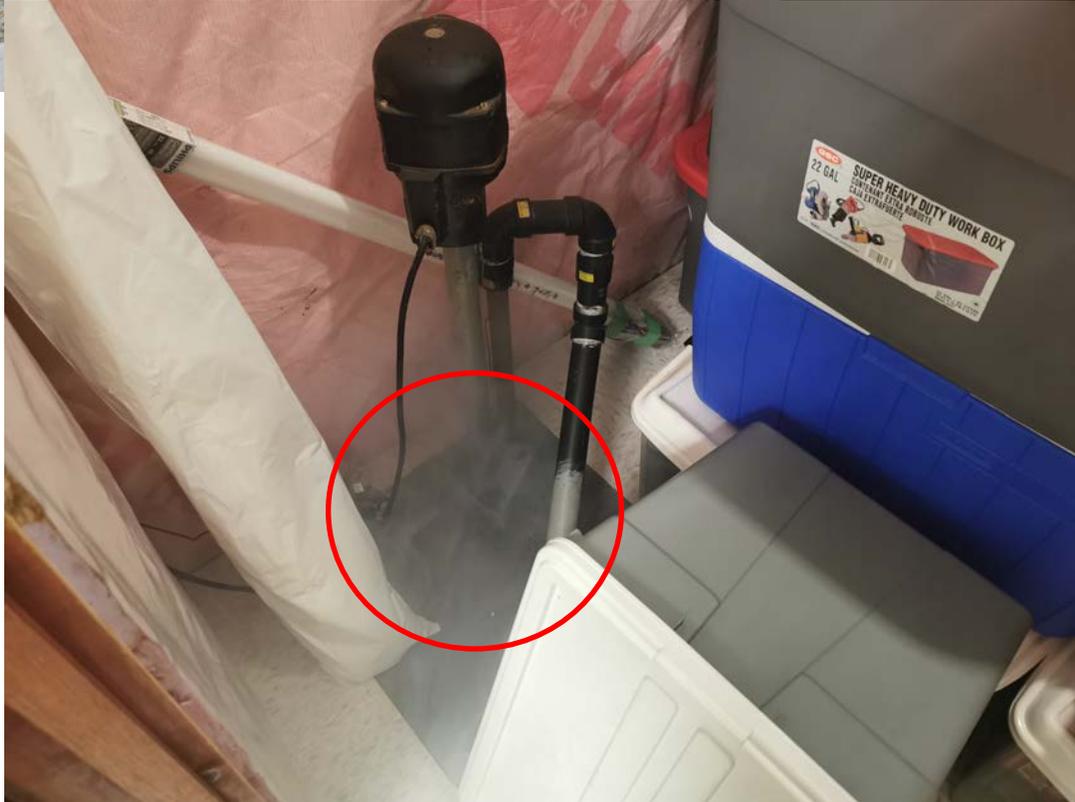
Defect Description: A sump pump pit in the basement is connected to the storm sewer via the weeping tiles and storm lateral. This smoked during our storm testing filling the basement with smoke. A definite connection to the storm sewer through this source.

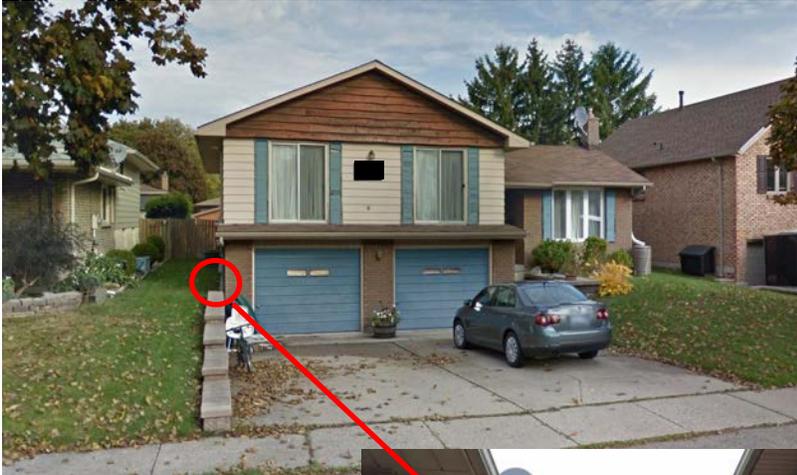
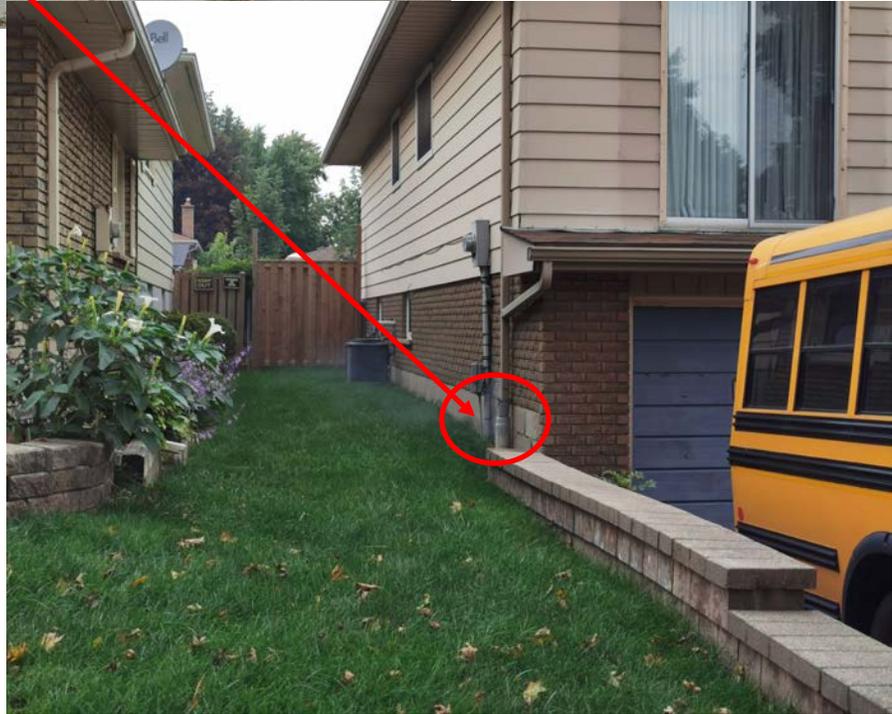
Defect Description: Downspout is connected to the storm sewer. Requires disconnection and discharge to the surface with positive drainage 1 m away from the building foundation wall to prevent sewer inflow via the weeping tiles.

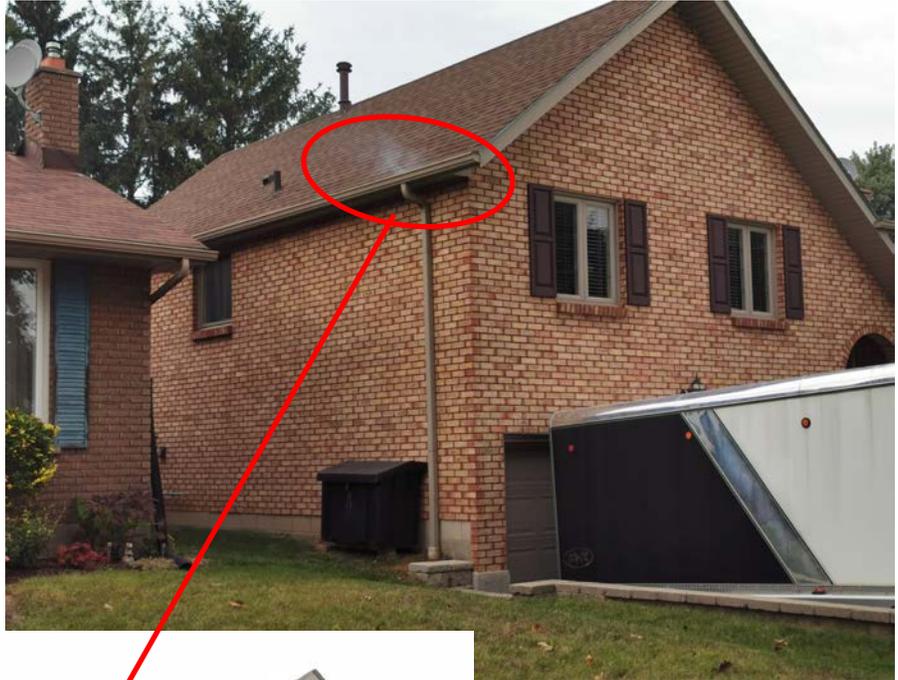
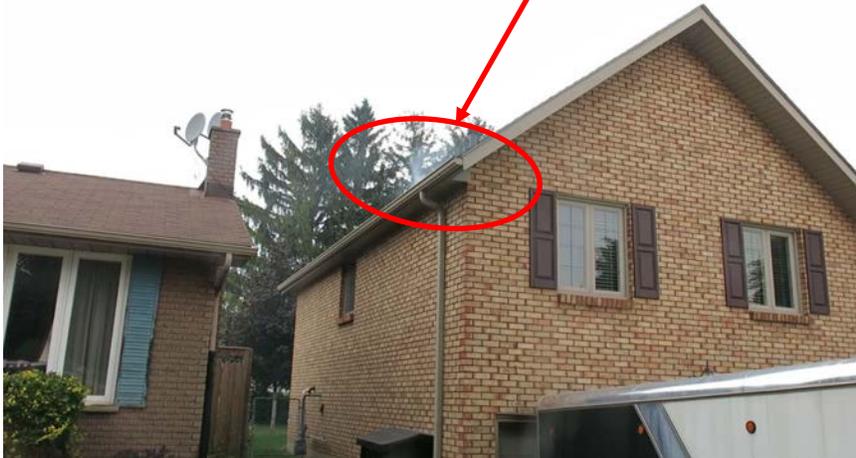
Defect Description: Downspout is connected to the storm sewer. Requires disconnection and discharge to an appropriate outlet with positive drainage away from the building foundation wall to prevent sewer inflow.

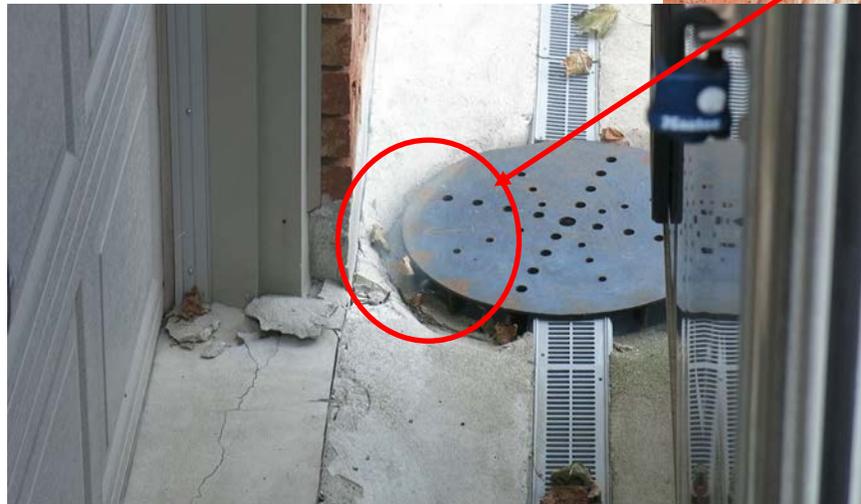
Defect Description: Reverse grade driveway drain is directly connected to the storm sewer as evidenced by visible smoke at the surface drain in the driveway during smoke testing of the storm sewer system.

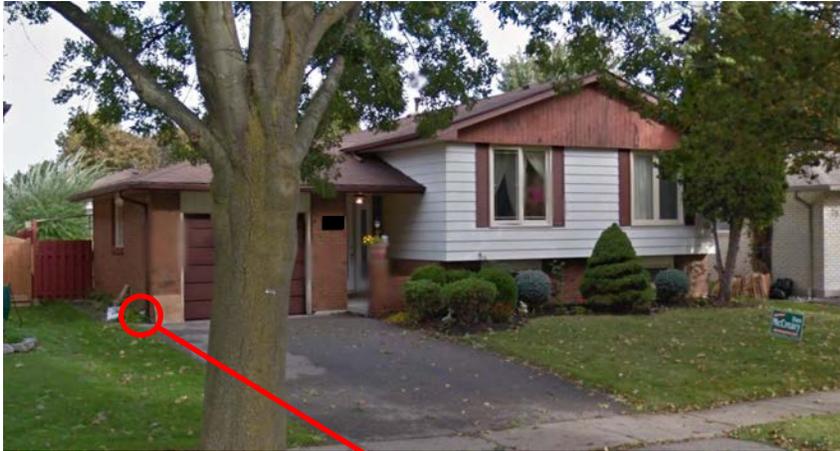
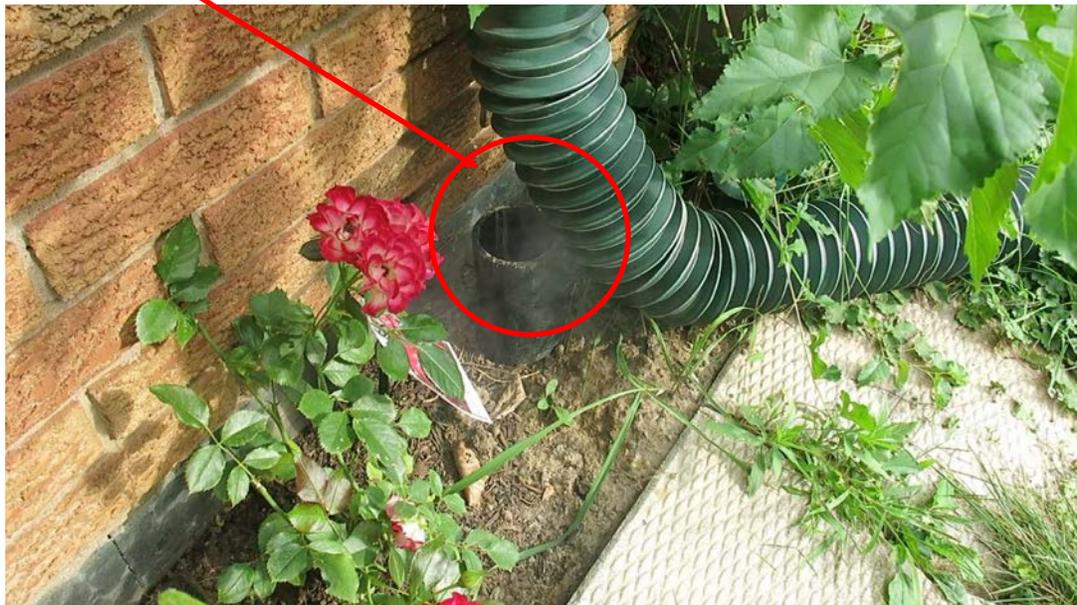
Improperly Disconnected Downspout with connection to Storm System

Defect Description: Downspout is connected to the storm sewer. This repair requires capping the former downspout connection to the storm sewer. Any downspout discharge to be directed to the surface with positive drainage 1 m away from the building foundation wall to prevent sewer inflow via the weeping tiles.

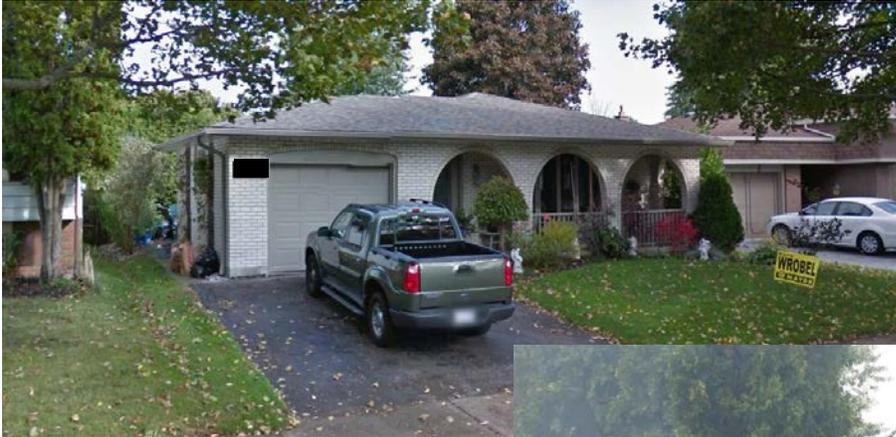
Defect Description: Heavy smoke was seen from the plumbing vent during storm smoke testing indicating a connection with the storm sewer system. Sanitary sewer smoke testing or dye testing is recommended to confirm connection of the plumbing to the storm sewer prior to any corrective action.

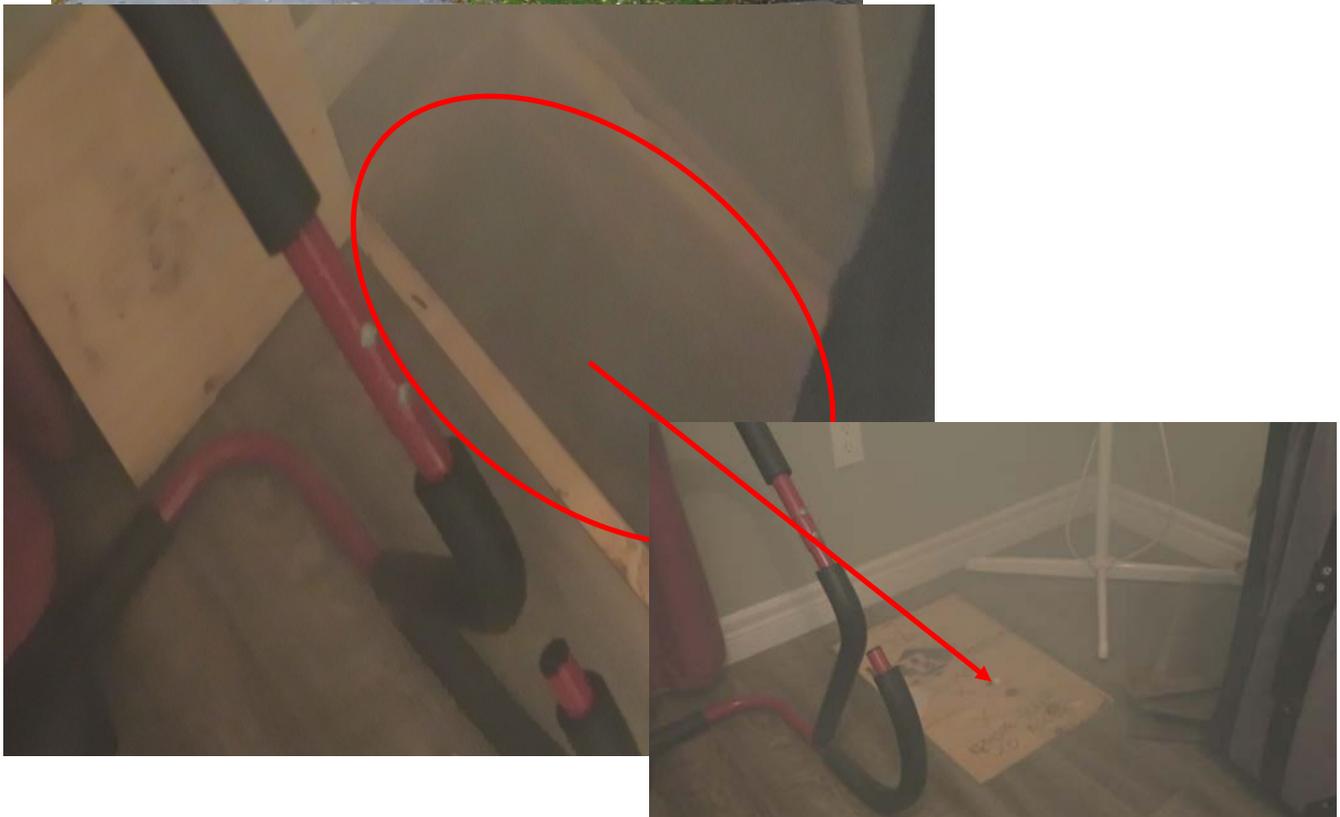
Defect Description: A sump pit / cleanout in the basement is connected to the storm sewer via the weeping tiles and storm lateral. This smoked during our storm testing filling the basement with smoke. A definite connection to the storm sewer through this source.

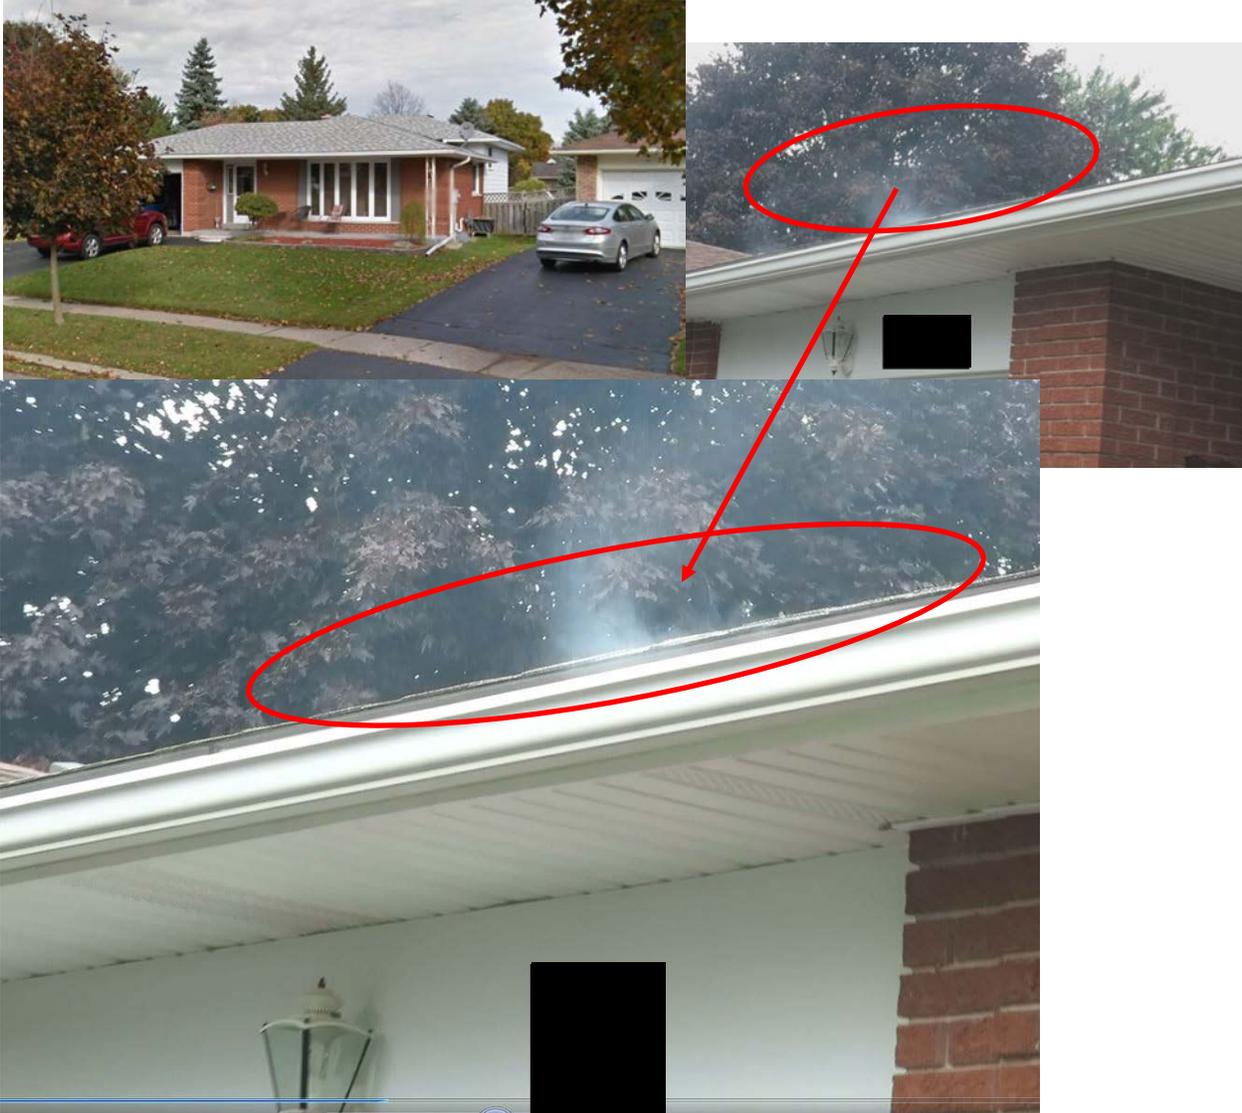
Defect Description: Smoke appeared at the eavestrough but the nearest downspout was disconnected. Source is unknown but could be a broken plumbing vent discharging into the eaves and the san lateral is connected to the storm sewer (a cross connection). Smoke test sanitary system or dye test to confirm connection.

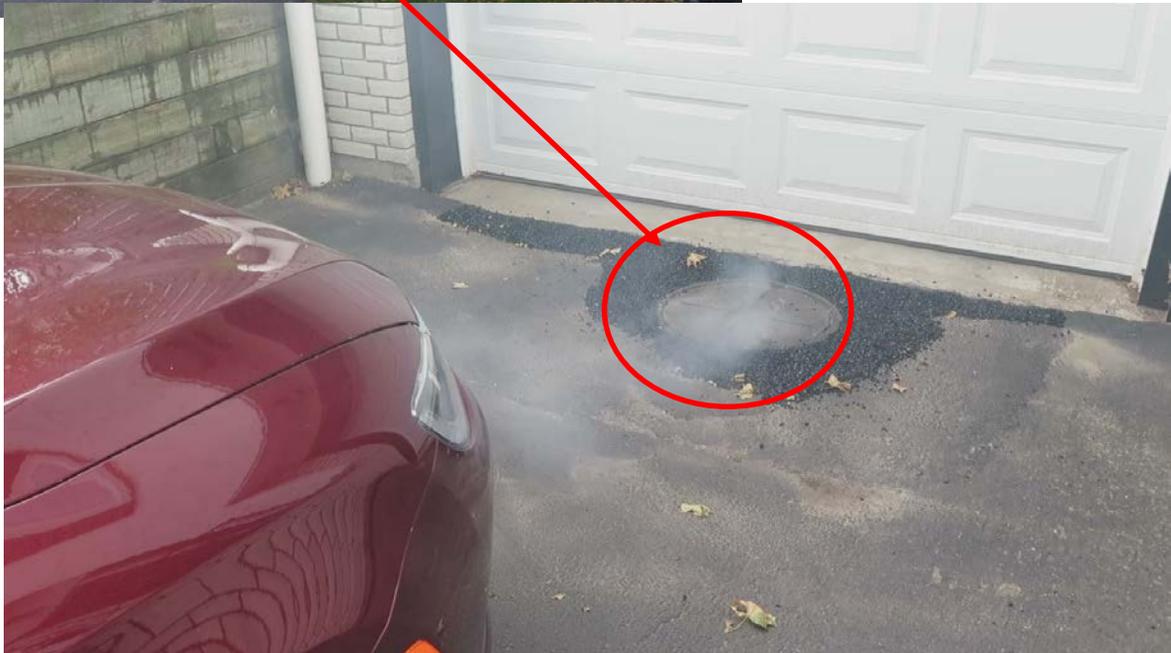
Defect Description: Reverse grade driveway drain is directly connected to the storm sewer as evidenced by visible smoke at the surface drain in the reverse grade driveway during smoke testing of the storm sewer system.

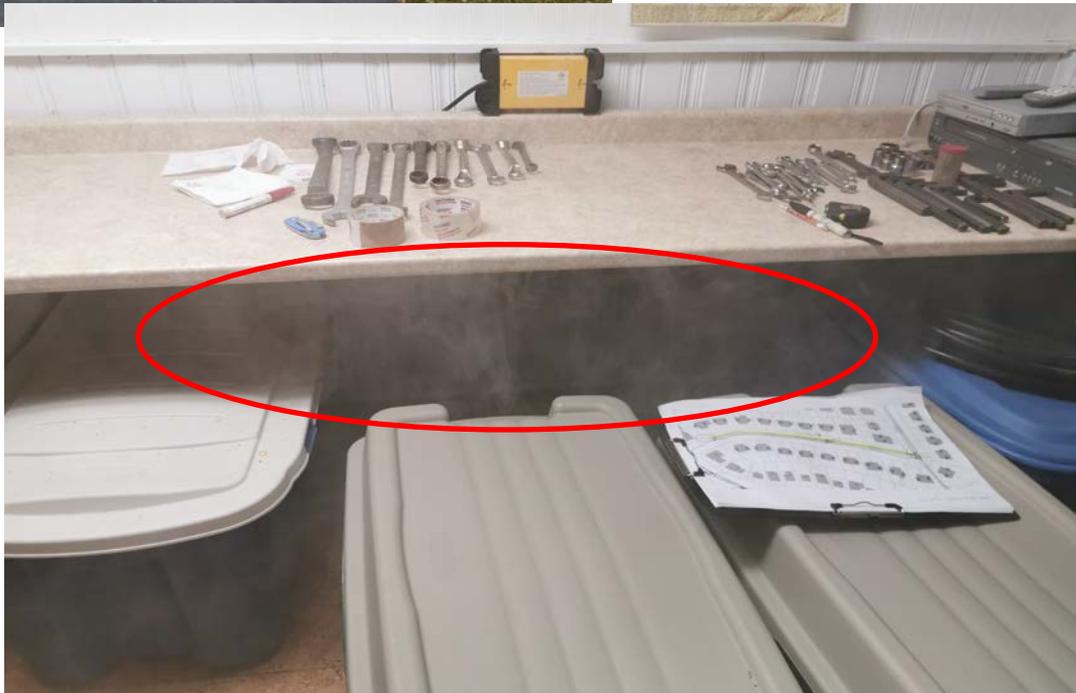
Defect Description: A sump pit / clean out in the basement is connected to the storm sewer via the weeping tiles and storm lateral. This smoked during our storm testing filling the basement with smoke. A definite connection to the storm sewer through this source.

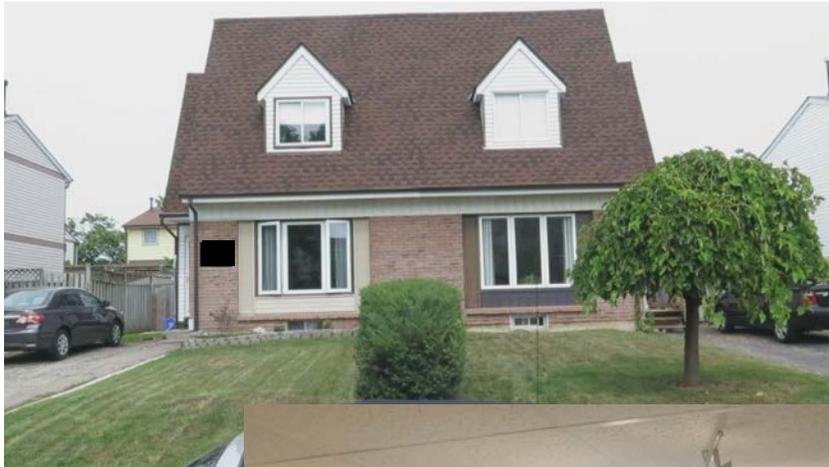
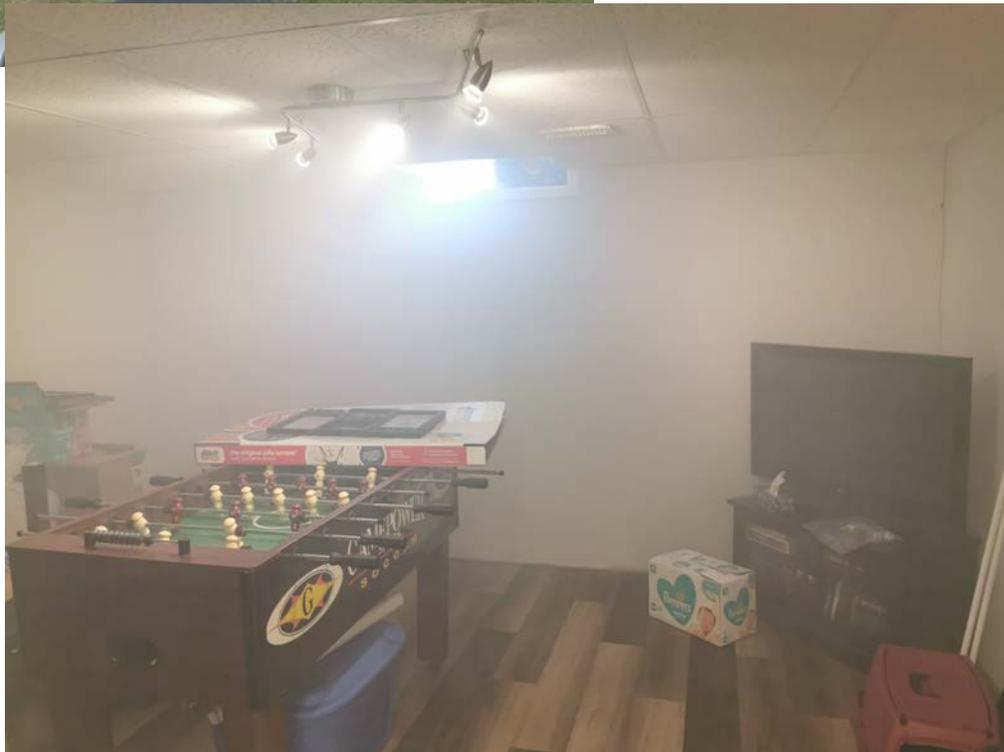
Defect Description: An area under floor boards, not visible, is the likely source for smoke. A sump pit /clean out in the basement is connected to the storm sewer via the weeping tiles and storm lateral. This smoked during our storm testing filling the basement with smoke. A definite connection to the storm sewer through this source.

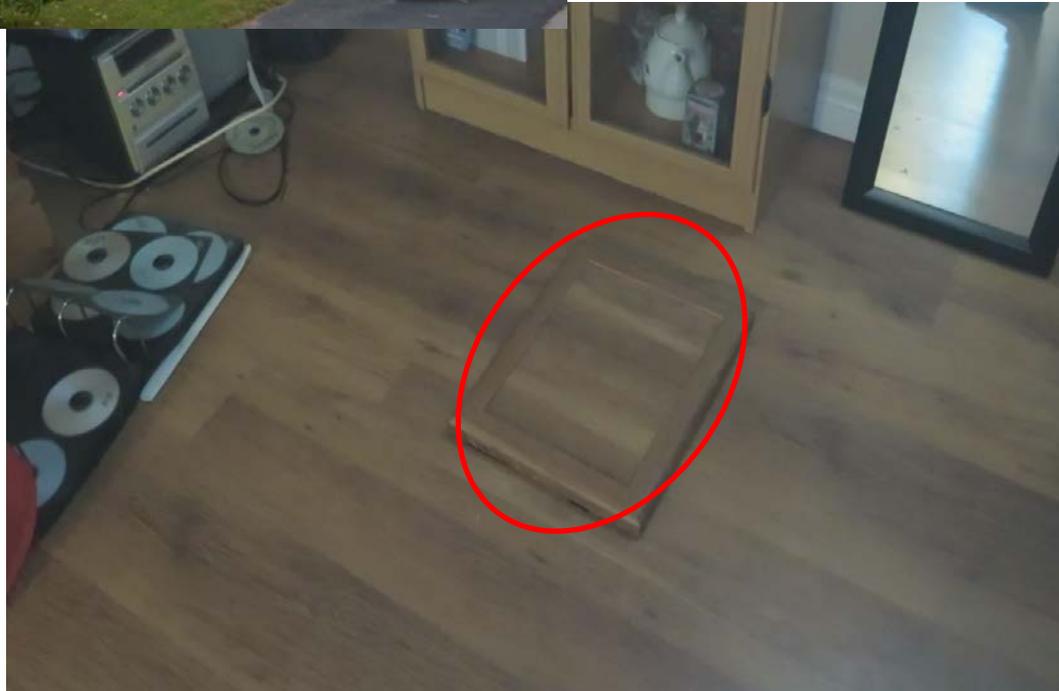
Defect Description: A sump pit / clean out in the basement is connected to the storm sewer via the weeping tiles and storm lateral. This smoked during our storm testing filling the basement with smoke. A definite connection to the storm sewer through this source.

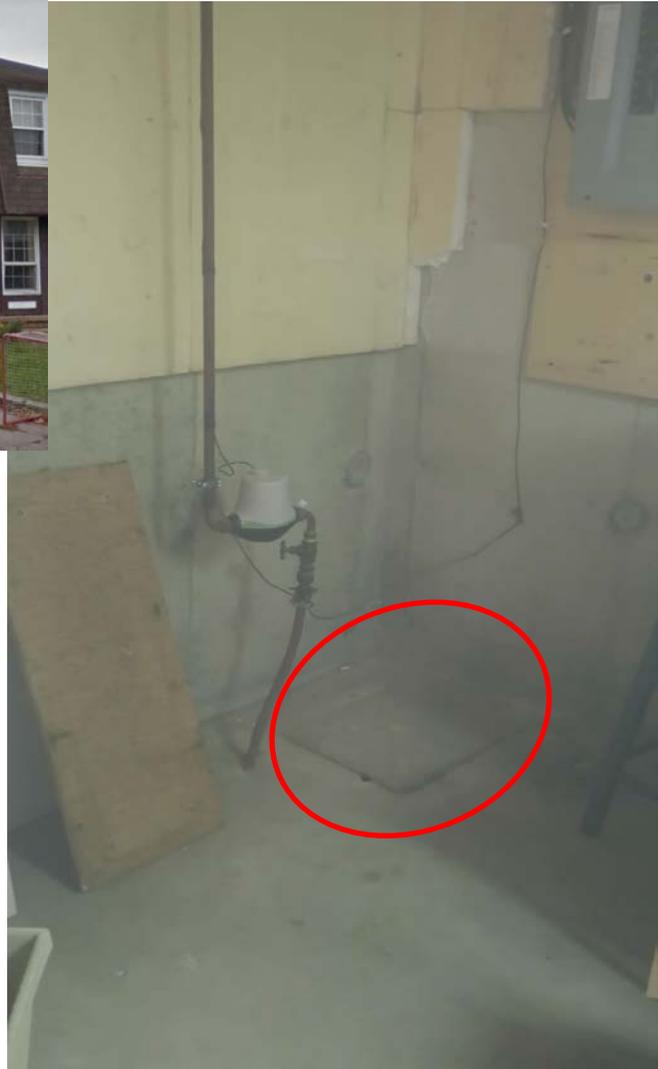
Defect Description: A sump pit / clean out in the basement is connected to the storm sewer via the weeping tiles and storm lateral. This smoked during our storm testing filling the basement with smoke. A definite connection to the storm sewer through this source.

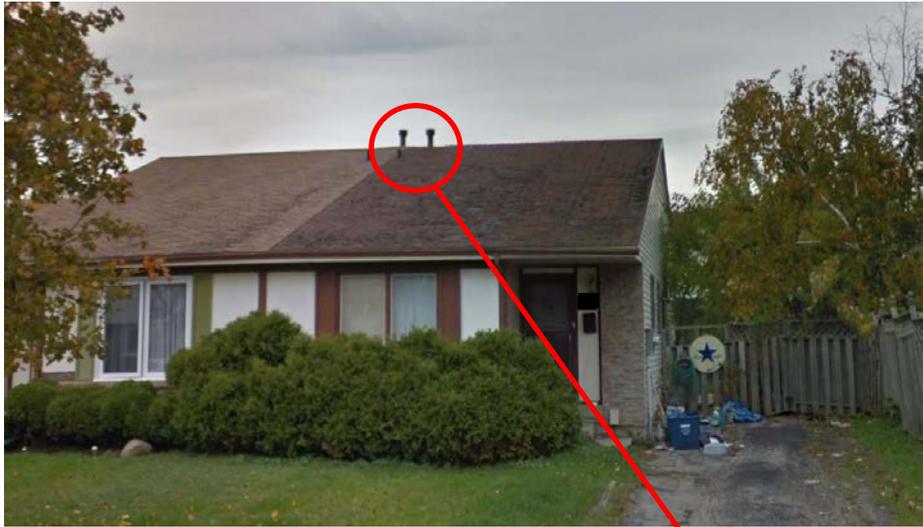
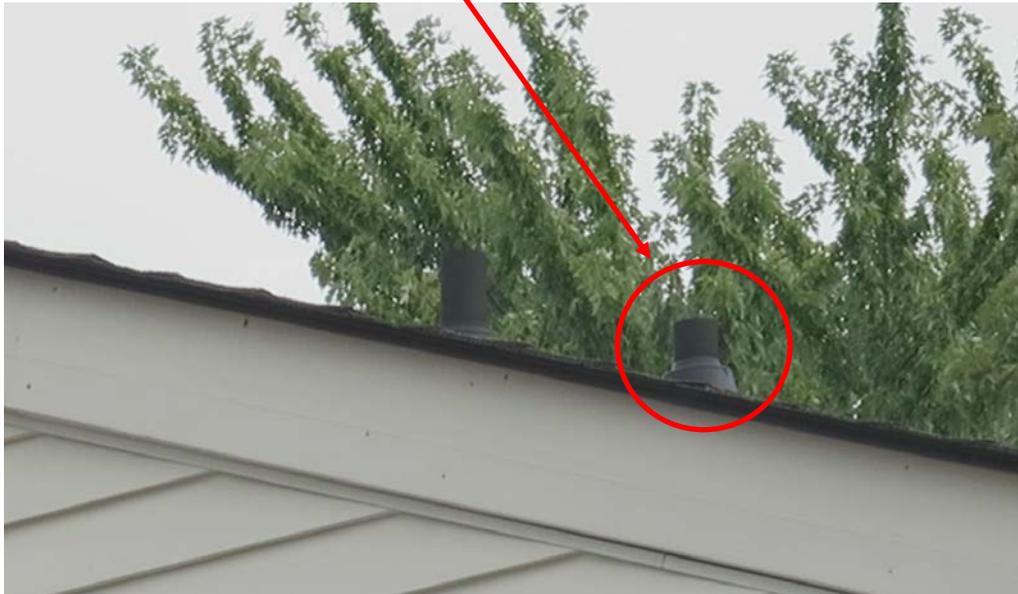
Defect Description: Smoke was seen from the plumbing vent during storm smoke testing indicating a connection with the storm sewer system. Sanitary sewer smoke testing or dye testing is recommended to confirm connection of the plumbing to the storm sewer prior to any corrective action.

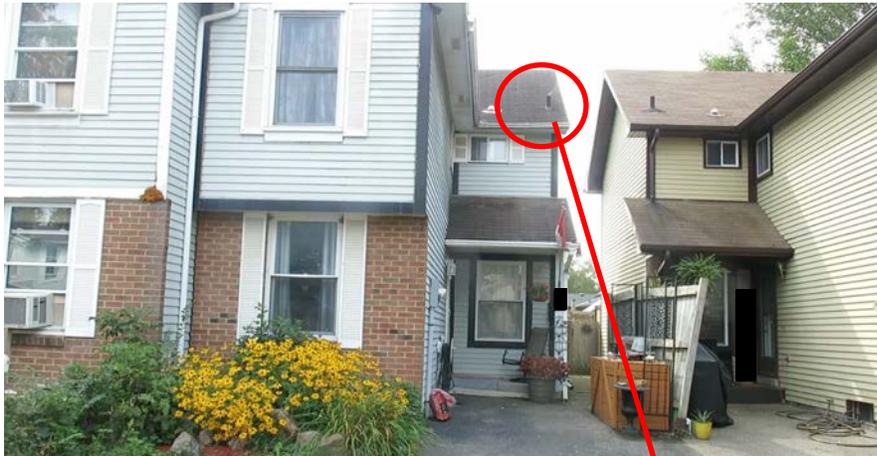
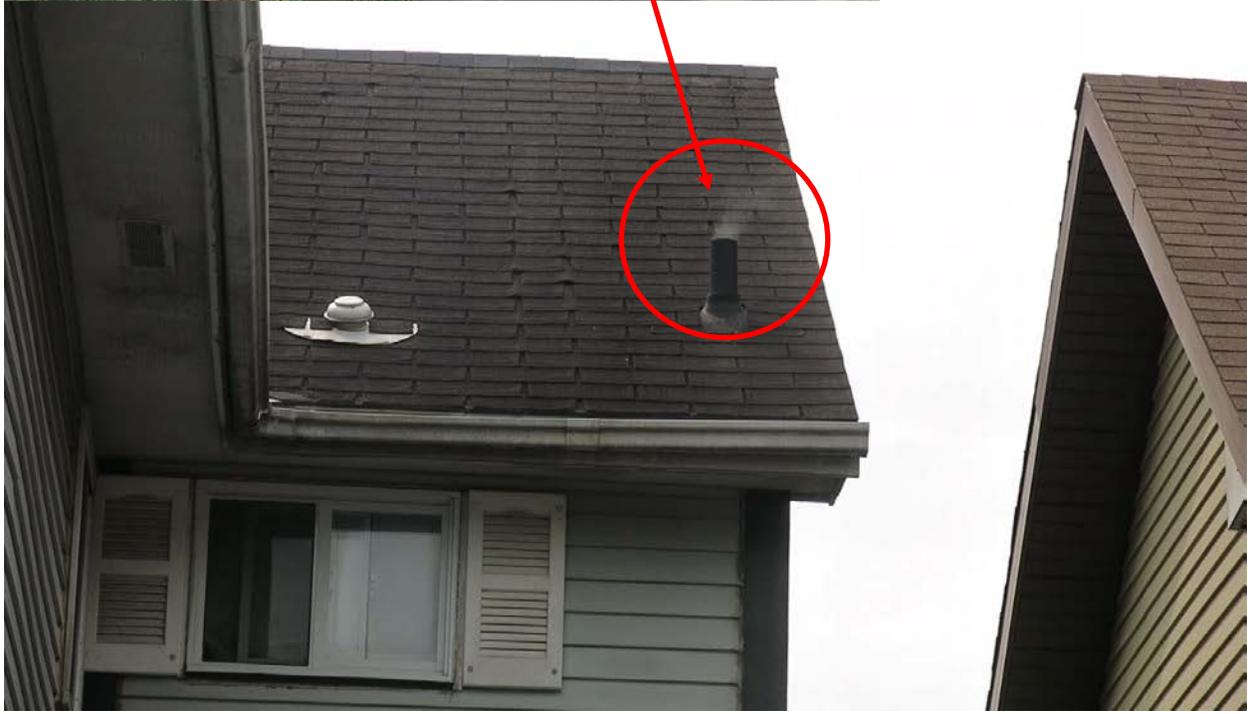
Defect Description: Smoke was seen from the plumbing vent during storm smoke testing indicating a connection with the storm sewer system. Sanitary sewer smoke testing or dye testing is recommended to confirm connection of the plumbing to the storm sewer prior to any corrective action.

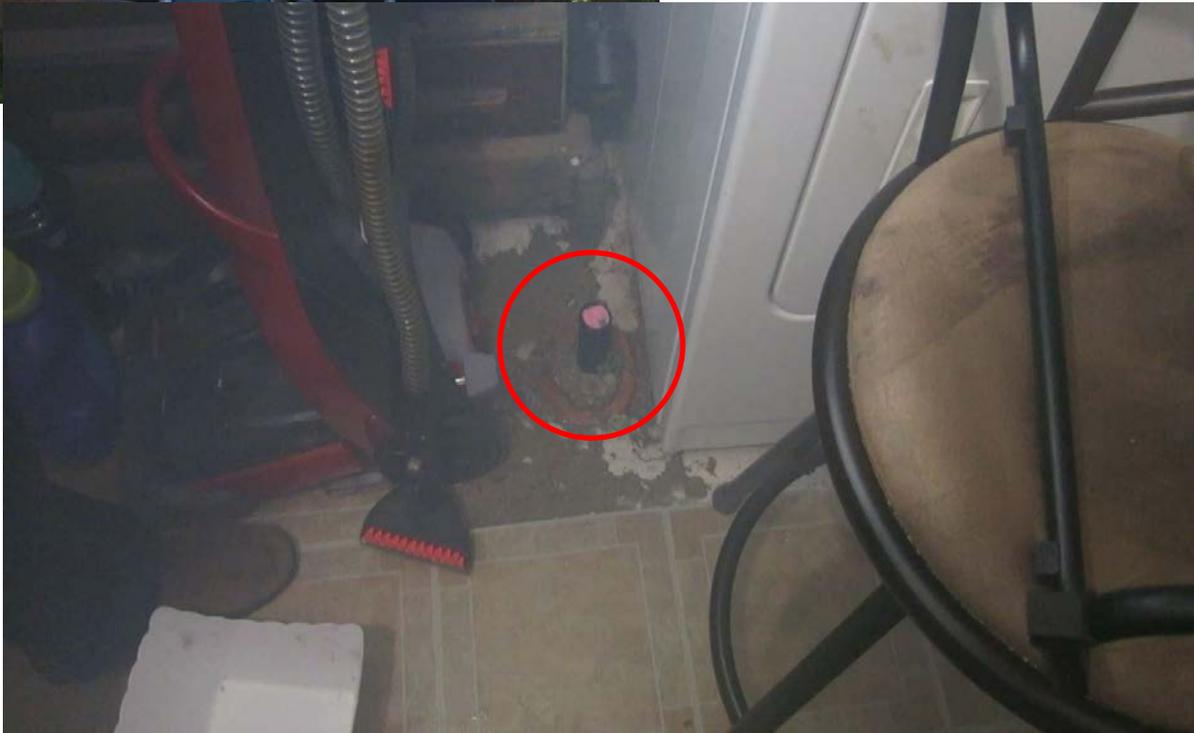
Defect Description: A sump pit / clean out in the basement is connected to the storm sewer via the weeping tiles and storm lateral. This smoked during our storm testing filling the basement with smoke. A definite connection to the storm sewer through this source.

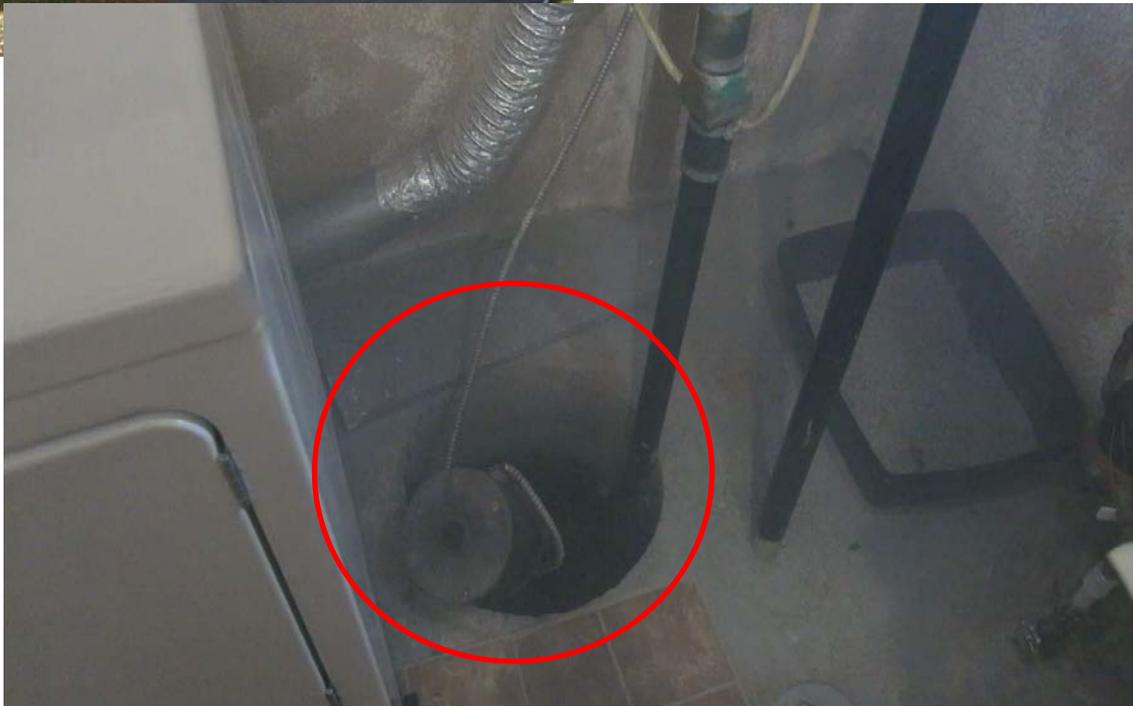
Defect Description: A sump pit / clean out in the basement is connected to the storm sewer via the weeping tiles and storm lateral. This smoked during our storm testing filling the basement with smoke. A definite connection to the storm sewer through this source.

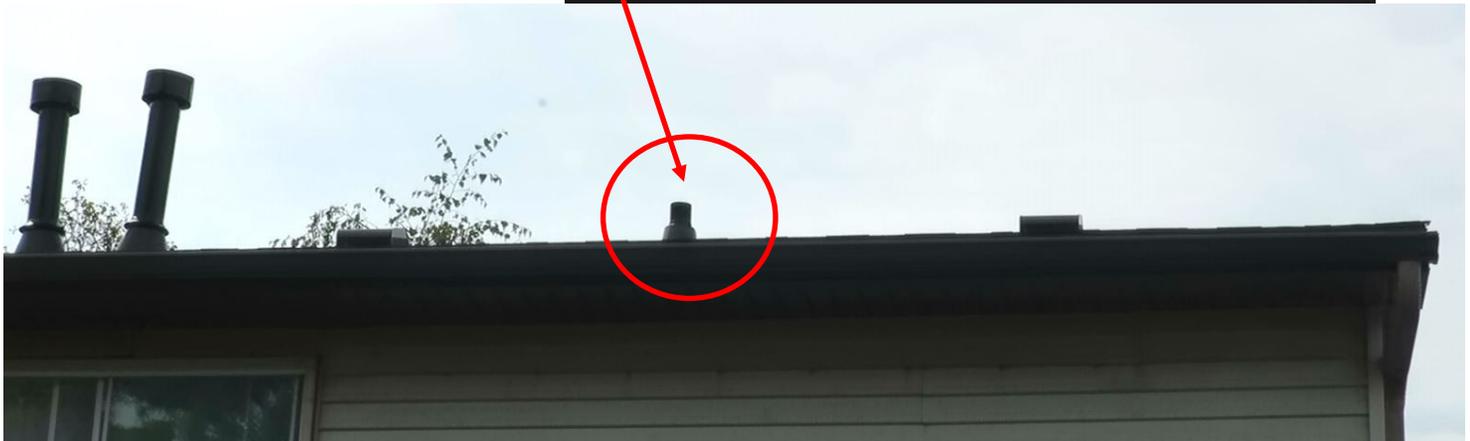
Defect Description: Smoke was seen from the plumbing vent during storm smoke testing indicating a connection with the storm sewer system. Sanitary sewer smoke testing or dye testing is recommended to confirm connection of the plumbing to the storm sewer prior to any corrective action.

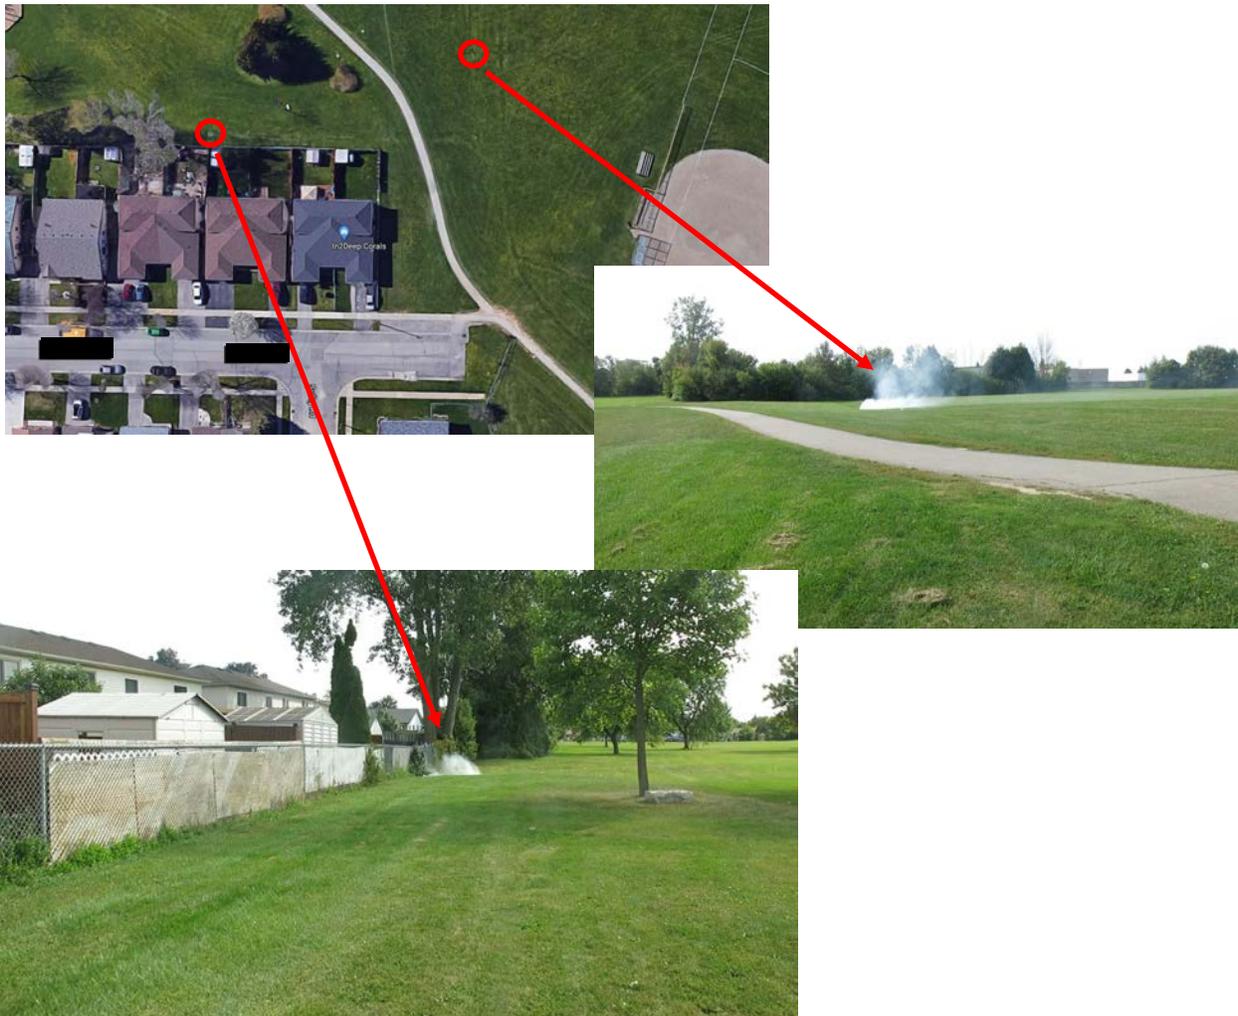
Defect Description: CB leads connect to Palomino Dr . The park ditch Inlet CB's are connected to the storm sewer on Palomino Dr. Surface water from the park during rain events is directed to the storm sewer utilizing capacity.

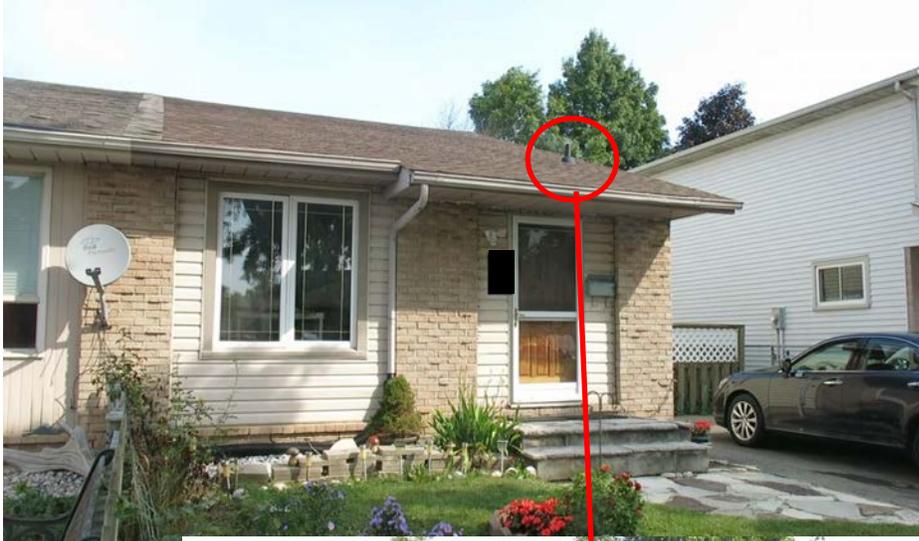
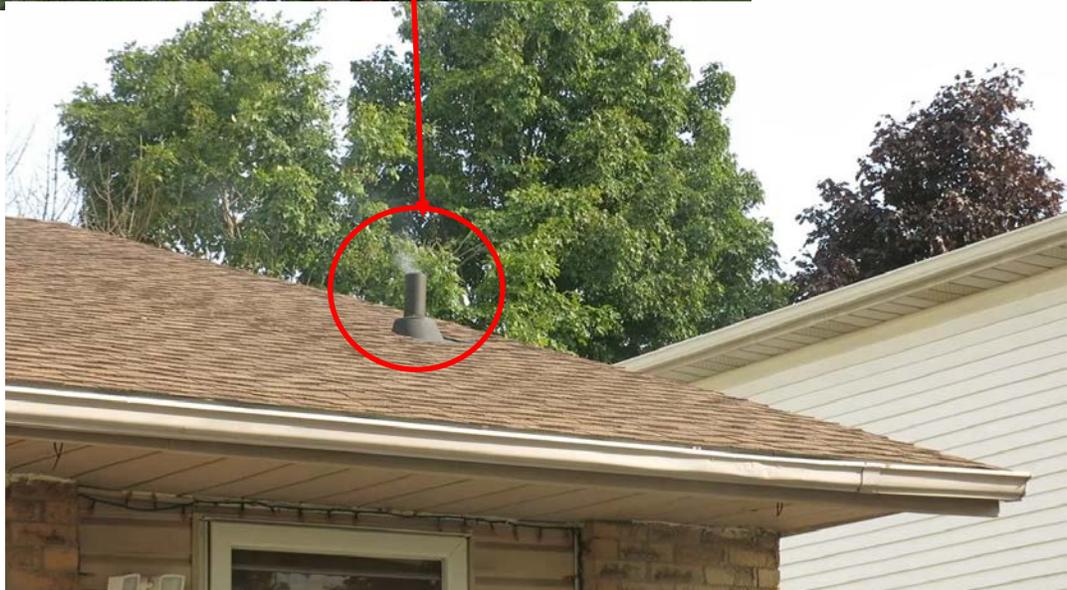
Defect Description: Smoke was seen from the plumbing vent during storm smoke testing indicating a connection with the storm sewer system. Sanitary sewer smoke testing or dye testing is recommended to confirm connection of the plumbing to the storm sewer prior to any corrective action.

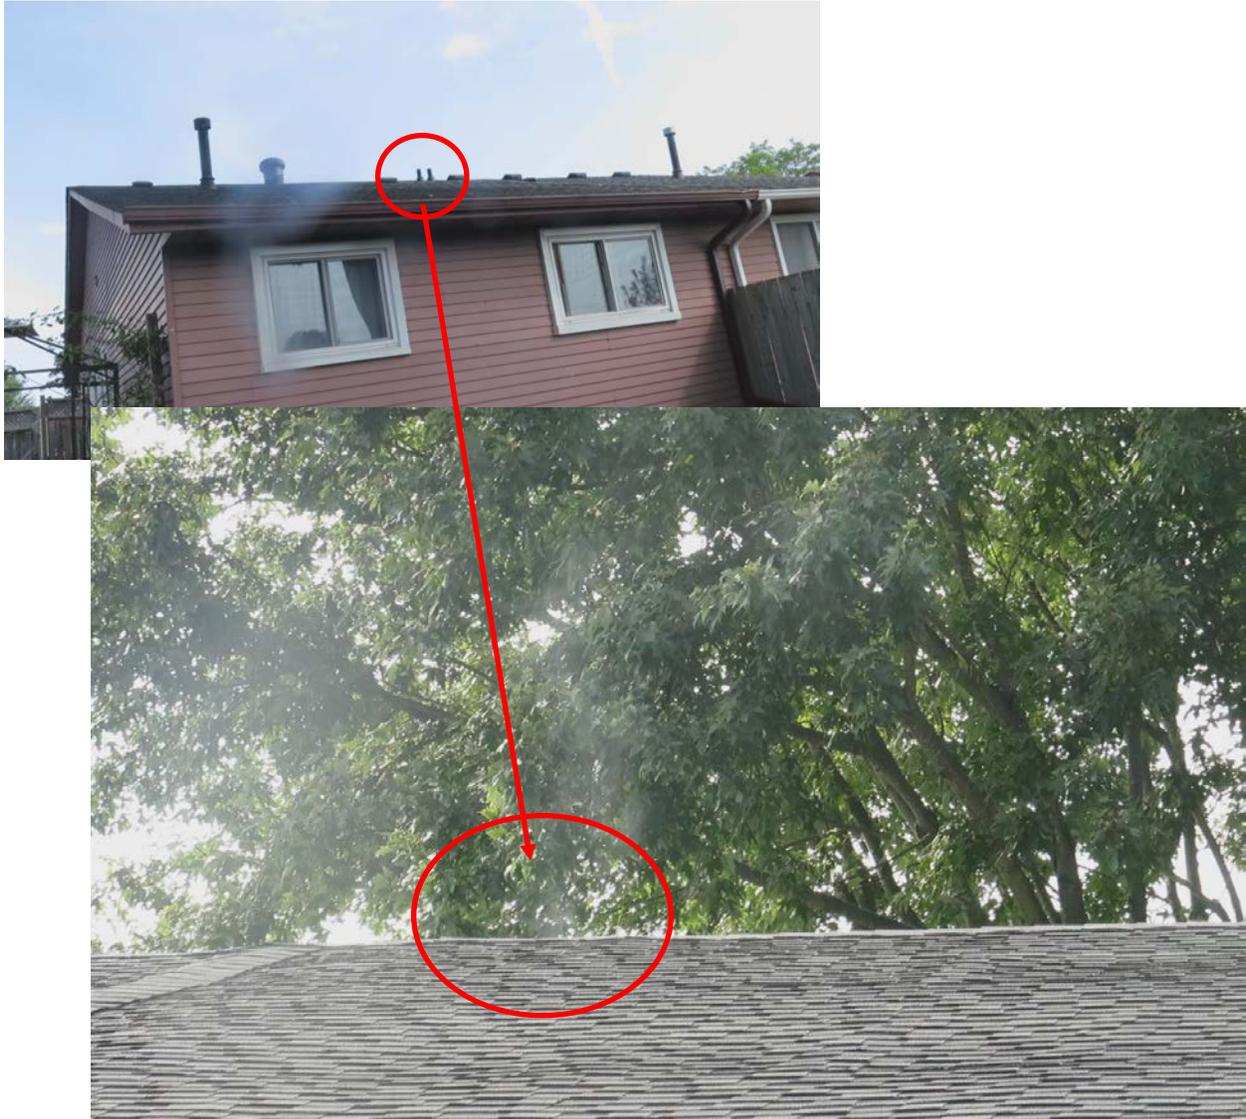
Defect Description: Smoke was seen from the plumbing vent during storm smoke testing indicating a connection with the storm sewer system. Sanitary sewer smoke testing or dye testing is recommended to confirm connection of the plumbing to the storm sewer prior to any corrective action.
