Smoke Test Report

March 13, 2020

Re: 2019 Brantford Storm Sewer Smoke Testing
(Support Information for North East Flood Remediation Study)

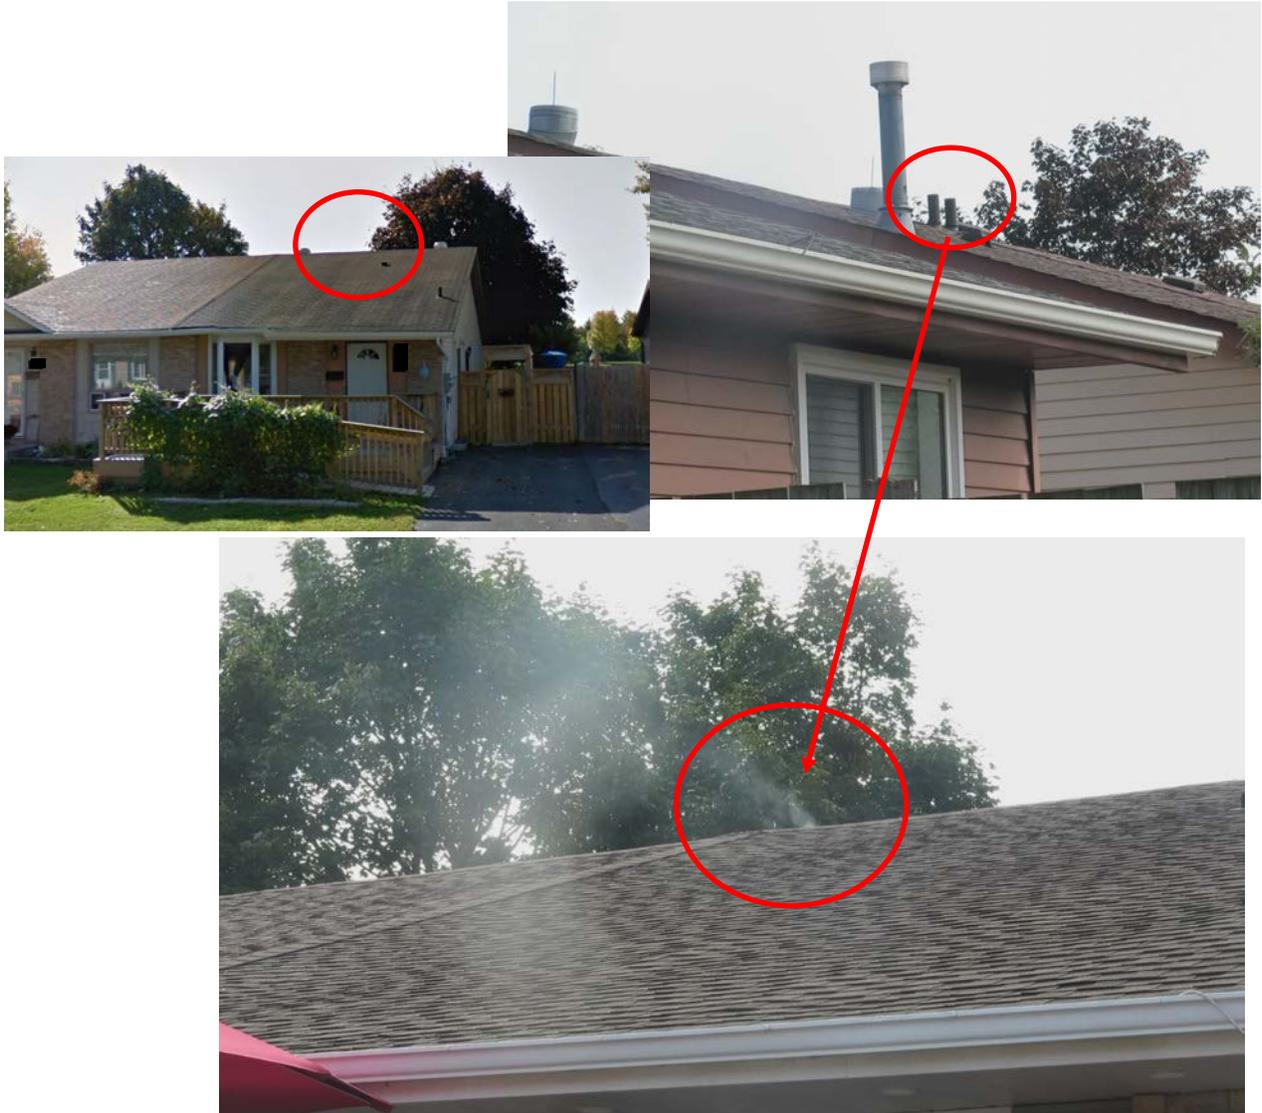
Defect Description: Smoke was seen from the plumbing vent during storm smoke testing indicating a connection with the storm sewer system. Sanitary sewer smoke testing or dye testing is recommended to confirm connection of the plumbing to the storm sewer prior to any corrective action.

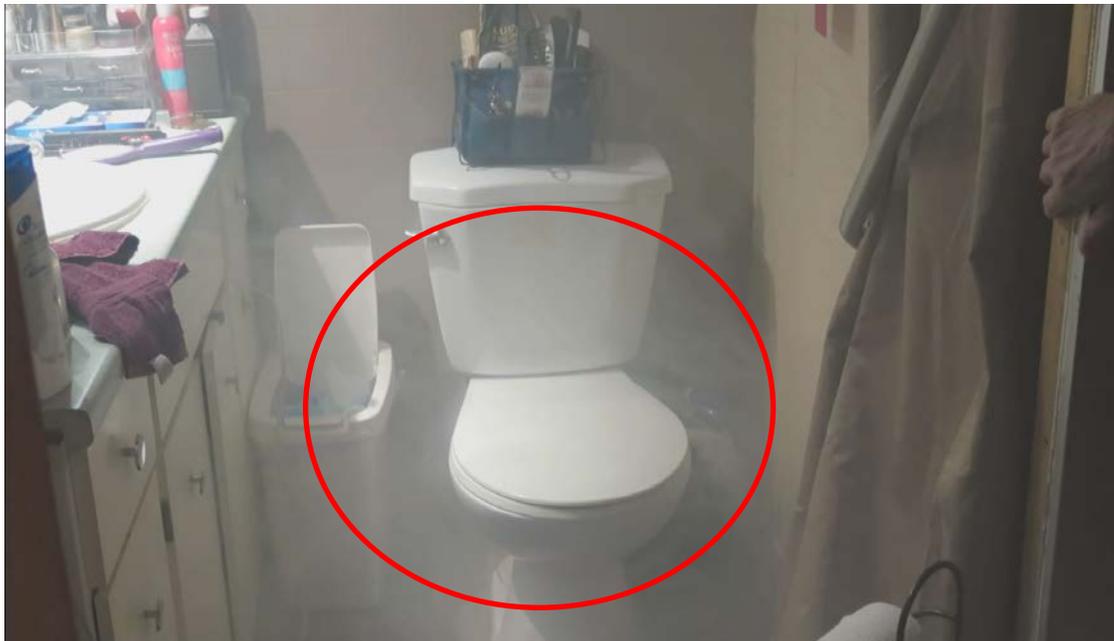
Defect Description: Smoke appeared in basement coming out of the walls. Unknown source possible plumbing cross connection issue. The san lateral is connected to the storm sewer (a cross connection). Smoke test sanitary system or dye test to confirm connection.

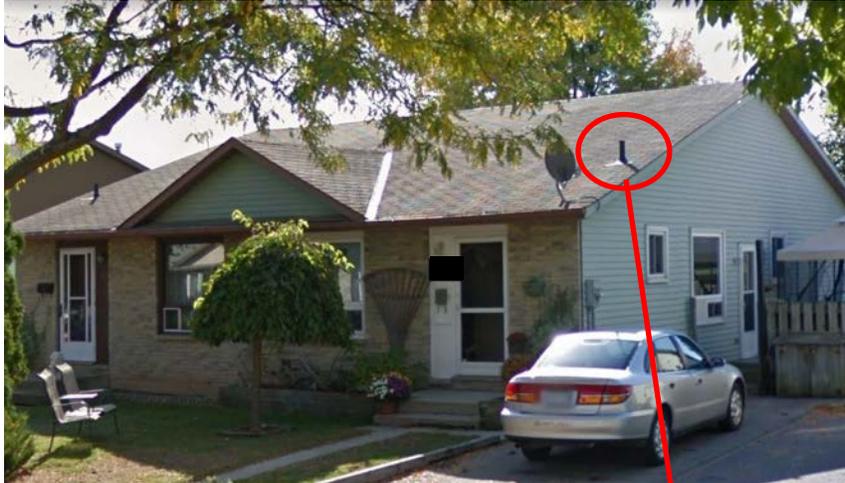
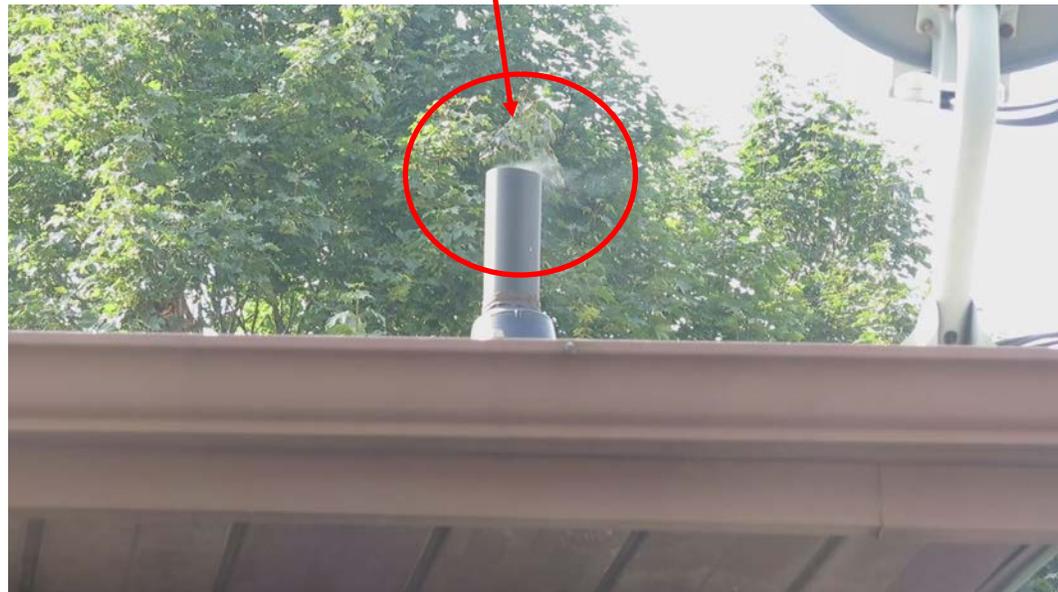
Defect Description: Smoke was seen from the plumbing vent during storm smoke testing indicating a connection with the storm sewer system. Sanitary sewer smoke testing or dye testing is recommended to confirm connection of the plumbing to the storm sewer prior to any corrective action.

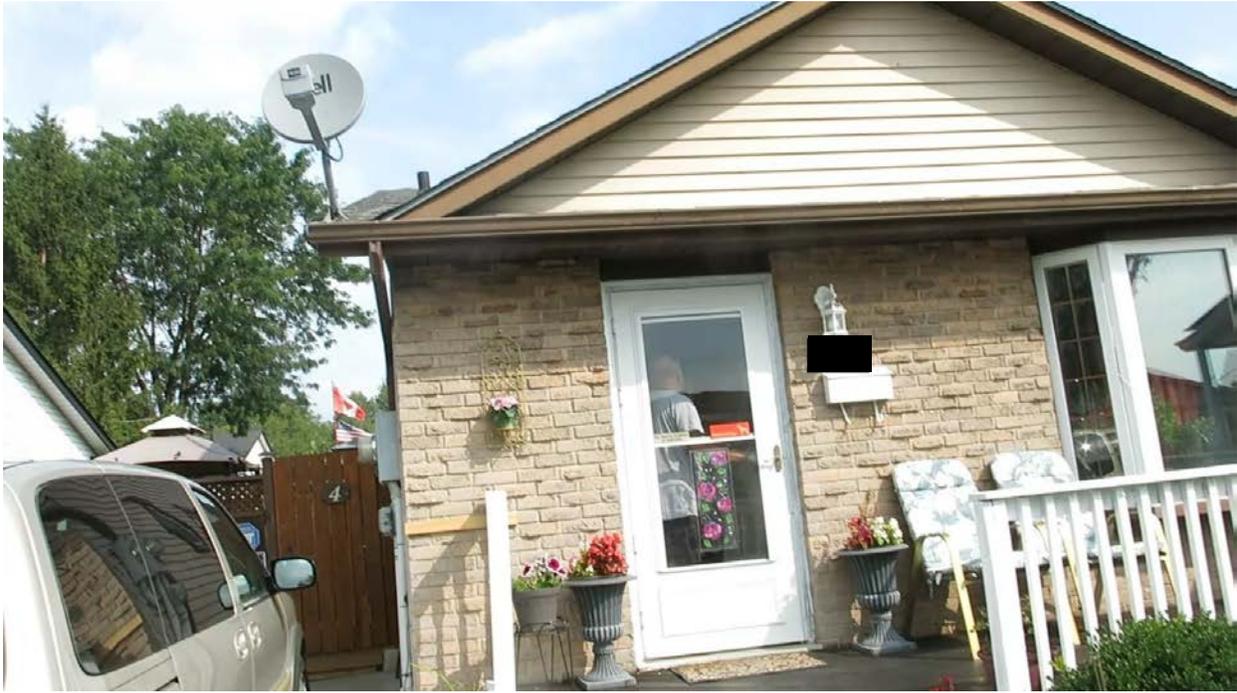
Defect Description: Smoke in basement coming out of the wall. Unknown source but suspect cracks in foundation and weeping tile connection to storm sewer.

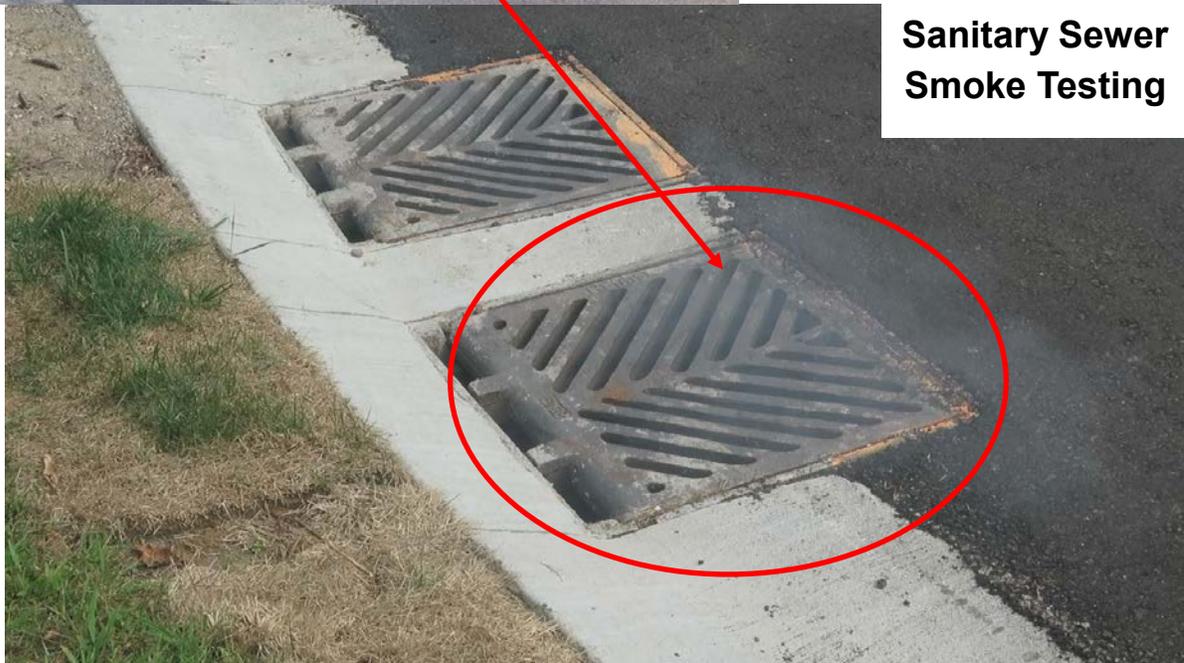
Sanitary Sewer
Smoke Testing

Defect Description: We smoked the sanitary sewer in this one location and observed an indirect connection from the storm catch basin to the sanitary sewer exists. The catch basin leads need to be inspected to ensure they are not leaking and re-lined as necessary. This CB also smoked during storm sewer smoke testing.
