Appendix 'N' – Heritage Impact Assessment

Heritage Impact Assessment

Three Grand River Crossings Schedule B Municipal Class Environmental Assessment, City of Brantford, Ontario

19128292-2001-R01-Rev2

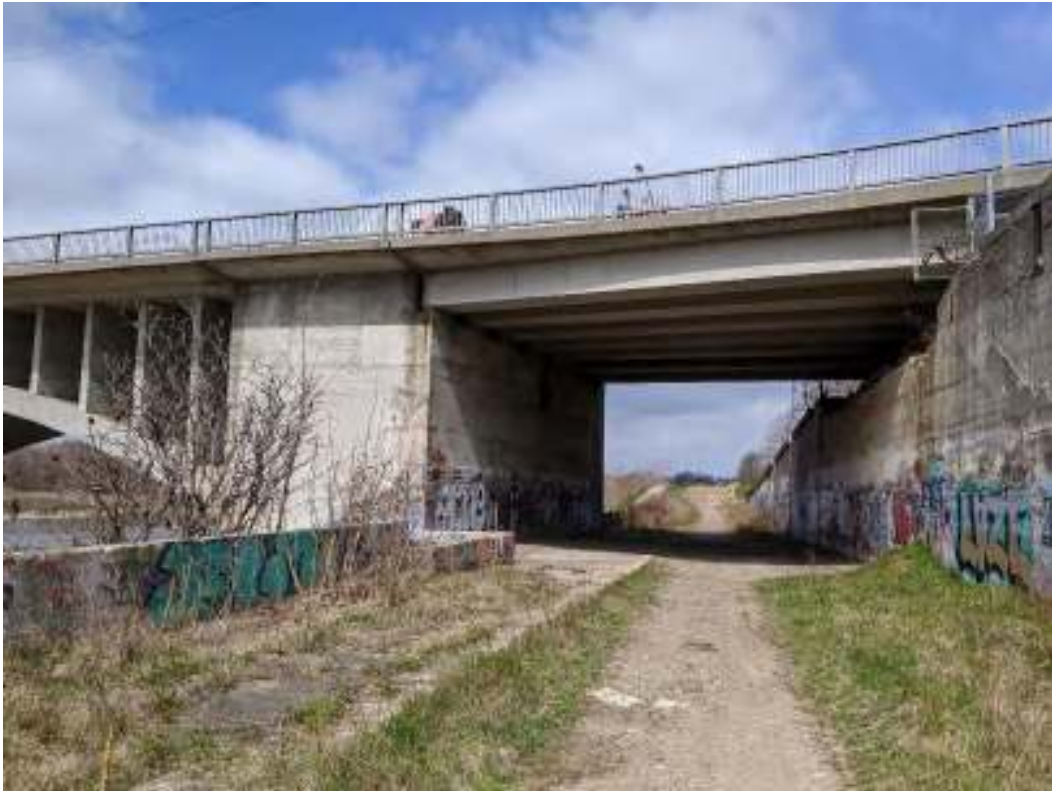
Figure 13: The Lorne Bridge Girder Span that forms the east approach of the Lorne Bridge

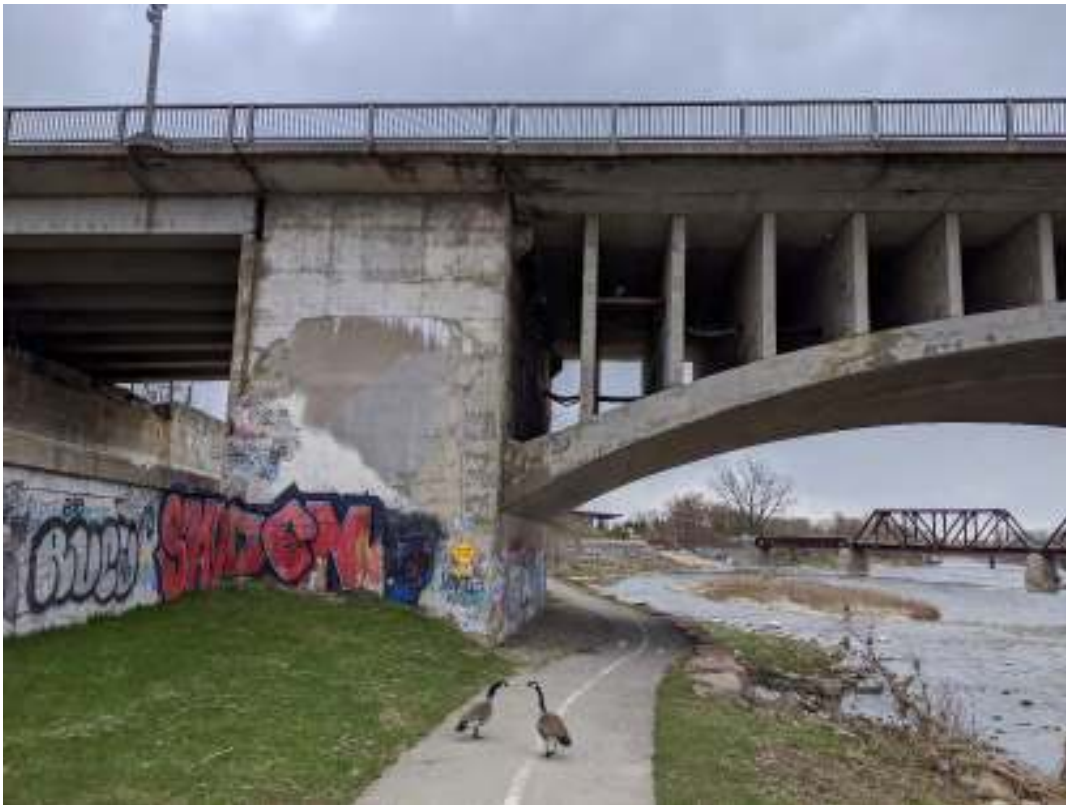
Figure 15: North side of the east abutment of the Lorne Bridge

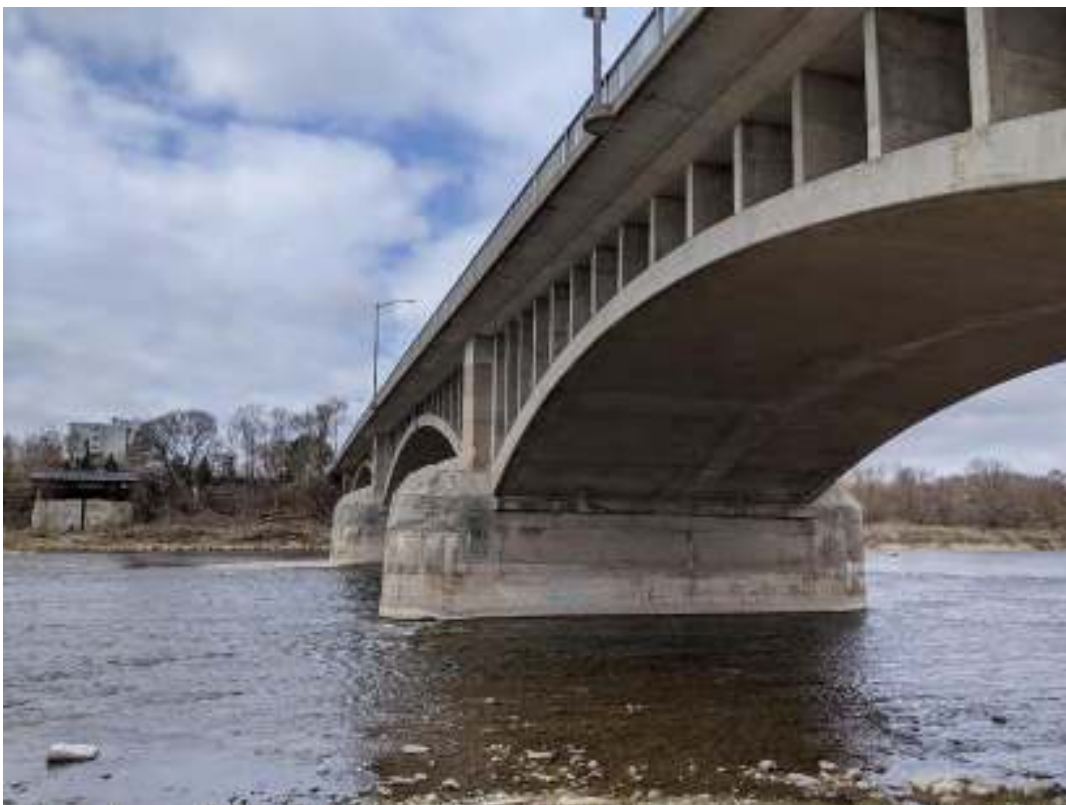
Figure 16: View west of the downriver sides of Pier No. 1 and Pier No. 2

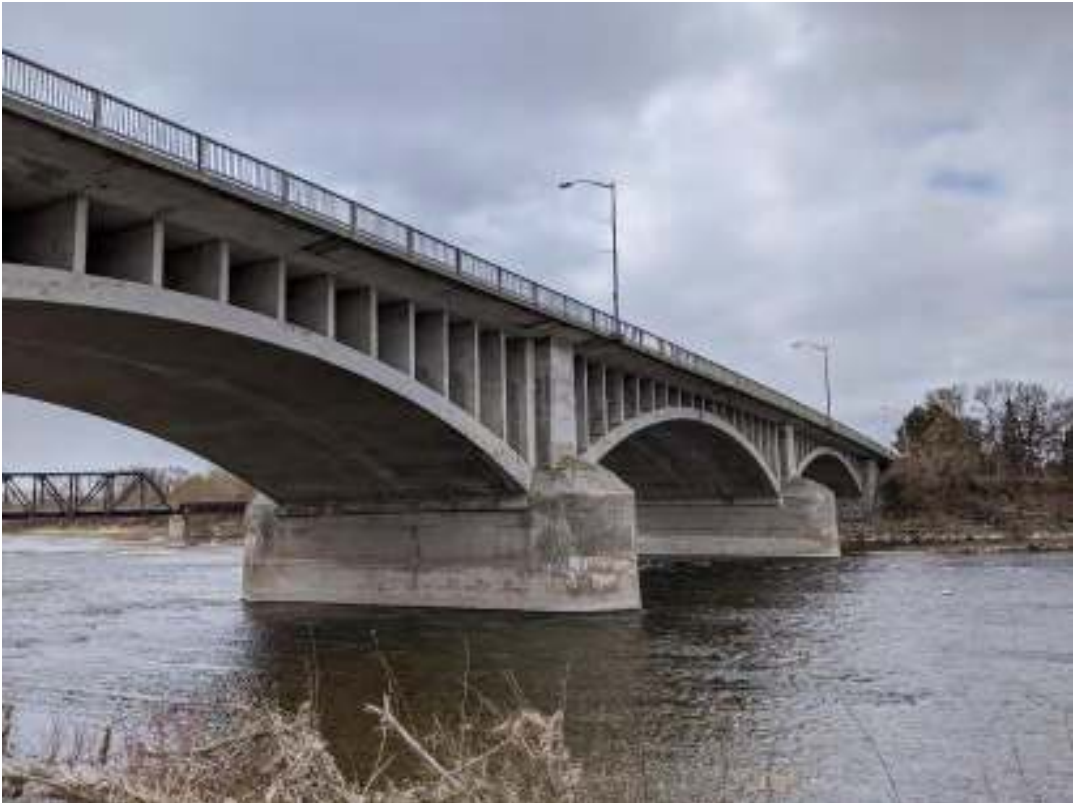
Figure 17: View west of the upriver sides of Pier No. 1 and Pier No. 2

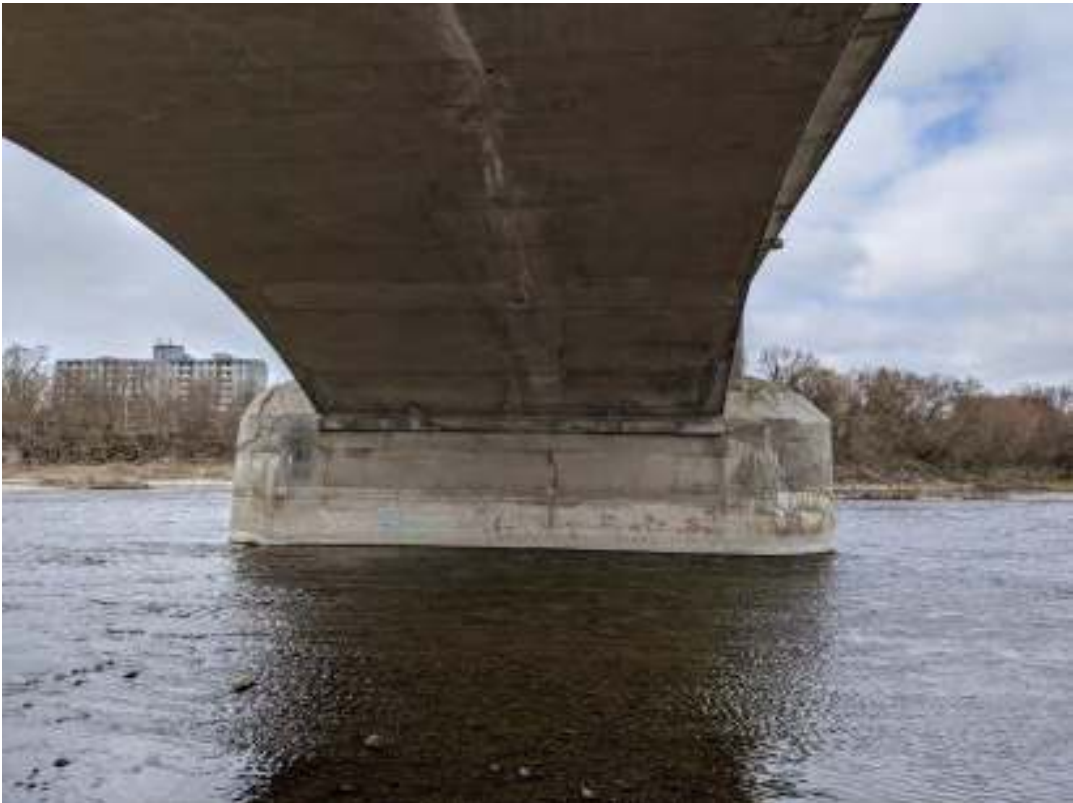
Figure 18: Spring of the arch at Pier No. 1

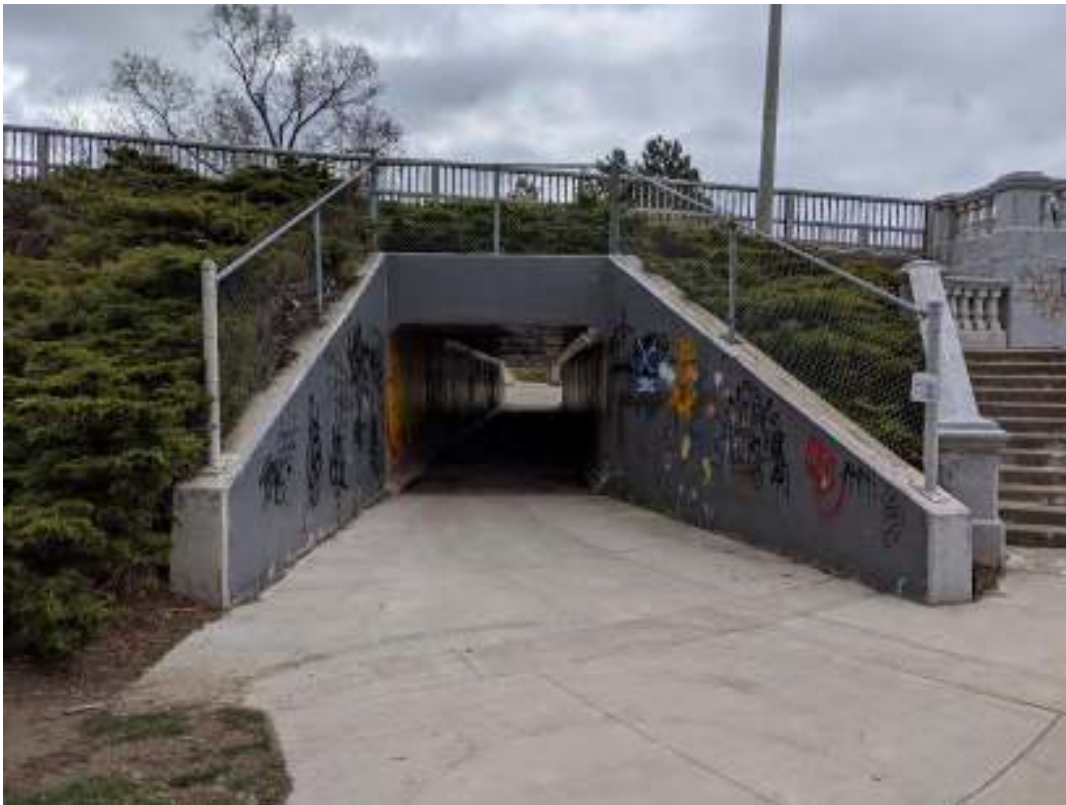
Figure 19: South headwall and wing walls of the concrete pedestrian underpass

Running through the west approach embankment is a concrete pedestrian underpass with asphalt surface, flat arch headwall and short concrete wing walls extending at an acute angle from the entrances (Figure 19 and Figure 20).

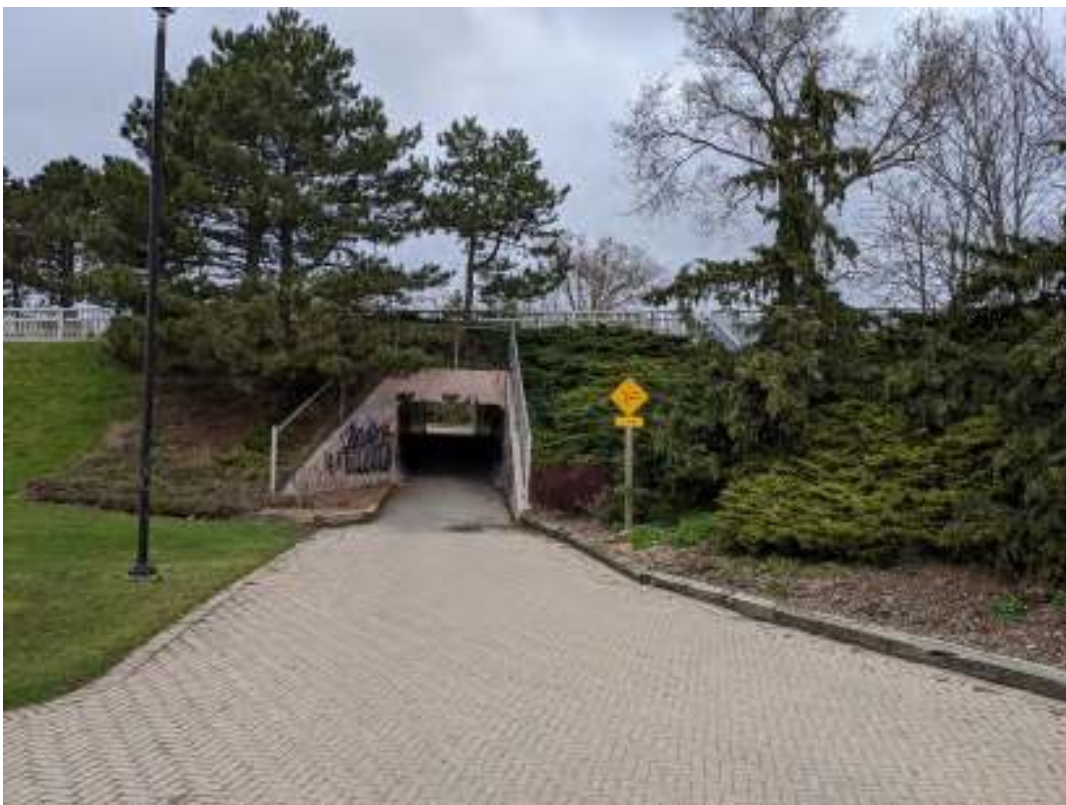
Figure 20: North headwall and wing walls of the concrete pedestrian underpass

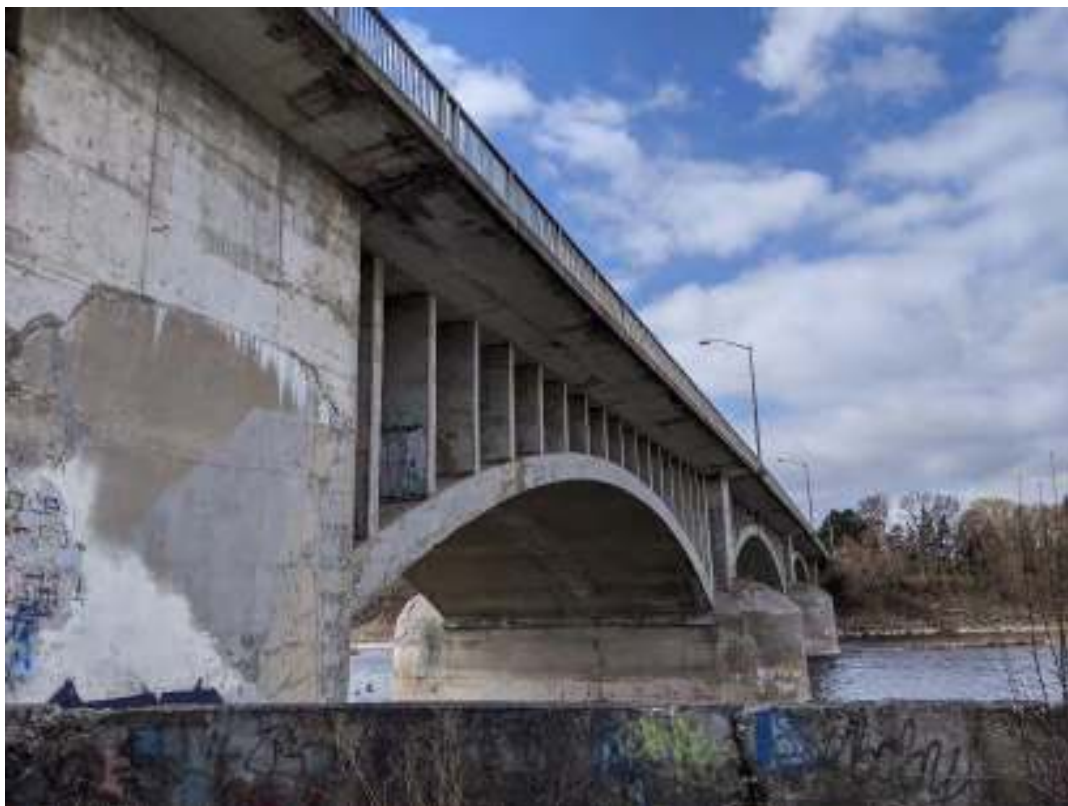
Figure 21: View west from the east abutment of the solid and thin concrete slab deck with chamfered soffit

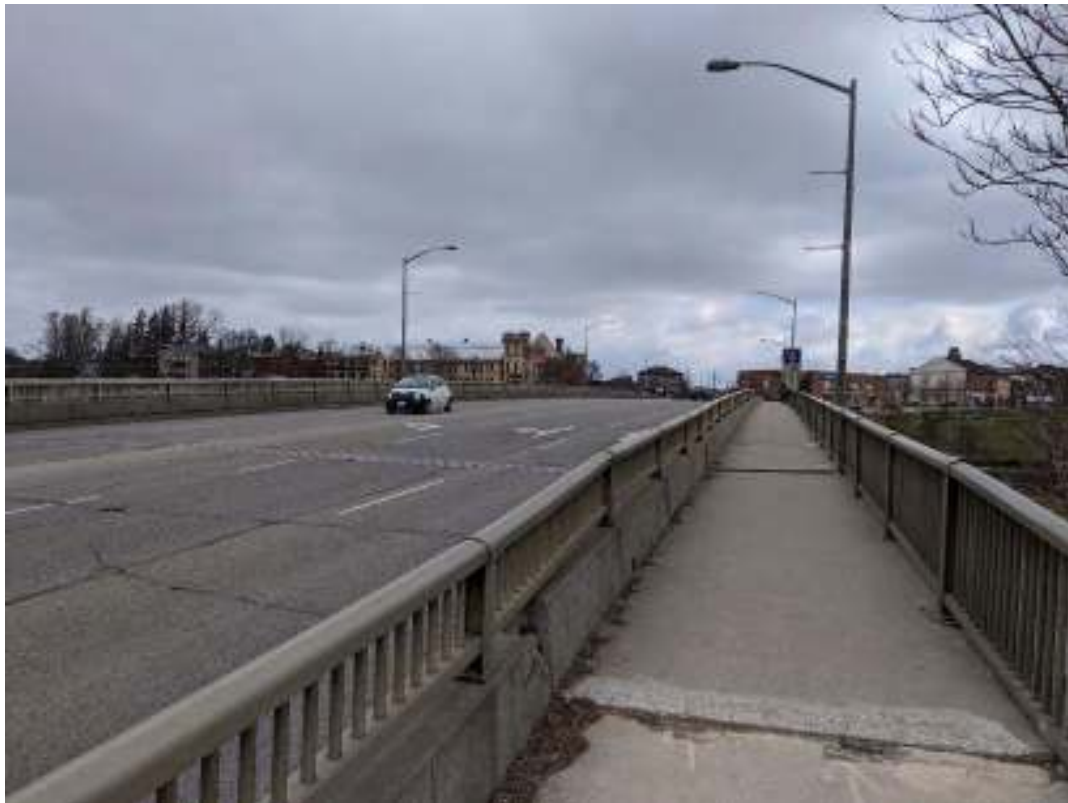
Figure 22: View east from near the centre of the bridge of the deck camber from the east and west, low cast-in-place concrete parapet walls with single railings either side of the asphalt wearing surface, and cast-in-place concrete sidewalk with aluminium post and panel railings

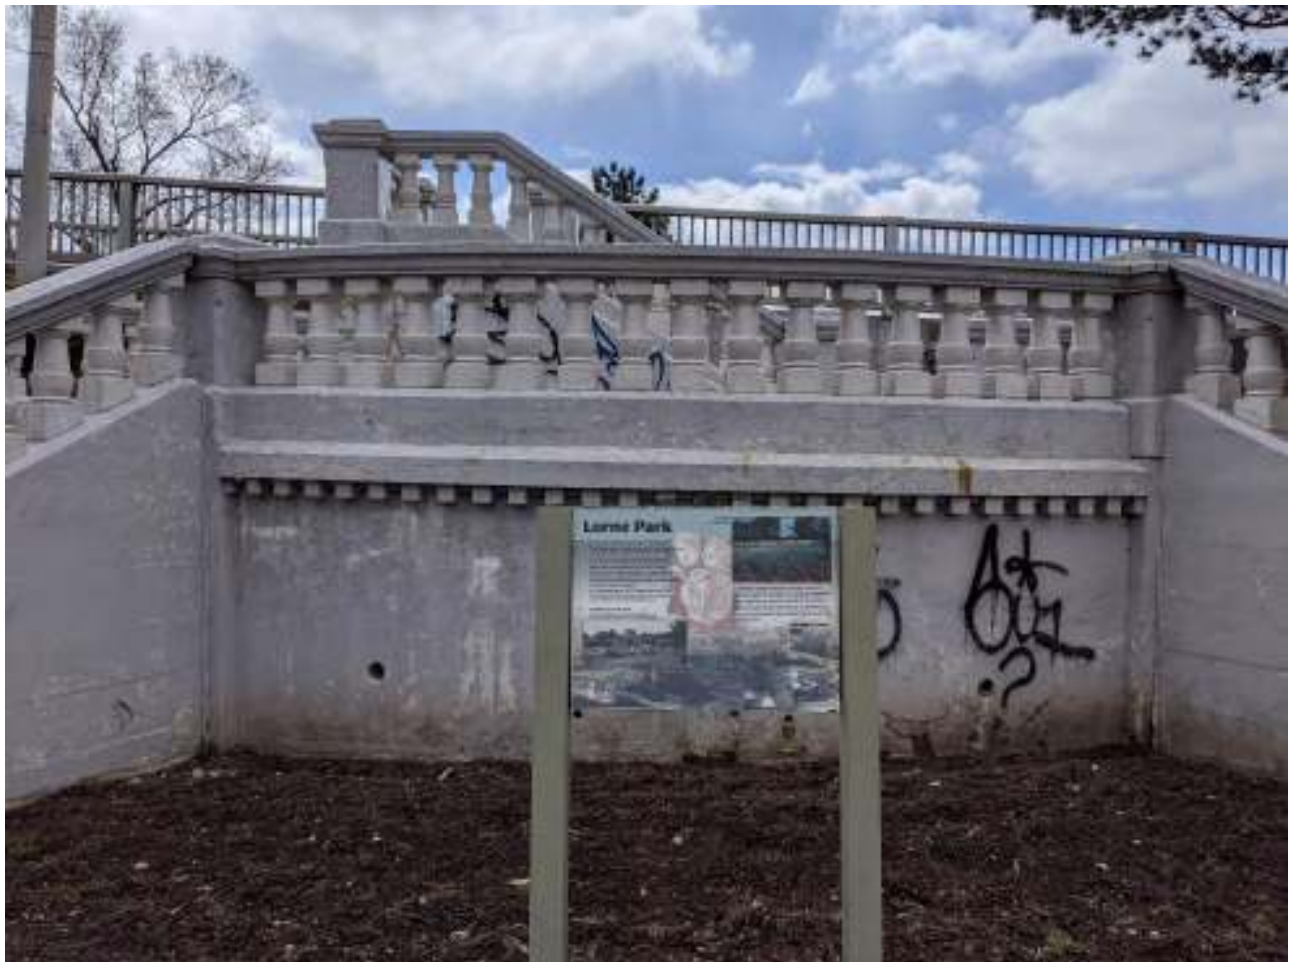
Figure 25: Outer face of the landing with denticulated cornice, thick square newels, and low chamfered and moulded handrail with “Renaissance” balusters

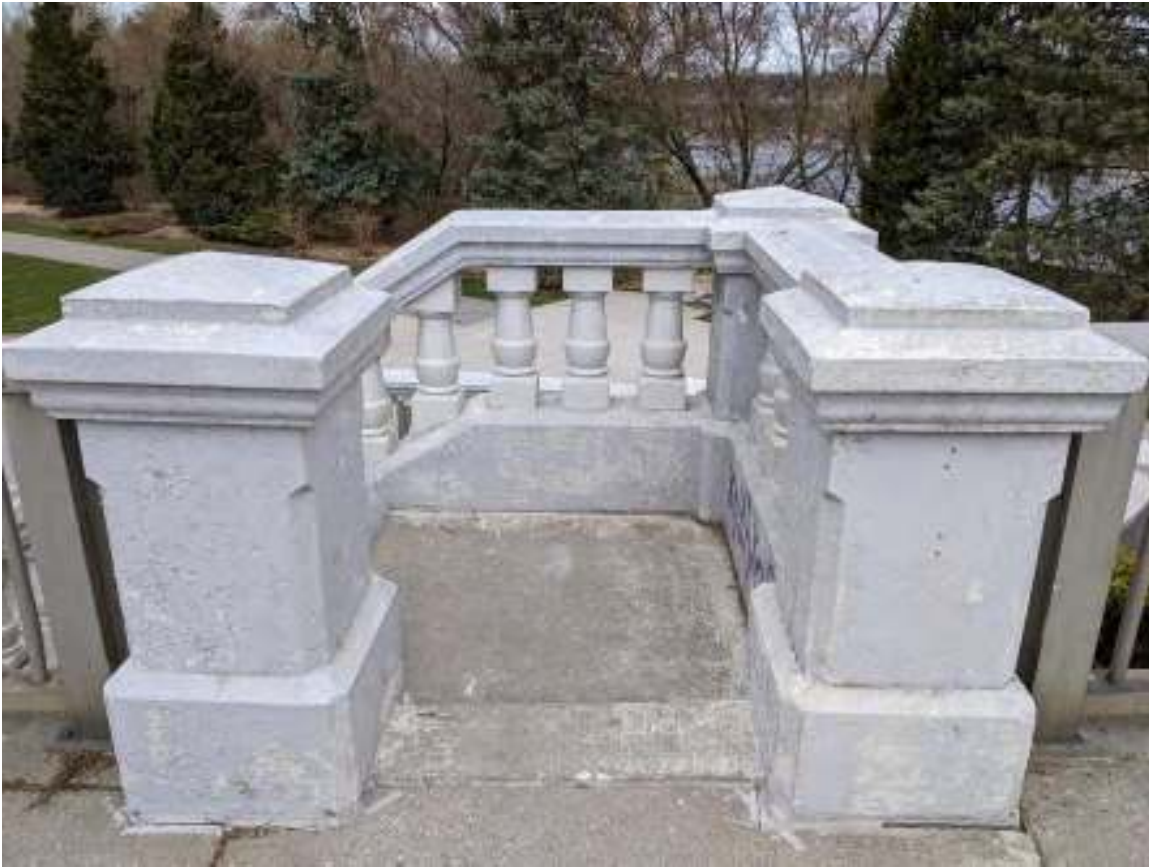
Figure 26: Half-pace landing at the west approach deck with thick square newels with chamfered and moulded caps, chamfered corners, and thick pedestals

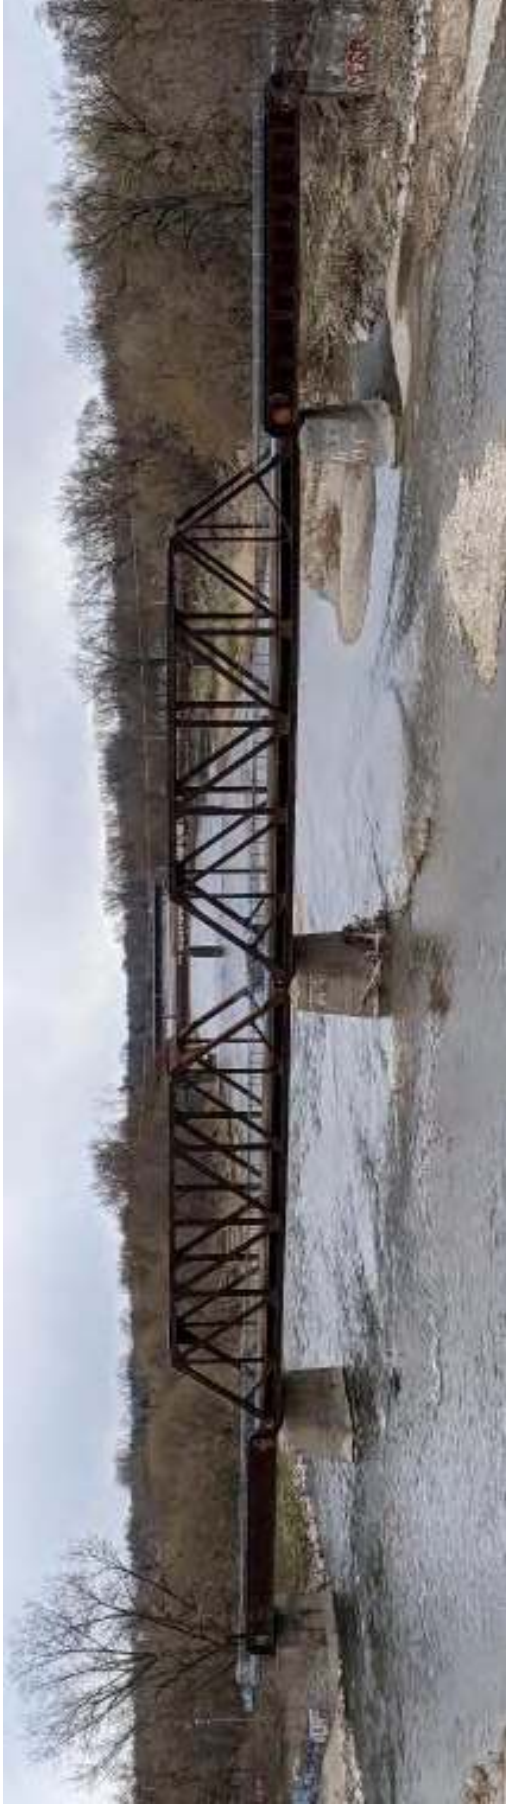
Figure 35: North elevation of the Brant's Crossing Bridge

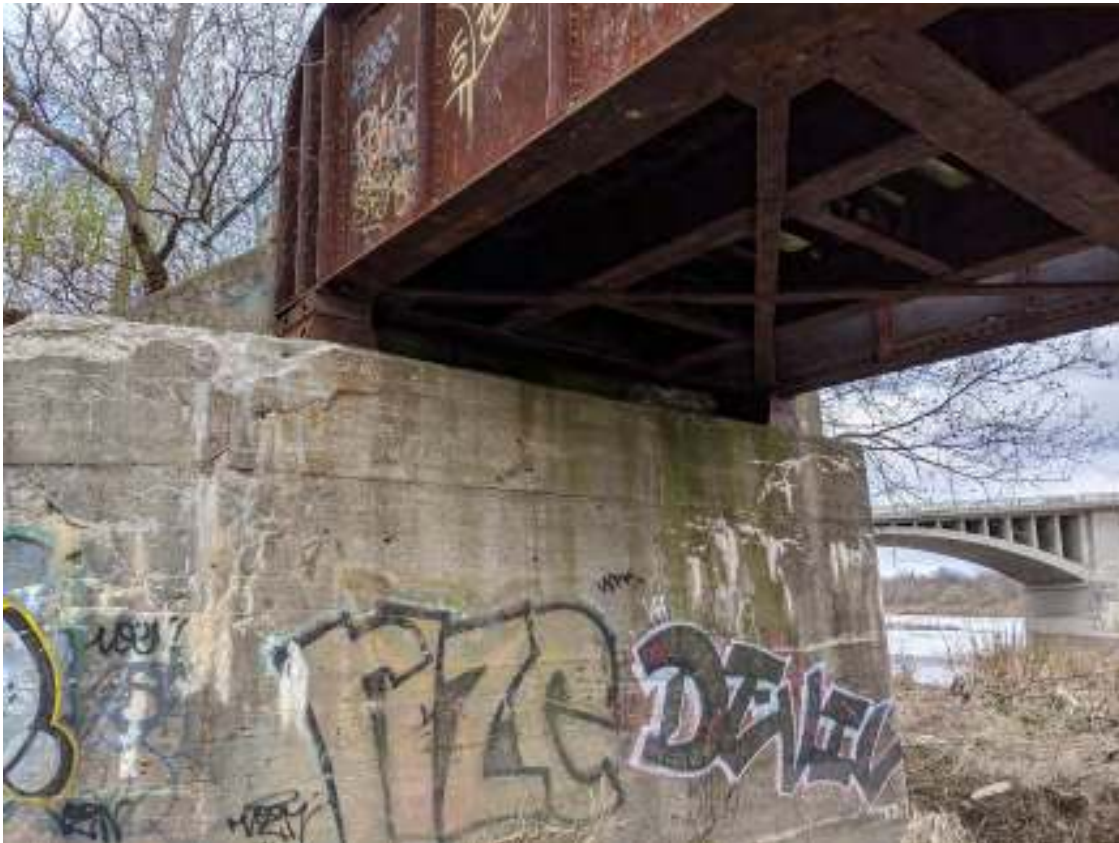
Figure 37: Front wall and ballast wall of the west abutment

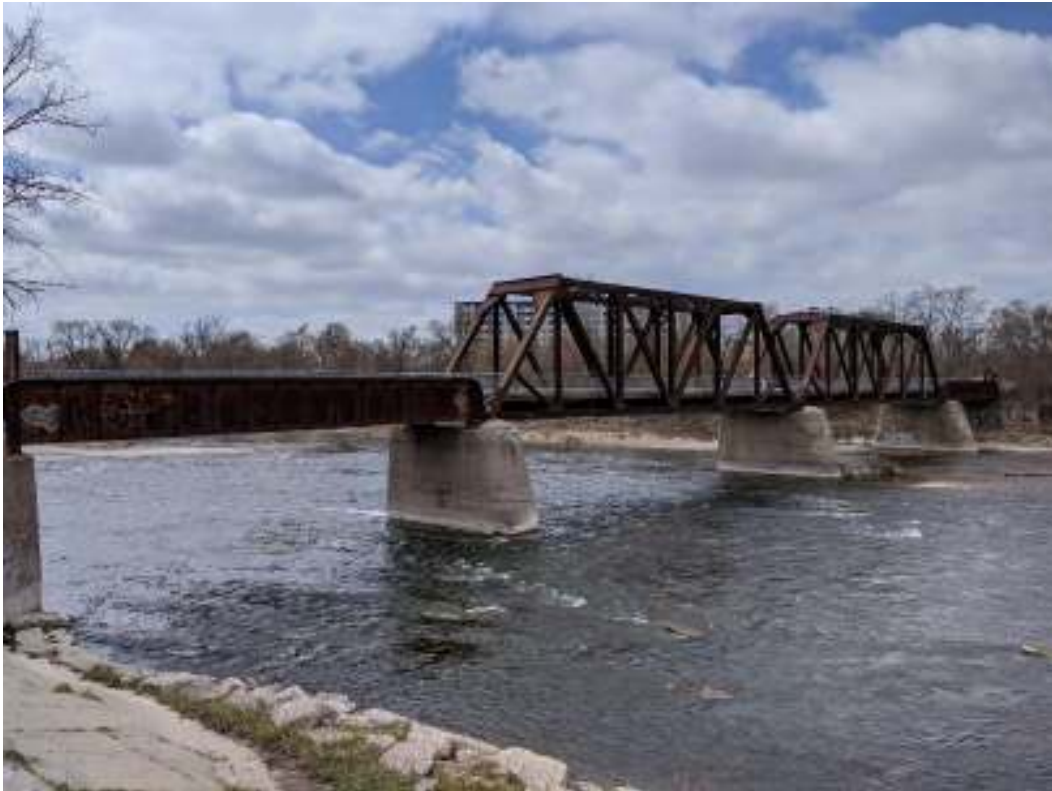
Figure 38: Upriver side of the piers, facing southwest

There are three piers each approximately 9.5 m wide, 3 m thick, and standing 7 m high. They are solid shaft cast-in-place concrete, with curved ends and moderate batter on the upstream side, and flat face with minor batter on the downstream side (Figure 38 and Figure 39); an exception is the west pier (No. 3), which has a steeper batter than the others on the downstream side (Figure 40). The pier foundations stand on exposed bedrock in the riverbed.

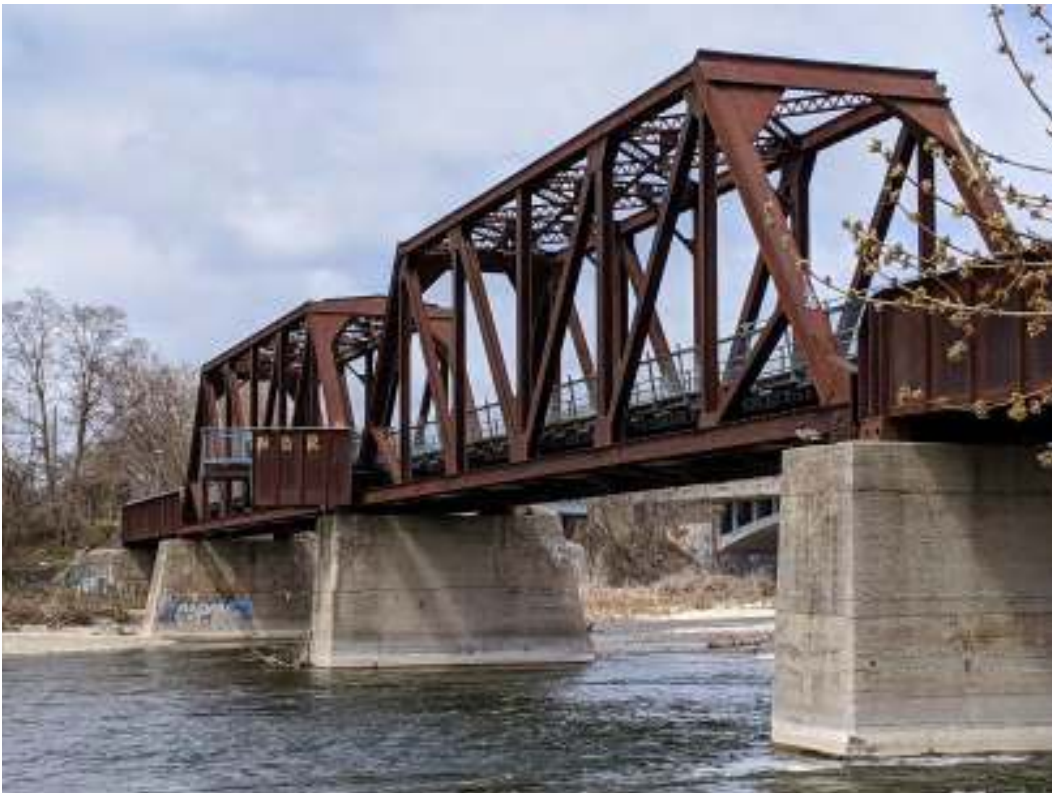
Figure 39: Downriver sides of the piers, facing northwest

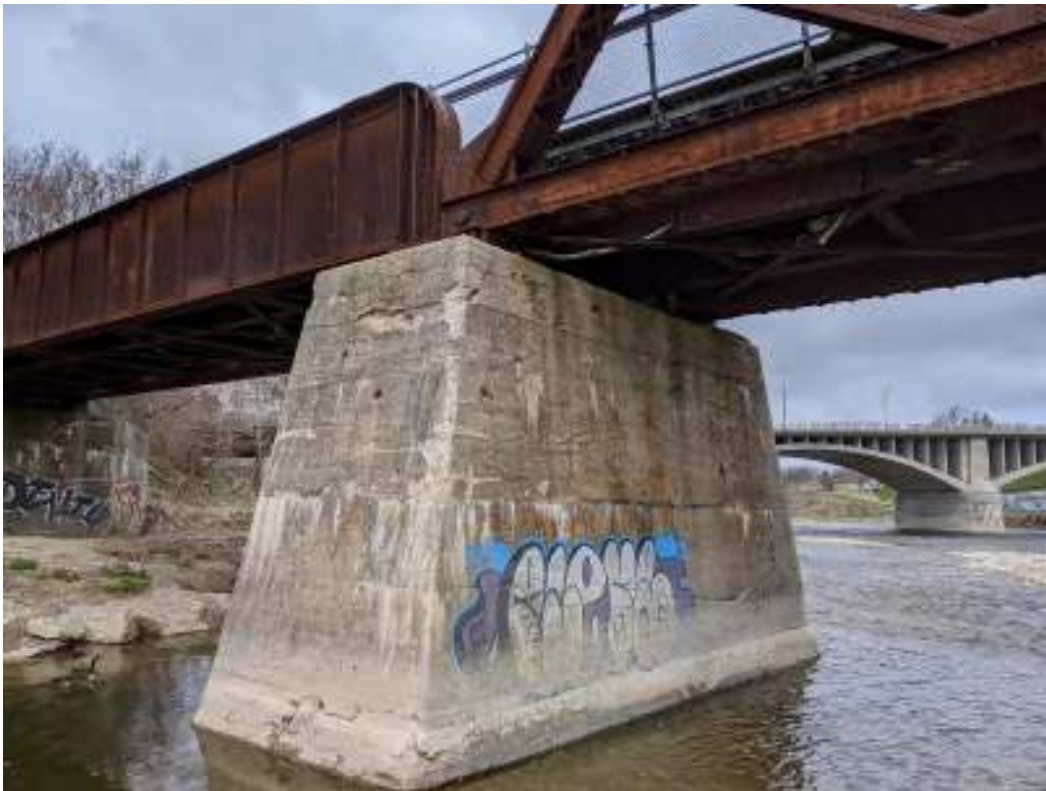
Figure 40: Downriver and east side of Pier No. 3

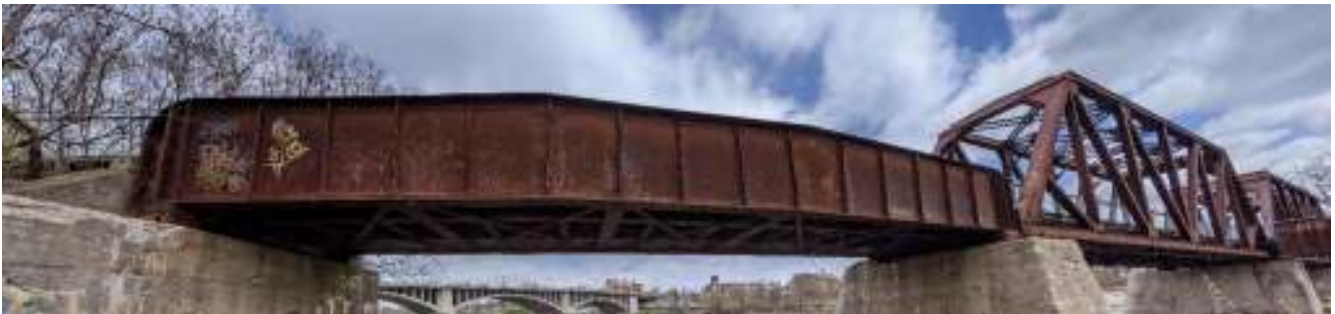
Figure 41: West approach girder span (includes some camera distortion).

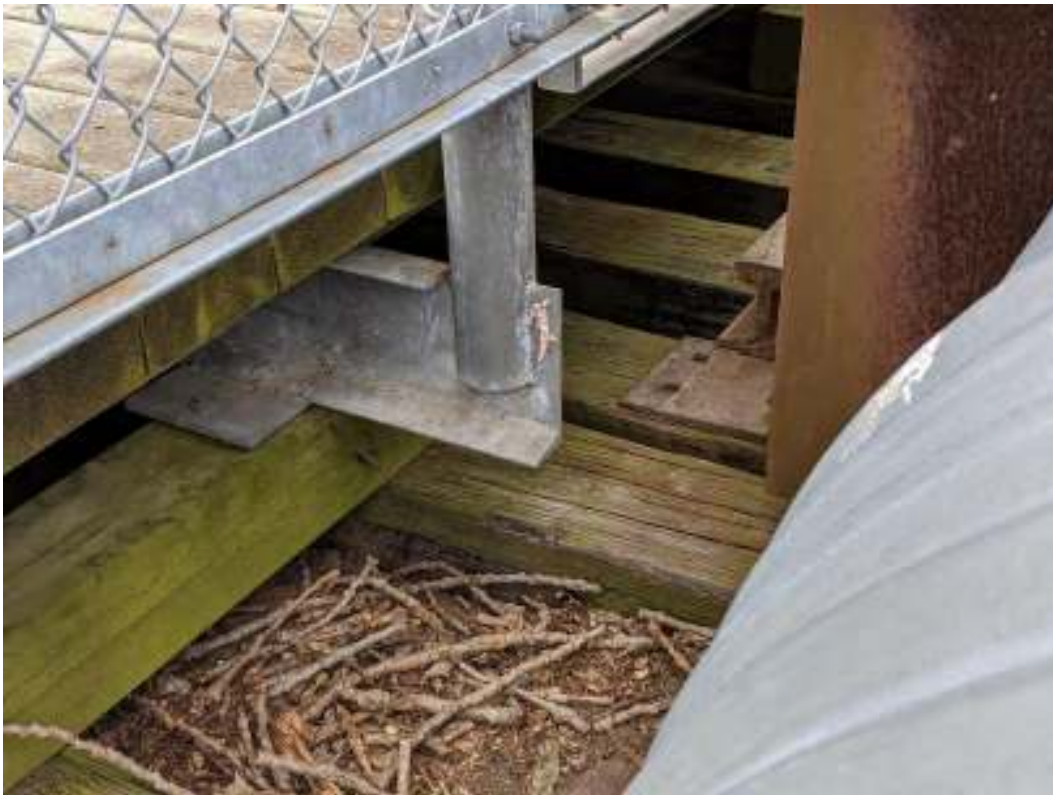
Figure 44: Remnants of the rail track (centre right) on the deck of the west approach span

The deck is closely spaced wood ties, over which are the track sections, corrugated pipe utility corridor, and the planked walkway with aluminium stringers and aluminium post and chain-link balustrade. On the upriver sides of both approach spans are large, perforated plates that appear to prevent access to the corrugated pipe utility corridor (Lance Brown 2020: pers. comm; Ken Chrysler 2020: pers. comm.) (Figure 53). Between the spans on the downriver side is a triangular platform formed with two lateral members and on either side are four-panel webs with vertical web stiffeners. This has been made into a viewing platform for the pedestrian walkway.

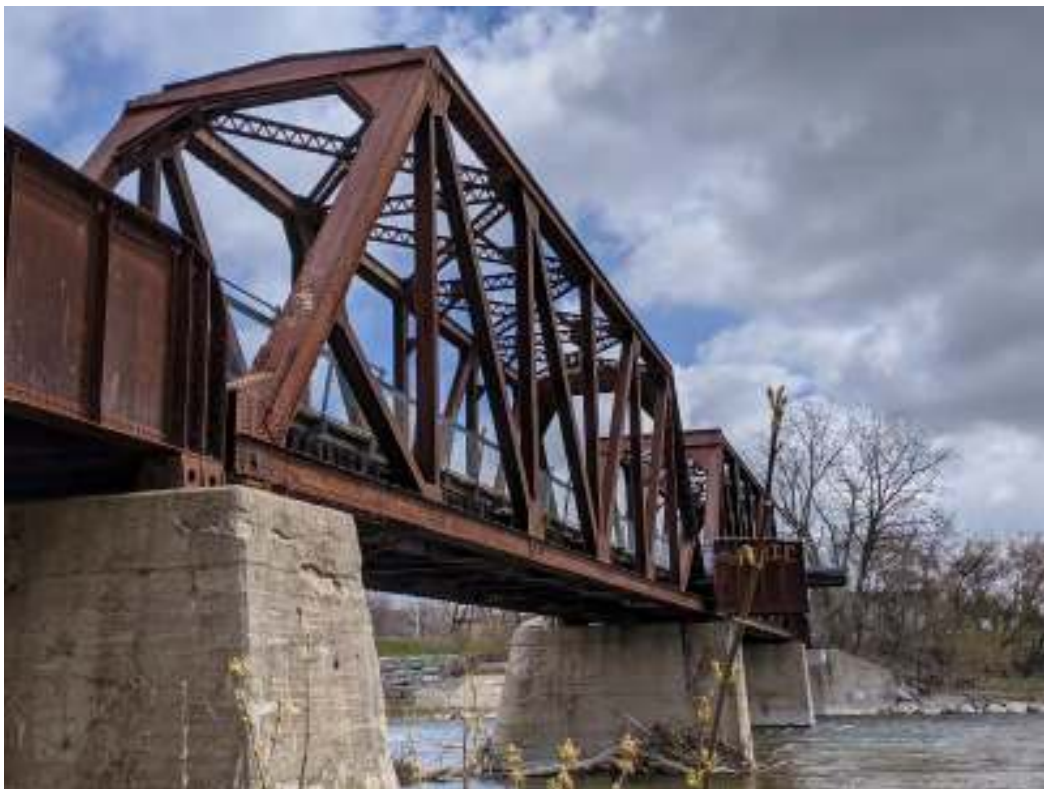
Figure 45: West and south sides of the west Pratt through truss span

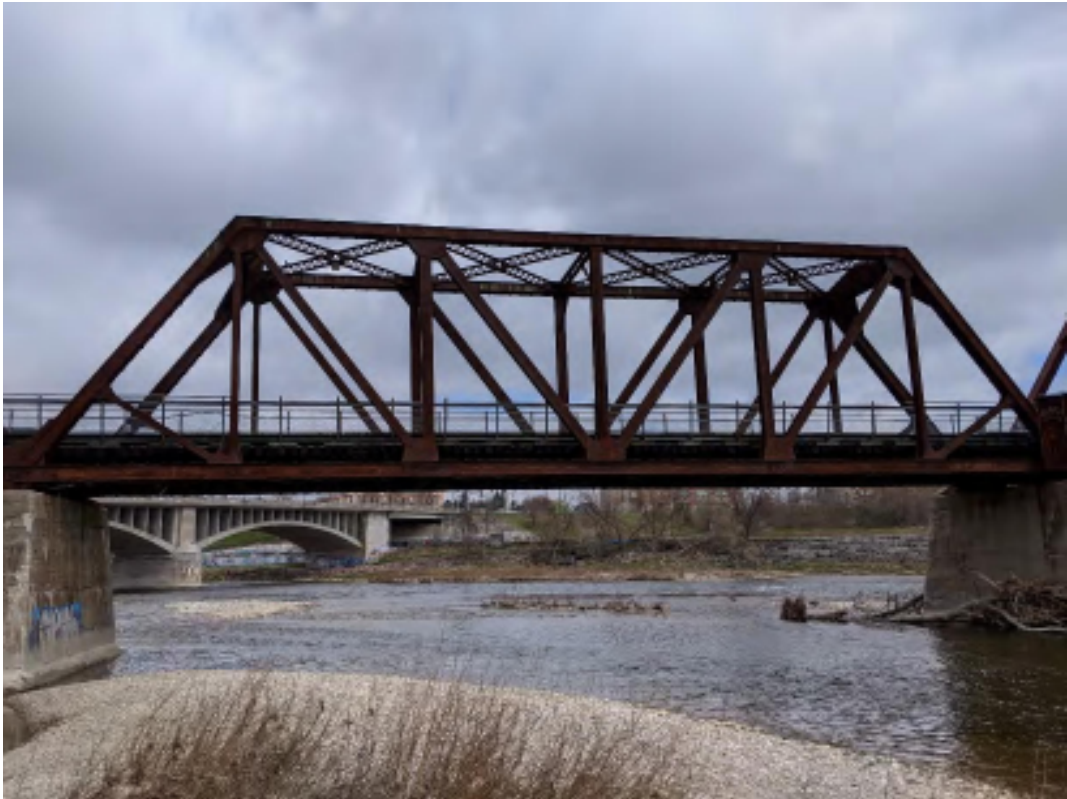
Figure 46: South side of the west Pratt through truss span

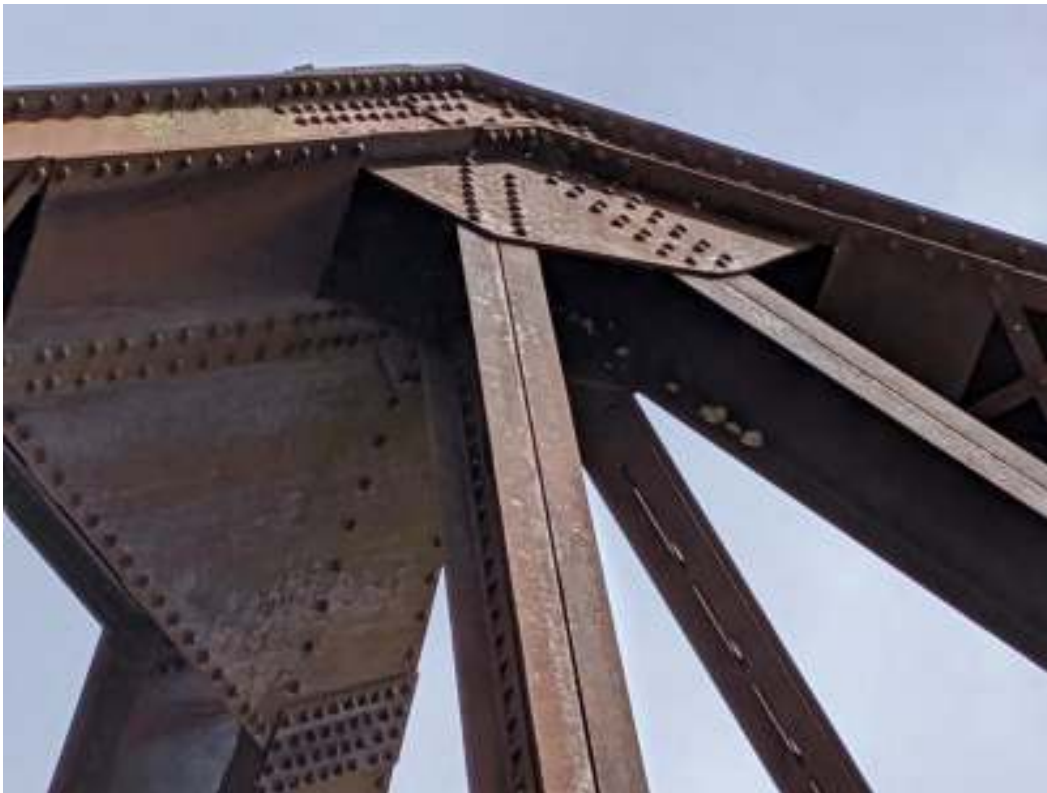
Figure 48: Detail of the end post of the west span showing the connection with the top chord, sway bracing, vertical post and diagonal and plating at the portal

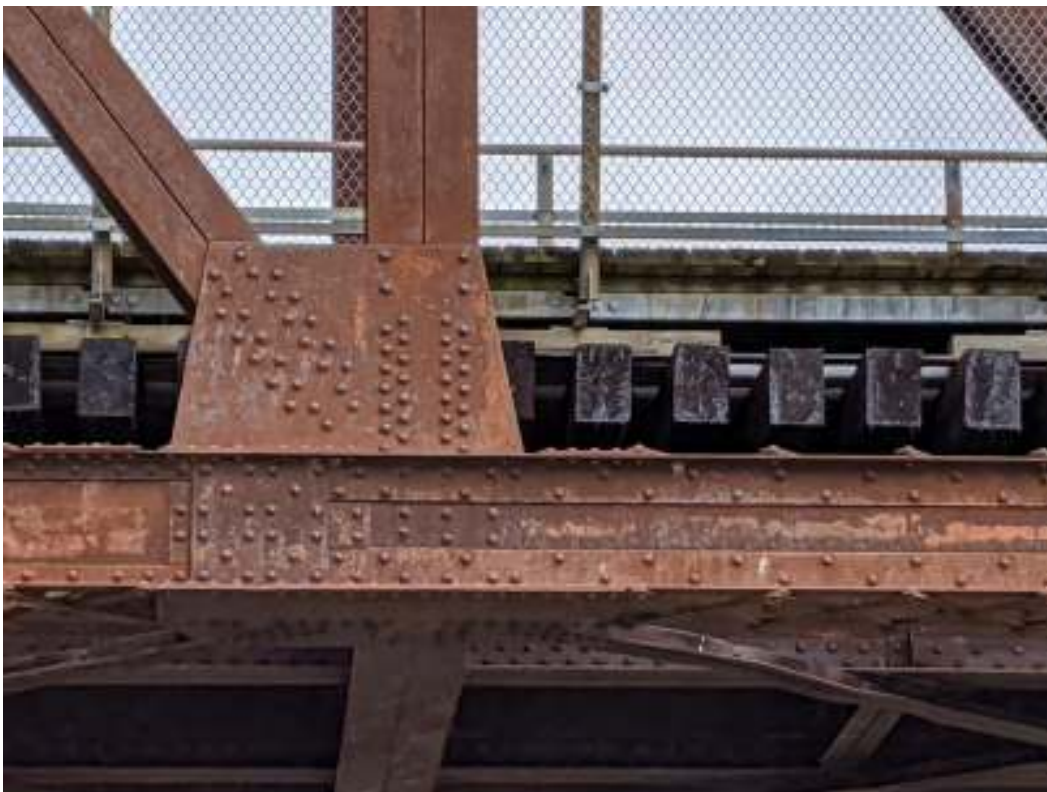
Figure 49: Gusset plates at the diagonal and vertical post, and the wood ties of the deck

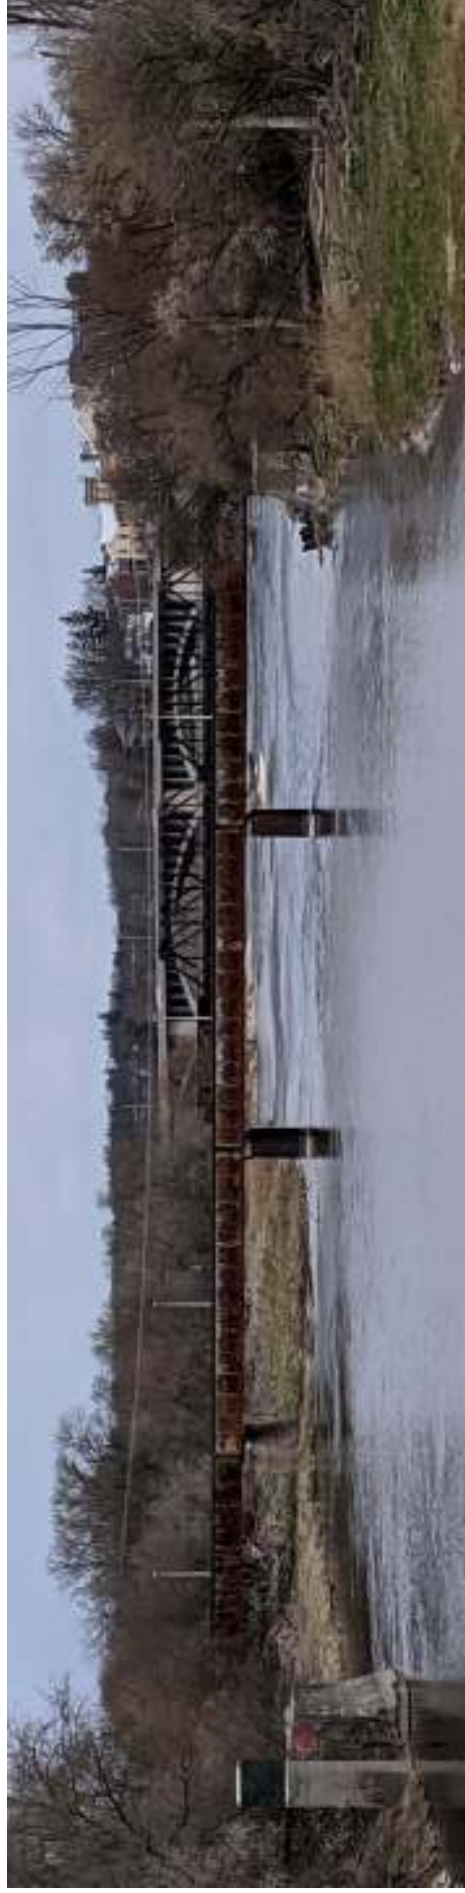
Figure 61: South elevation of the TH&B Crossing Bridge

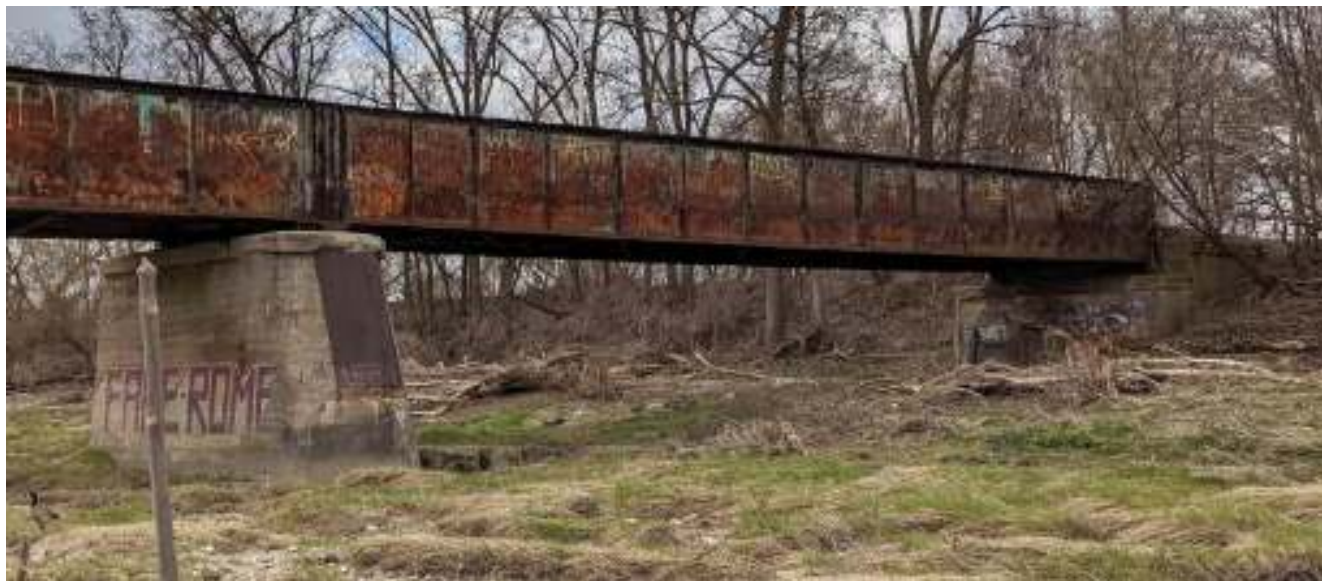
Figure 62: View facing southwest of the west abutment and pier

There are three piers, two of which are concrete-filled riveted iron or steel caissons or bents and one in cast-in-place concrete. The concrete pier is the furthest west, has a sharp nose with relatively steep batter and iron or steel cut break on its upriver side (Figure 67). It is topped by a projecting concrete slab with quarter-round top margin, and overall measures 8.85 m long, 3.8 m wide, and stands 5.45 m high. The two easterly pier bents stand 6.05 m high, are 7.2 m long overall, and each caisson is 2.10 m in diameter (Figure 68 and Figure 69). Each caisson is faced with rounded panels connected with rivetted strips, and are connected to each other at their mid and upper section by a web wall with top and bottom flanges and by a capping beam of seven I-beams with the interstices filled with concrete. The pier foundations stand on exposed dolostone bedrock in the riverbed.

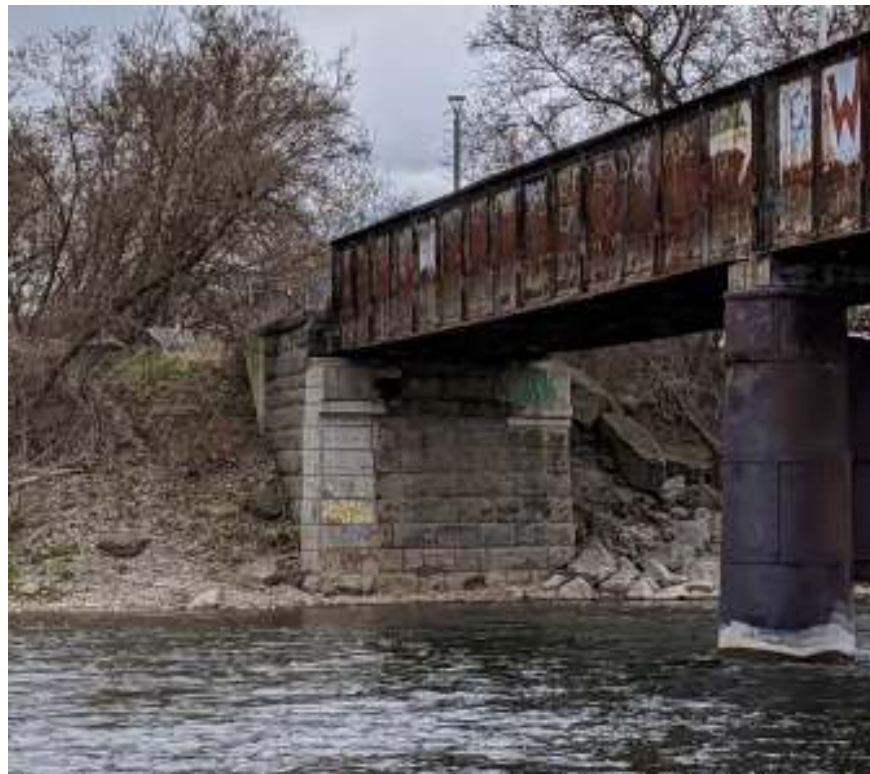
Figure 66: View facing southeast of the east abutment with ashlar construction and concrete repairs
