Appendix 'N' – Heritage Impact Assessment

Heritage Impact Assessment

Three Grand River Crossings Schedule B Municipal Class Environmental Assessment, City of Brantford, Ontario

19128292-2001-R01-Rev2

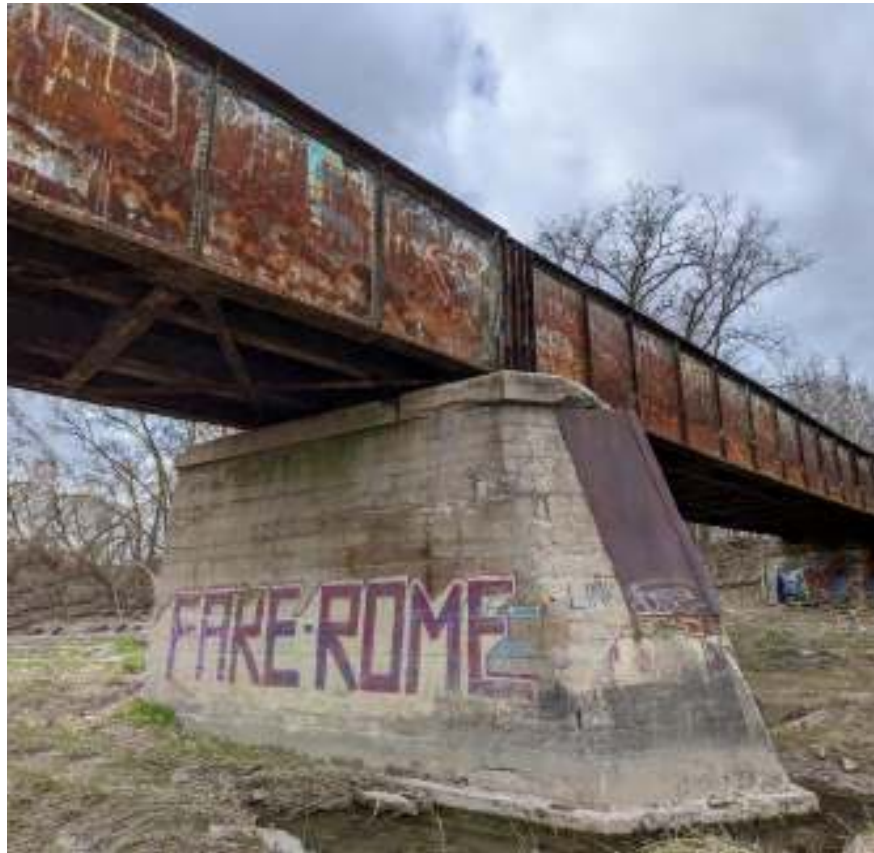
Figure 67: View facing south of the concrete pier

There are three piers, two of which are concrete-filled riveted iron or steel caissons or bents and one in cast-in-place concrete. The concrete pier is the furthest west, has a sharp nose with relatively steep batter and iron or steel cut break on its upriver side (Figure 67). It is topped by a projecting concrete slab with quarter-round top margin, and overall measures 8.85 m long, 3.8 m wide, and stands 5.45 m high. The two easterly pier bents stand 6.05 m high, are 7.2 m long overall, and each caisson is 2.10 m in diameter (Figure 68 and Figure 69). Each caisson is faced with rounded panels connected with rivetted strips, and are connected to each other at their mid and upper section by a web wall with top and bottom flanges and by a capping beam of seven I-beams with the interstices filled with concrete. The pier foundations stand on exposed dolostone bedrock in the riverbed.

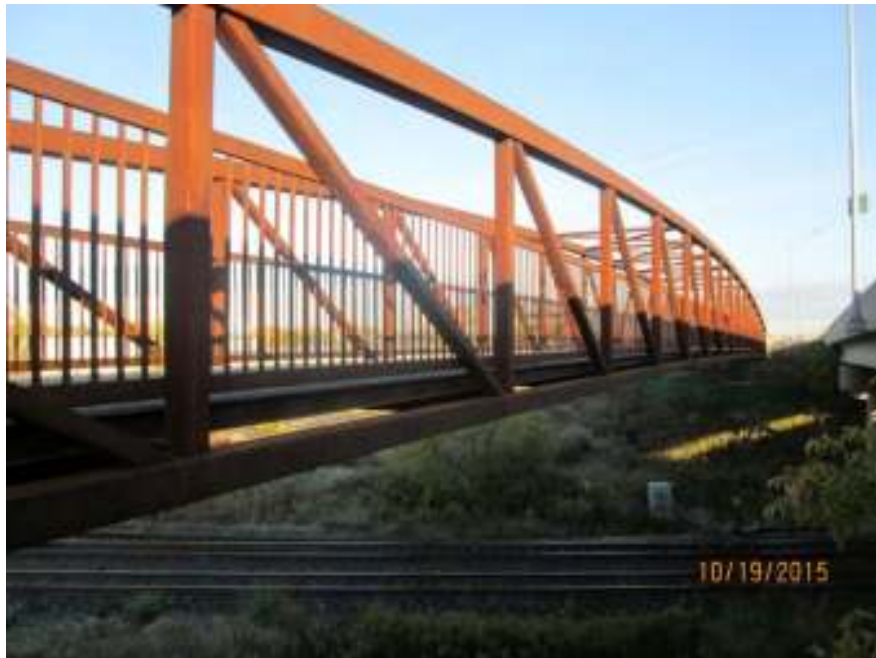
Figure 76: Example of a prefabricated steel through truss pedestrian bridge (courtesy GM BluePlan)

- removing the existing steel superstructure, the existing steel superstructure replaced with a new superstructure to convey pedestrian and cyclist traffic over the Grand River.
- major repairs to the concrete substructure, including adding additional height to account for flooding events
- installing a new steel superstructure on the repaired substructure
 - the new superstructure would be four new prefabricated steel trusses similar in appearance to the existing through trusses (Figure 76 and Figure 77).
- adding a staircase and ramp at the east and west approaches to provide access to the raised superstructure.

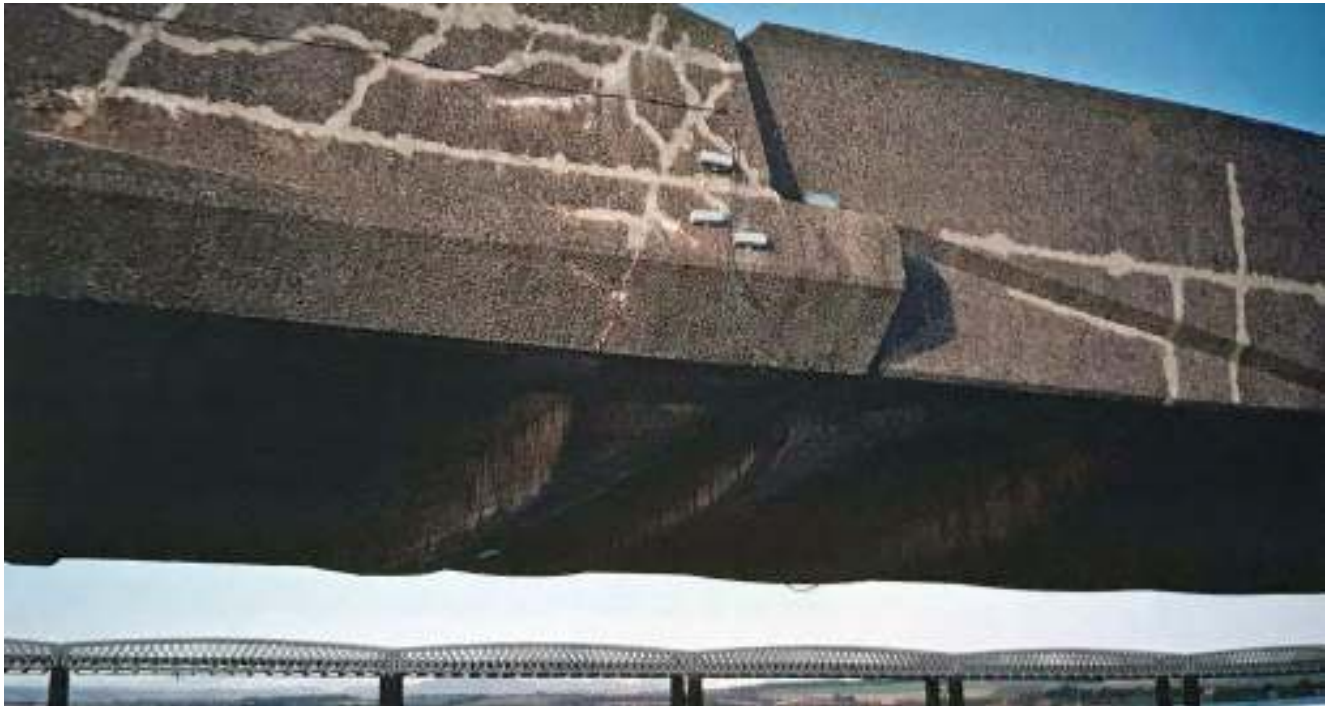
Figure 78: Example of an inappropriate crack repair, Montrose Bridge, Scotland (English Heritage 2018:182)

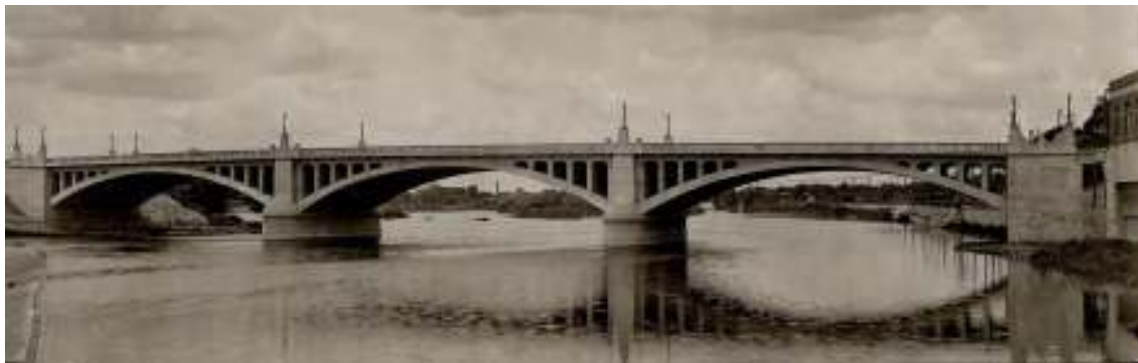
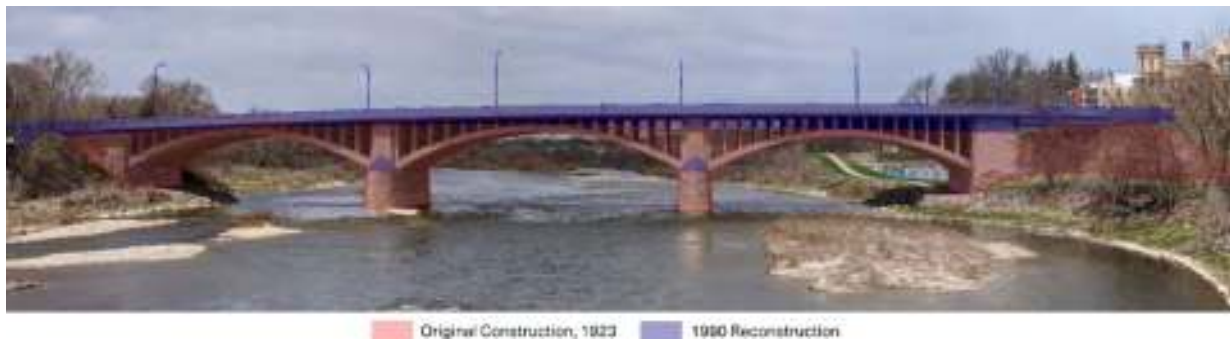
Figure 79: Comparison of the original and current Lorne Bridge configurations, with blue shading indicating where the new spandrel columns were added to the crown of the arches in 1980 (top image, the Lorne Bridge in 1924, Toronto Public Library – Toronto Star Archives)

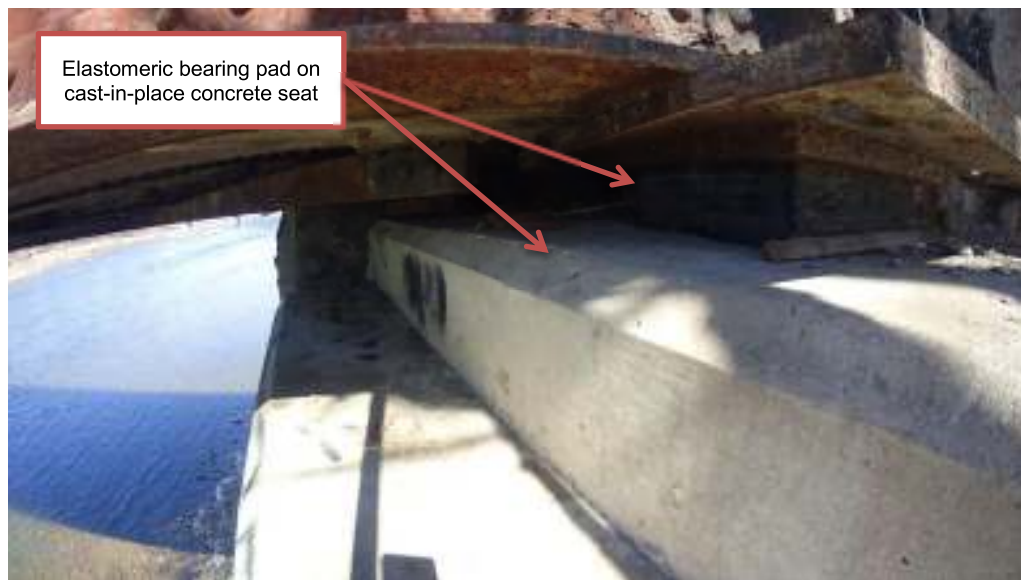
Figure 2: Replaced abutment bearing on Bridge 143

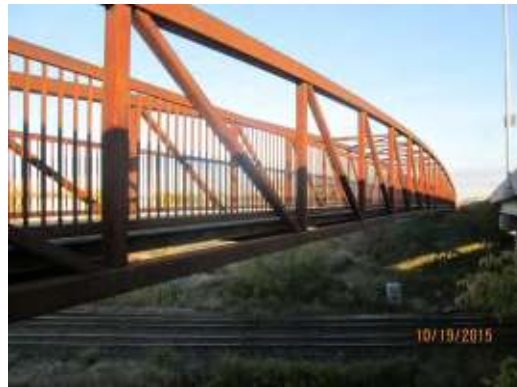
Figure 3: Prefabricated steel truss superstructure (Structure 152)
