## Appendix 'G' – Geotechnical Assessment

## Geotechnical Assessment

*Three Grand River Crossings (Lorne Bridge, Brant's Crossing Bridge, and TH&B Railway River Crossing Bridge), City of Brantford, Ontario*

19128292-1000-R01-Rev0

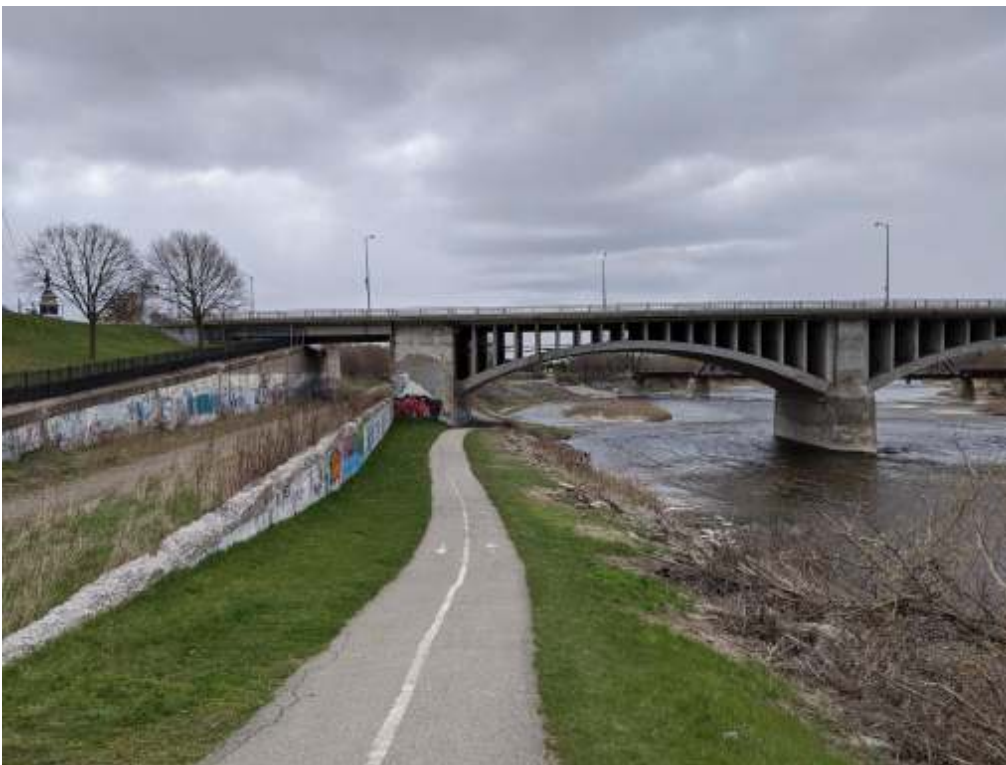
Photograph 5: Lorne bridge – Looking at east pier and abutment from upstream side of the bridge.

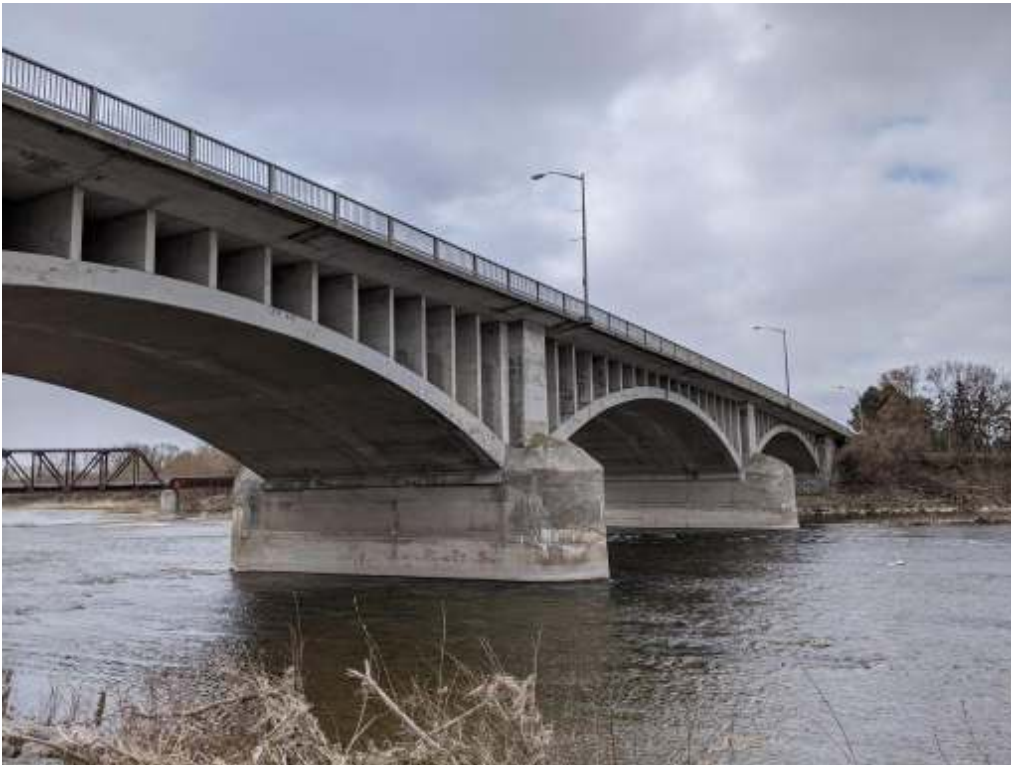
Photograph 6: Lorne bridge – Looking at east pier and west pier from upstream side of the bridge.

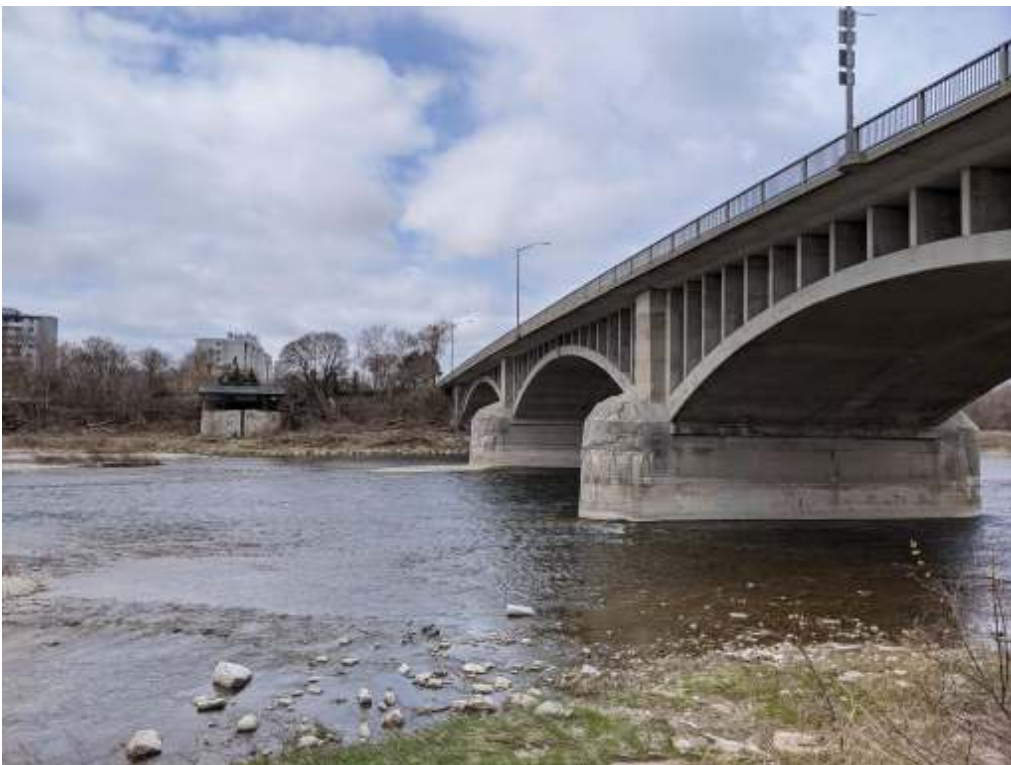
Photograph 7: Lorne bridge – Looking at east pier and west pier from downstream side.

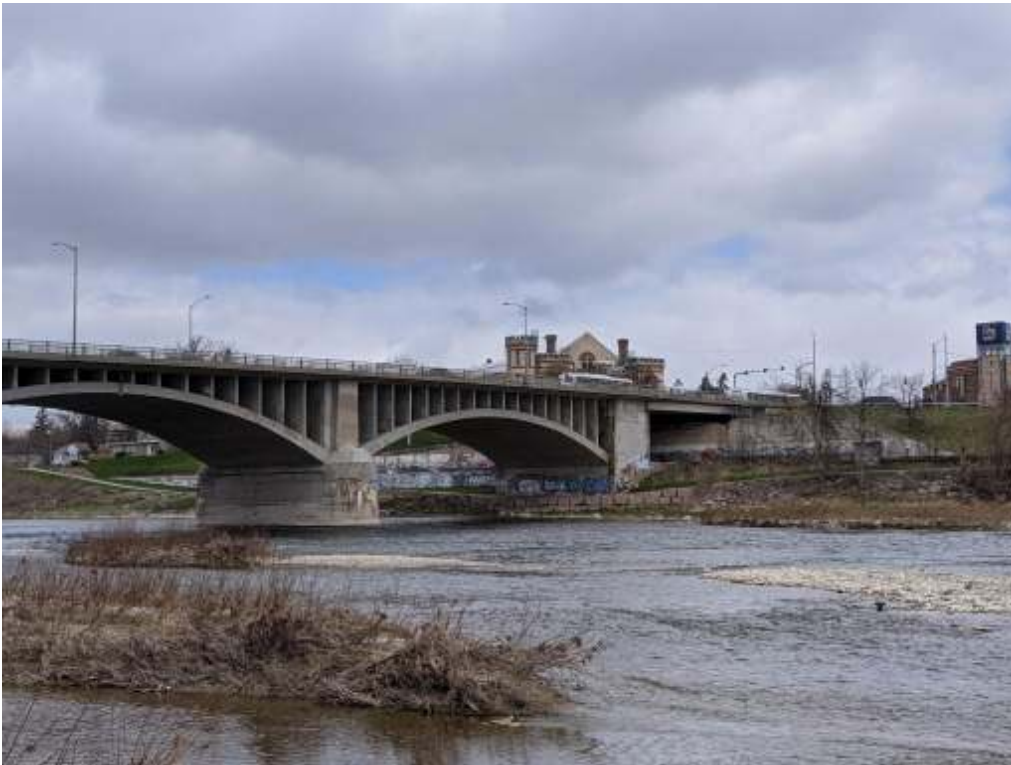
Photograph 8: Lorne bridge - Looking towards east pier and abutment from downstream side.

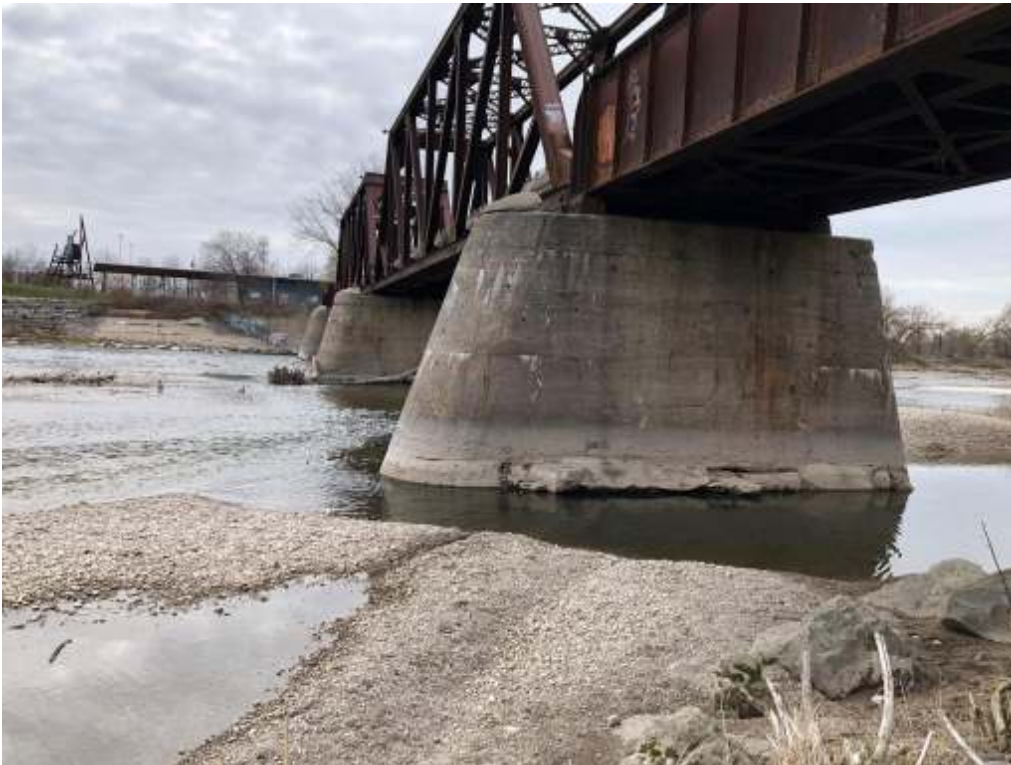
Photograph 10: Brant's bridge- Looking at west pier from the upstream side of the bridge and west abutment.

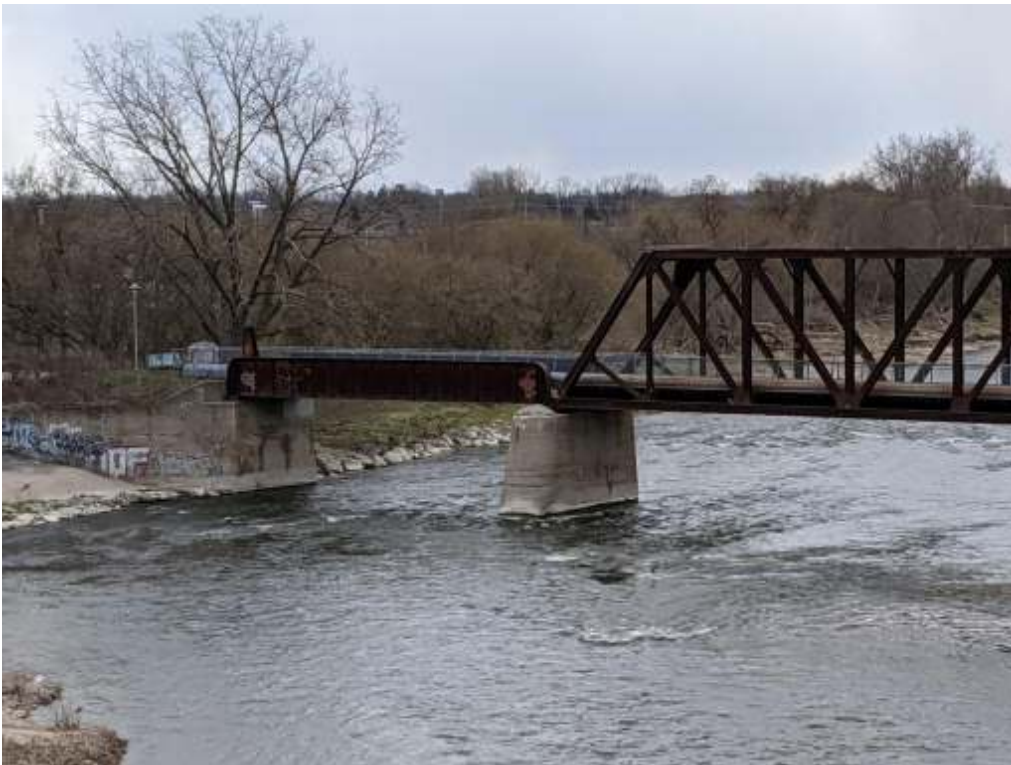
Photograph 11: Brant's bridge- Looking at east pier and east abutment from upstream side.

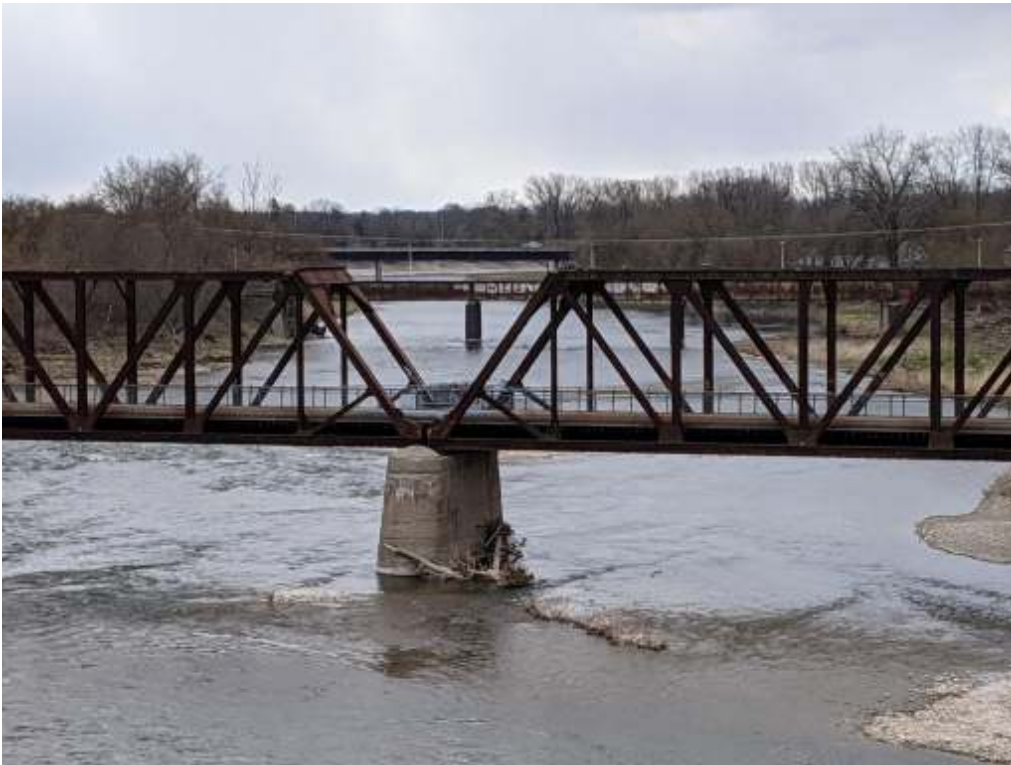
Photograph 12: Brant's bridge – Looking at central pier looking from upstream side.

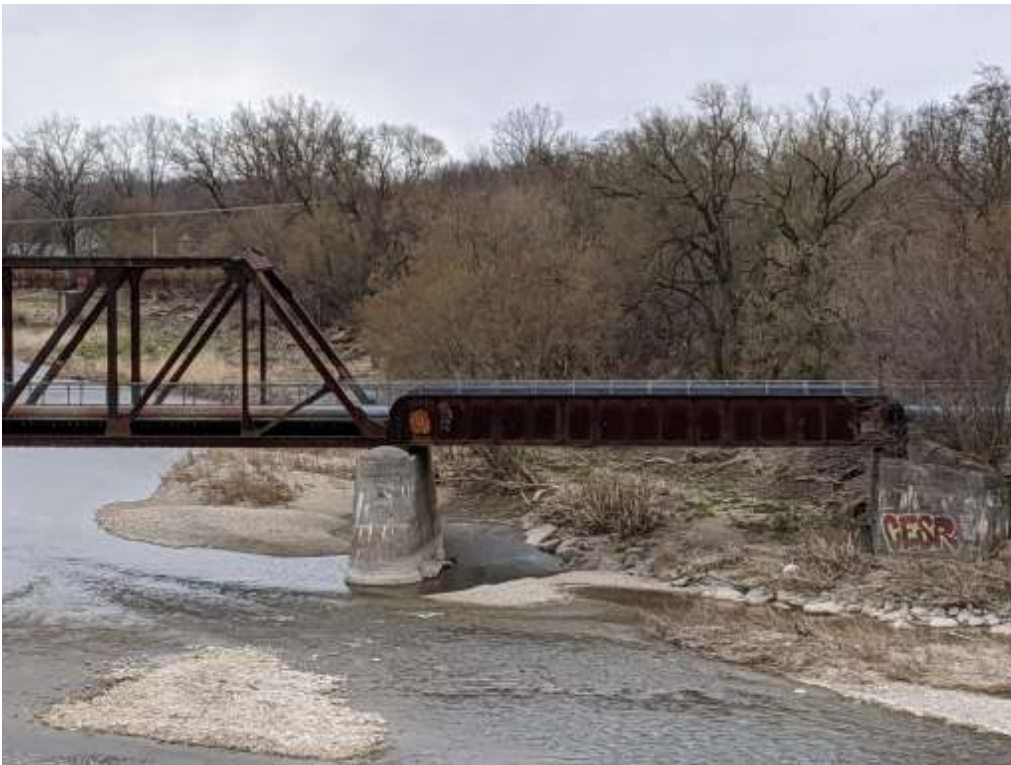
Photograph 13: Brants bridge – Looking at west pier and west abutment from upstream side.

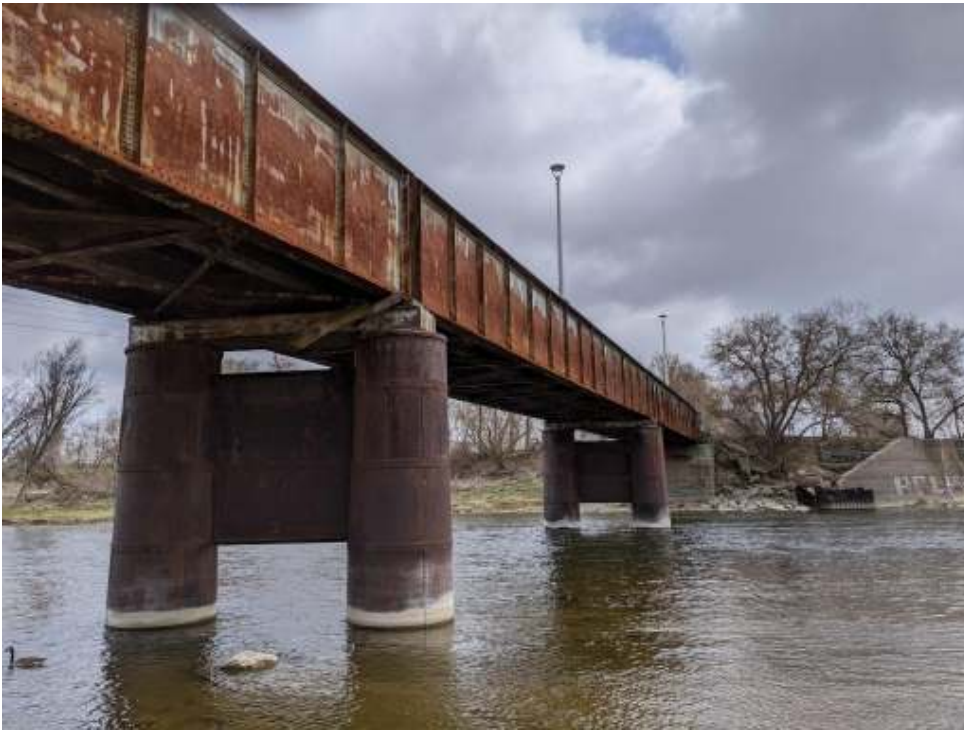
Photograph 14: TH&B Crossing Bridge– Looking at central pier, east pier, and east abutment from downstream side.

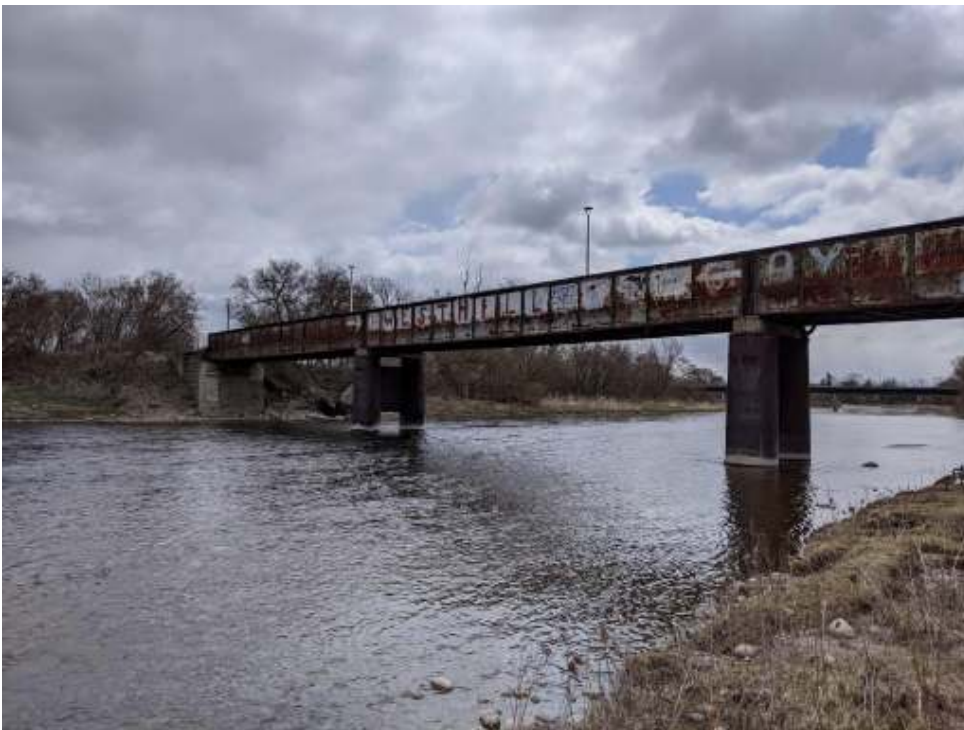
Photograph 15: TH&B Crossing Bridge – Looking at central pier, east pier and east abutment from upstream side.

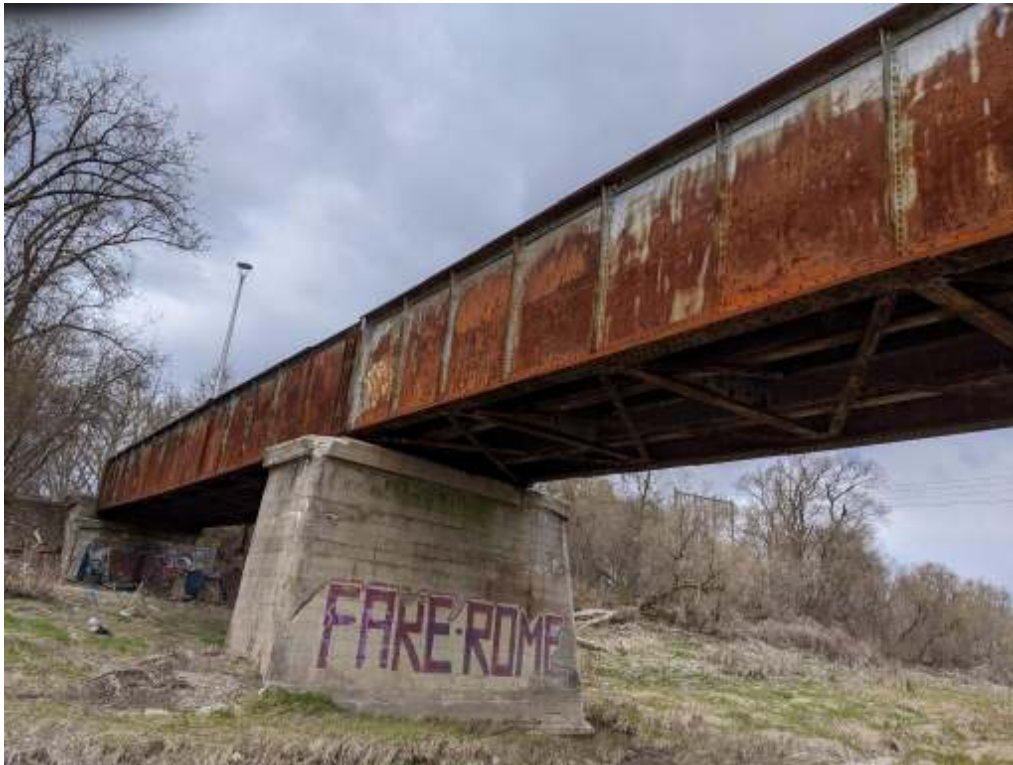
Photograph 16: TH&B Crossing Bridge – Looking at west pier and west abutment from downstream side.
