CITY OF BRANTFORD
**THREE GRAND
RIVER CROSSINGS**
MUNICIPAL CLASS EA

Virtual Public Information Centre

April 2021

FREQUENTLY ASKED QUESTIONS (FAQ) DOCUMENT

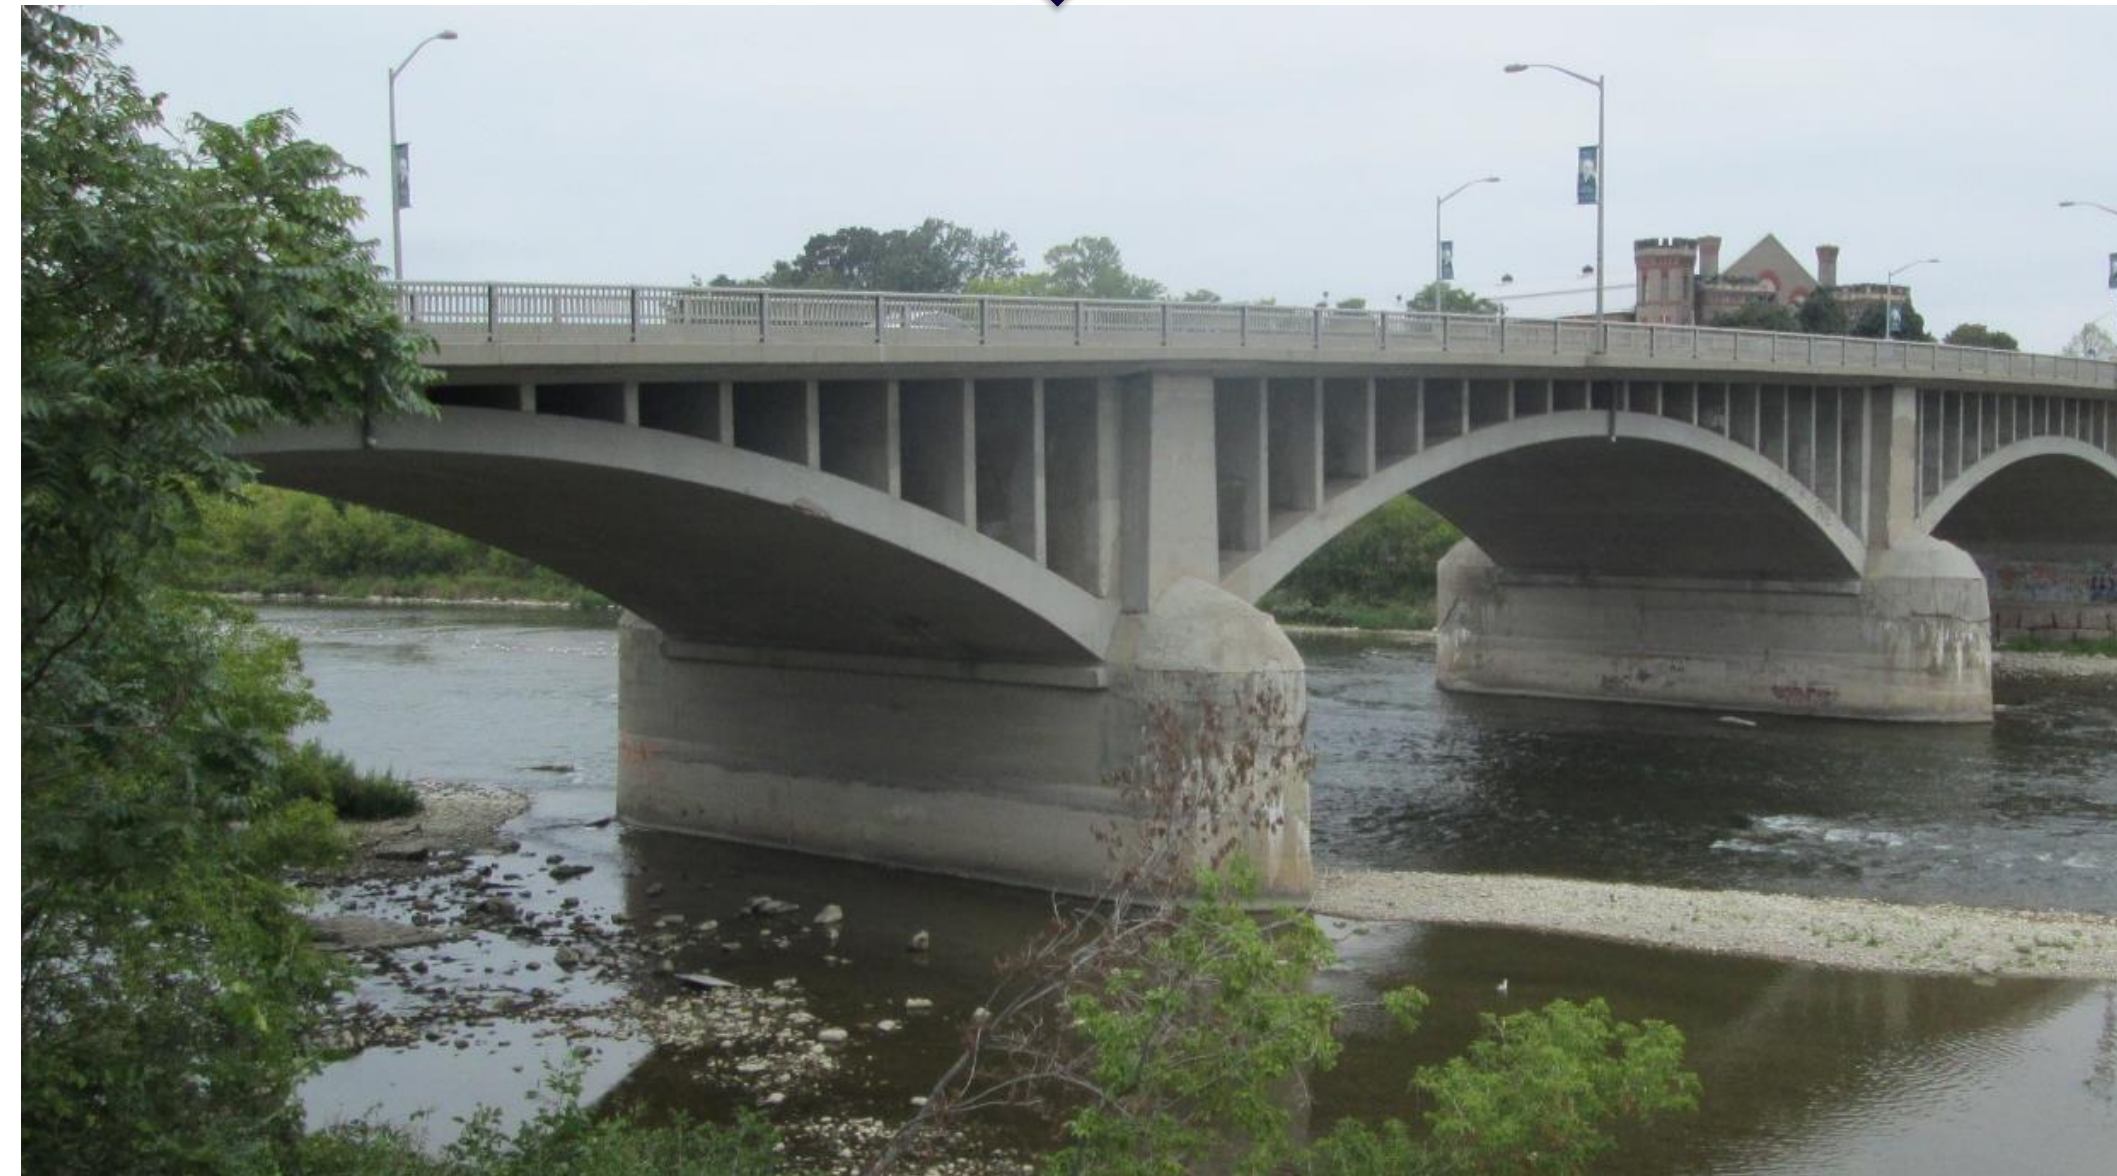
Lorne Bridge

- Three unique structures, the oldest of which was originally built in 1924
- No formal cycling lane in the roadway and cyclists typically share the sidewalk with pedestrians
- Requires 30 tonne load limit in winter months
- Requires major structural repairs to maintain the crossing

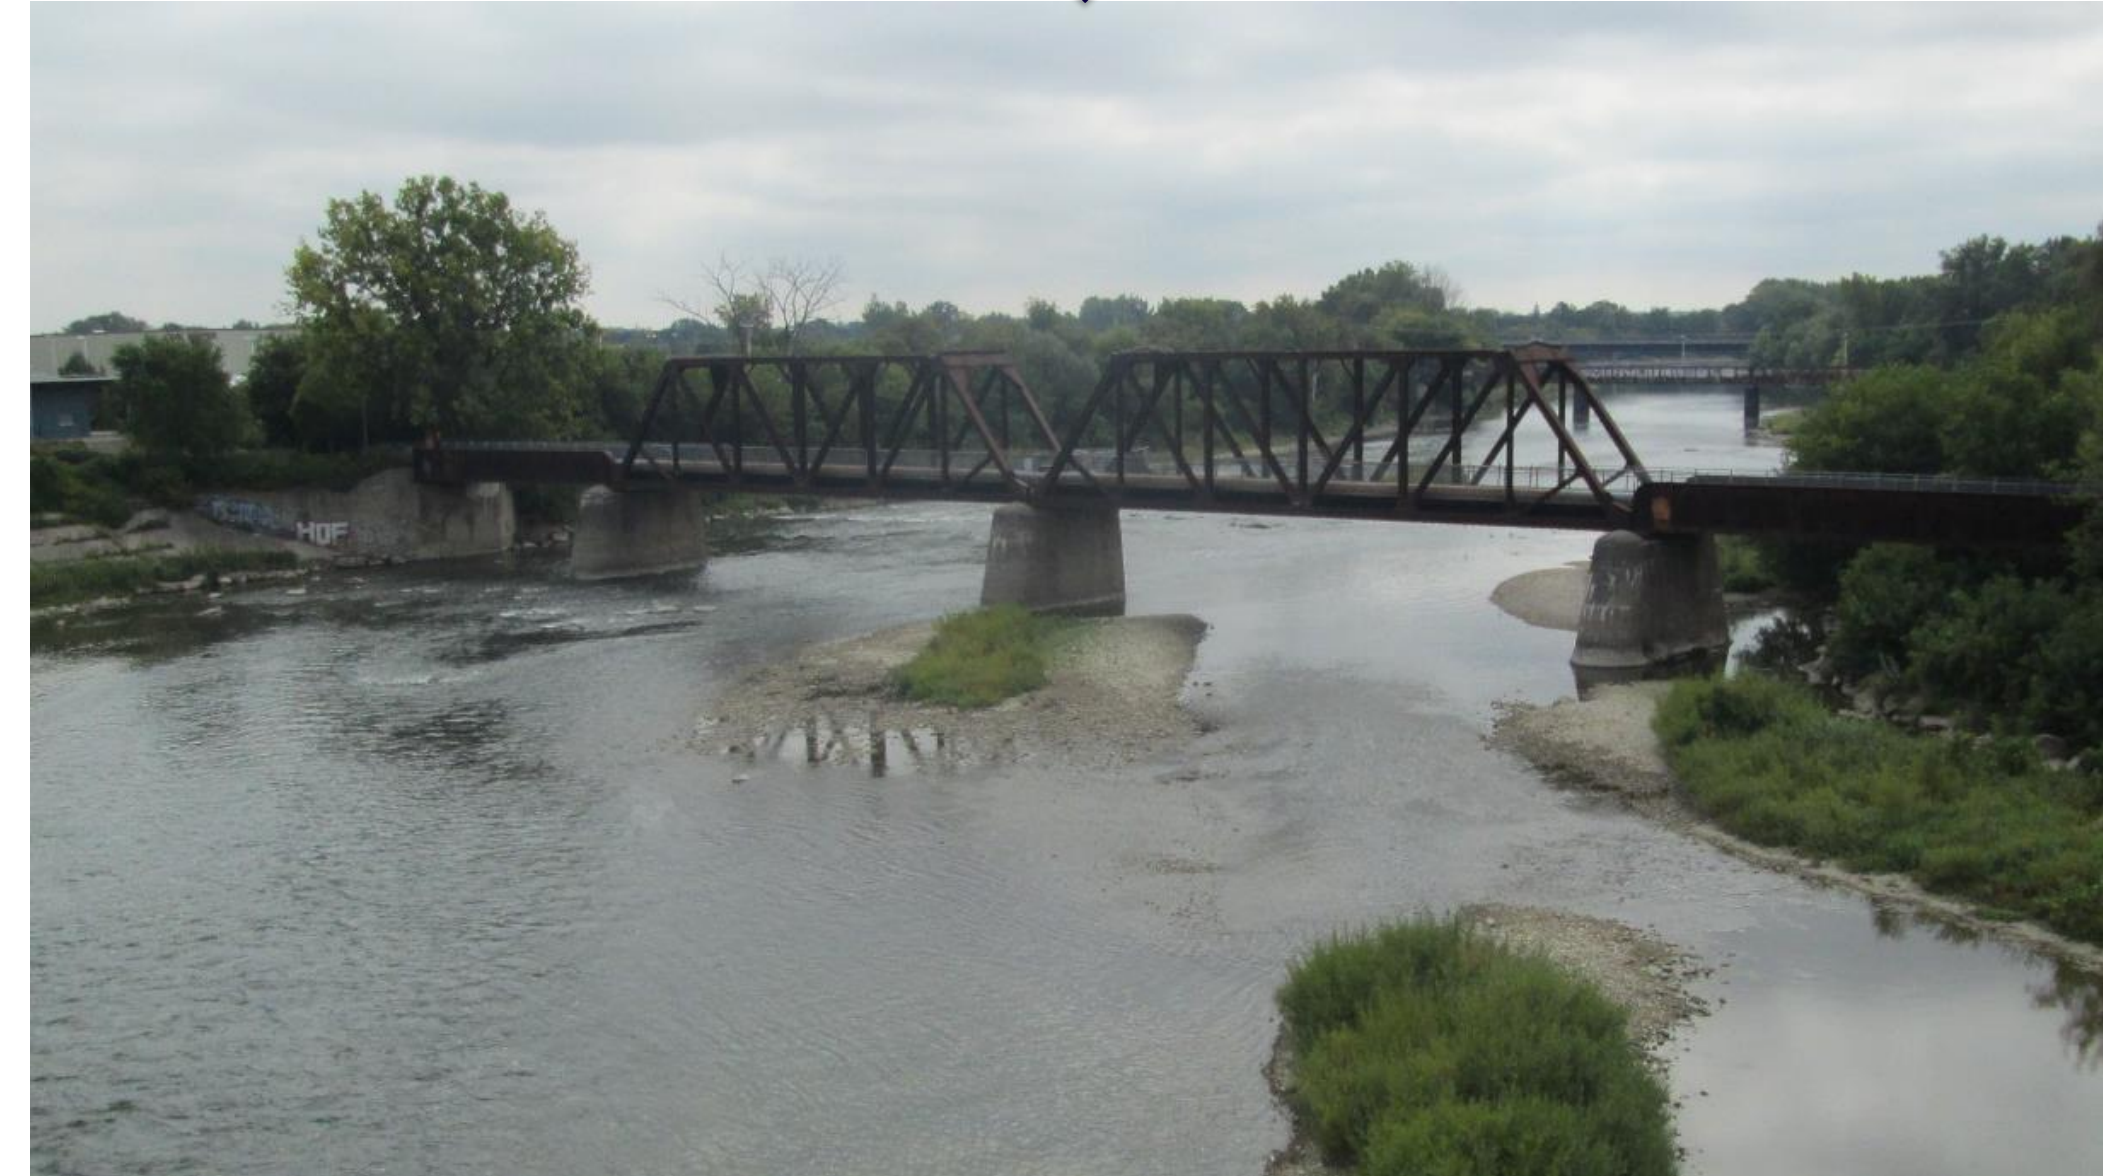
- Originally built in 1912 to convey railway traffic and has been converted to carry pedestrian traffic
- Closed since February 2018 following a flooding and ice jam event
- Minor rehabilitation required to open the bridge; however, to remain open beyond approximately 3-5 years, major structural repairs are necessary

- A minor rehabilitation is required in order to re-open the Brant's Crossing Bridge in the short term and could occur following the outcome of this Environmental Assessment. However, more extensive work is required in order to have the bridge remain open beyond approximately 3 to 5 years.

A minor rehabilitation is required to reopen the Brant's Crossing Bridge in the short term. However, a major rehabilitation is required in order to have the bridge remain open beyond approximately 3 to 5 years. A major rehabilitation would be required to keep the crossing open for somewhere between 15 to 30 years. After that, it is expected that repairs would become ineffective and replacement would be required.

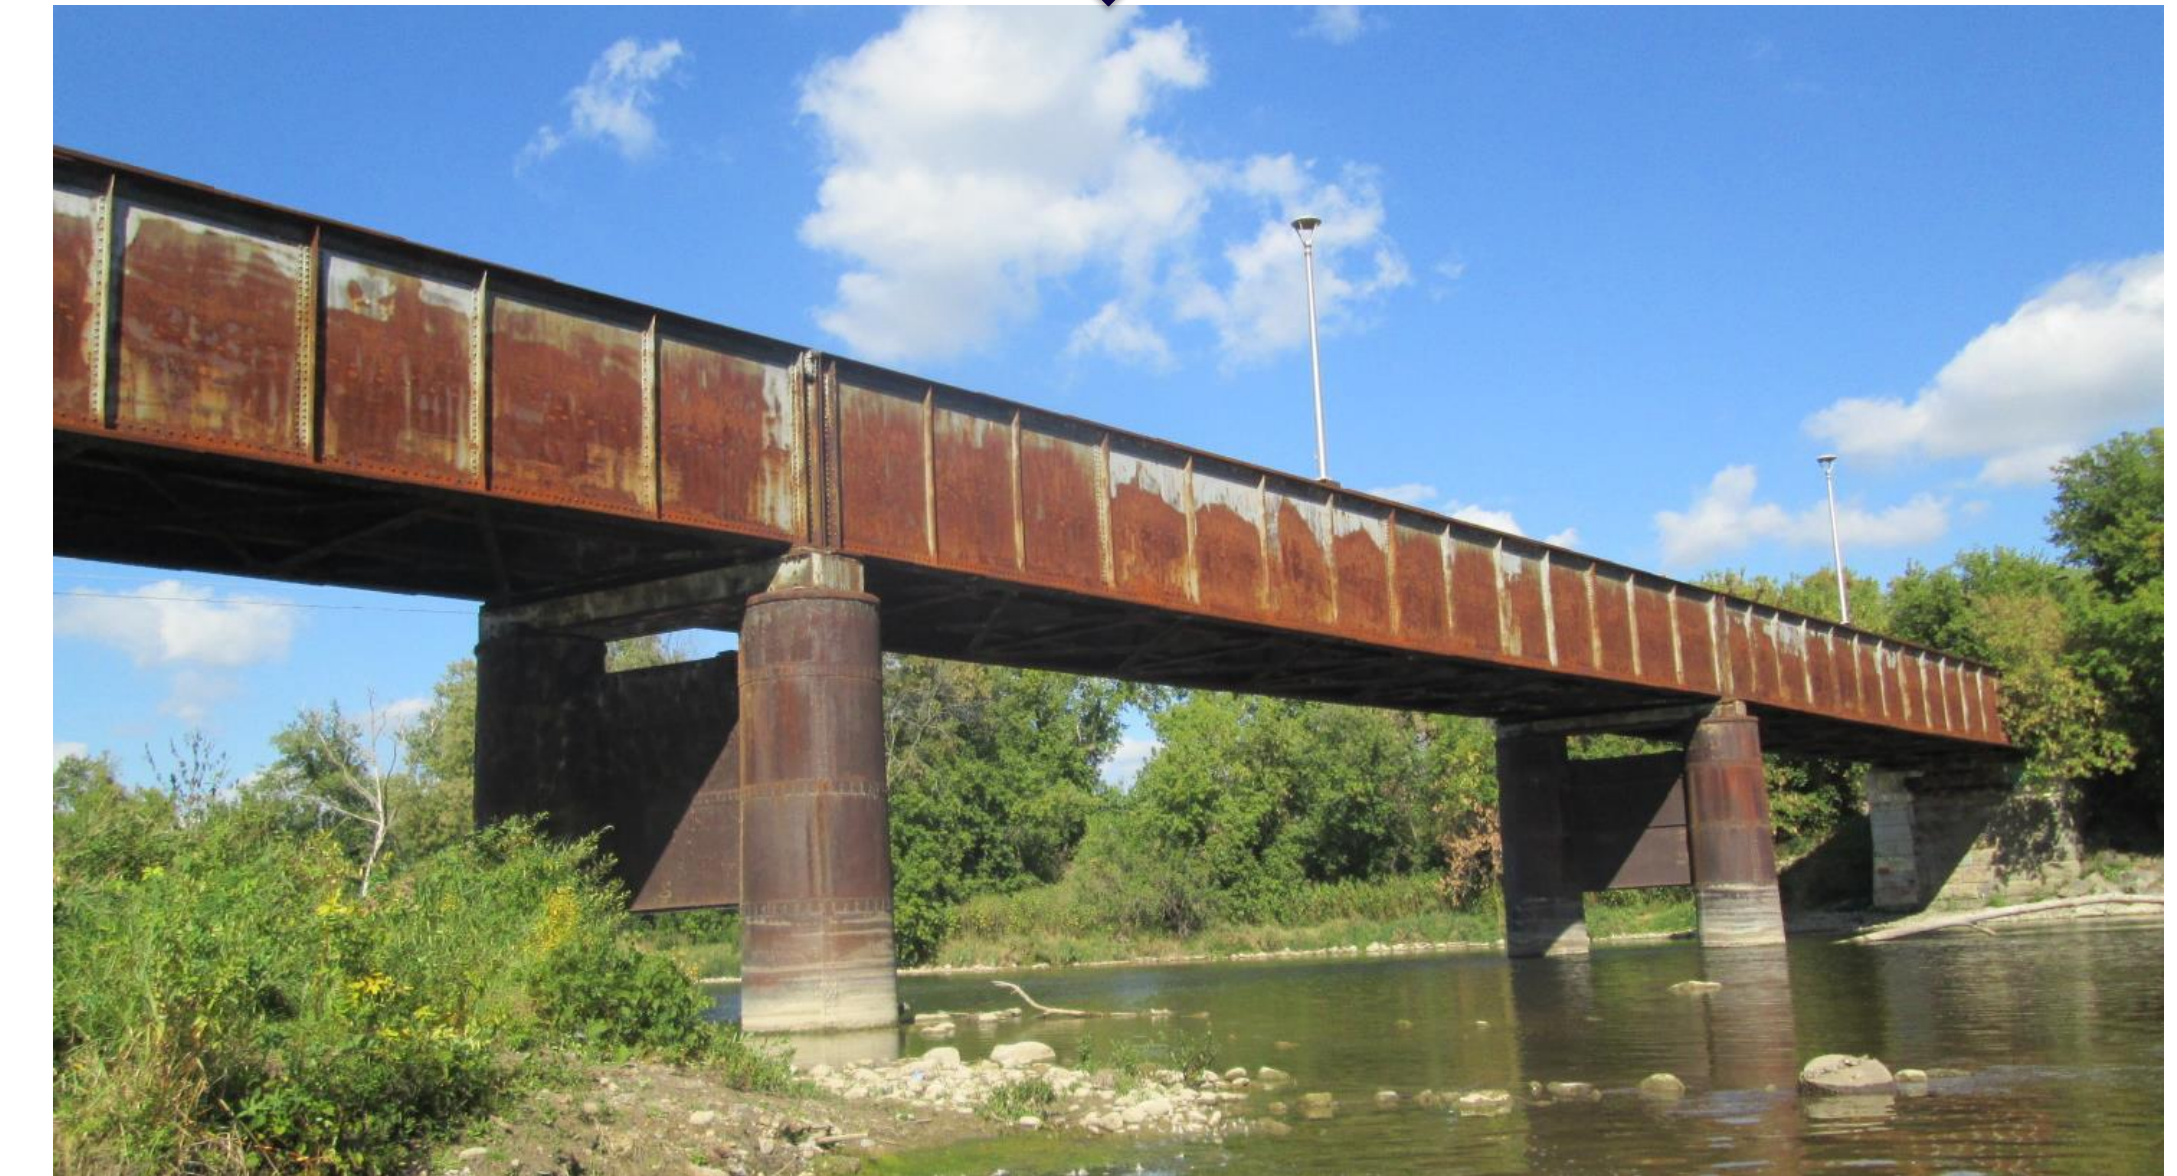
- Originally built in 1893 as a rail crossing bridge but has been converted to carry pedestrian and cyclist traffic
- Was temporarily closed following 2018 ice jam event but later reopened following a structural investigation
- For this structure to remain open beyond approximately 5-10 years, major repairs are necessary

The rehabilitation of the TH&B Crossing Bridge will include a full replacement of the existing wood deck. A variety of materials for the new deck could be explored during the detailed design phase.

The recommended solution for the TH&B Crossing Bridge is to complete minor repairs to the structure, and eventually remove the structure at the end of its useful life. As the walls of this bridge are the structural element of the bridge, they cannot be opened up to provide better views; however, it may be possible to slightly raise the existing bridge deck so that users could more easily see above of these walls.

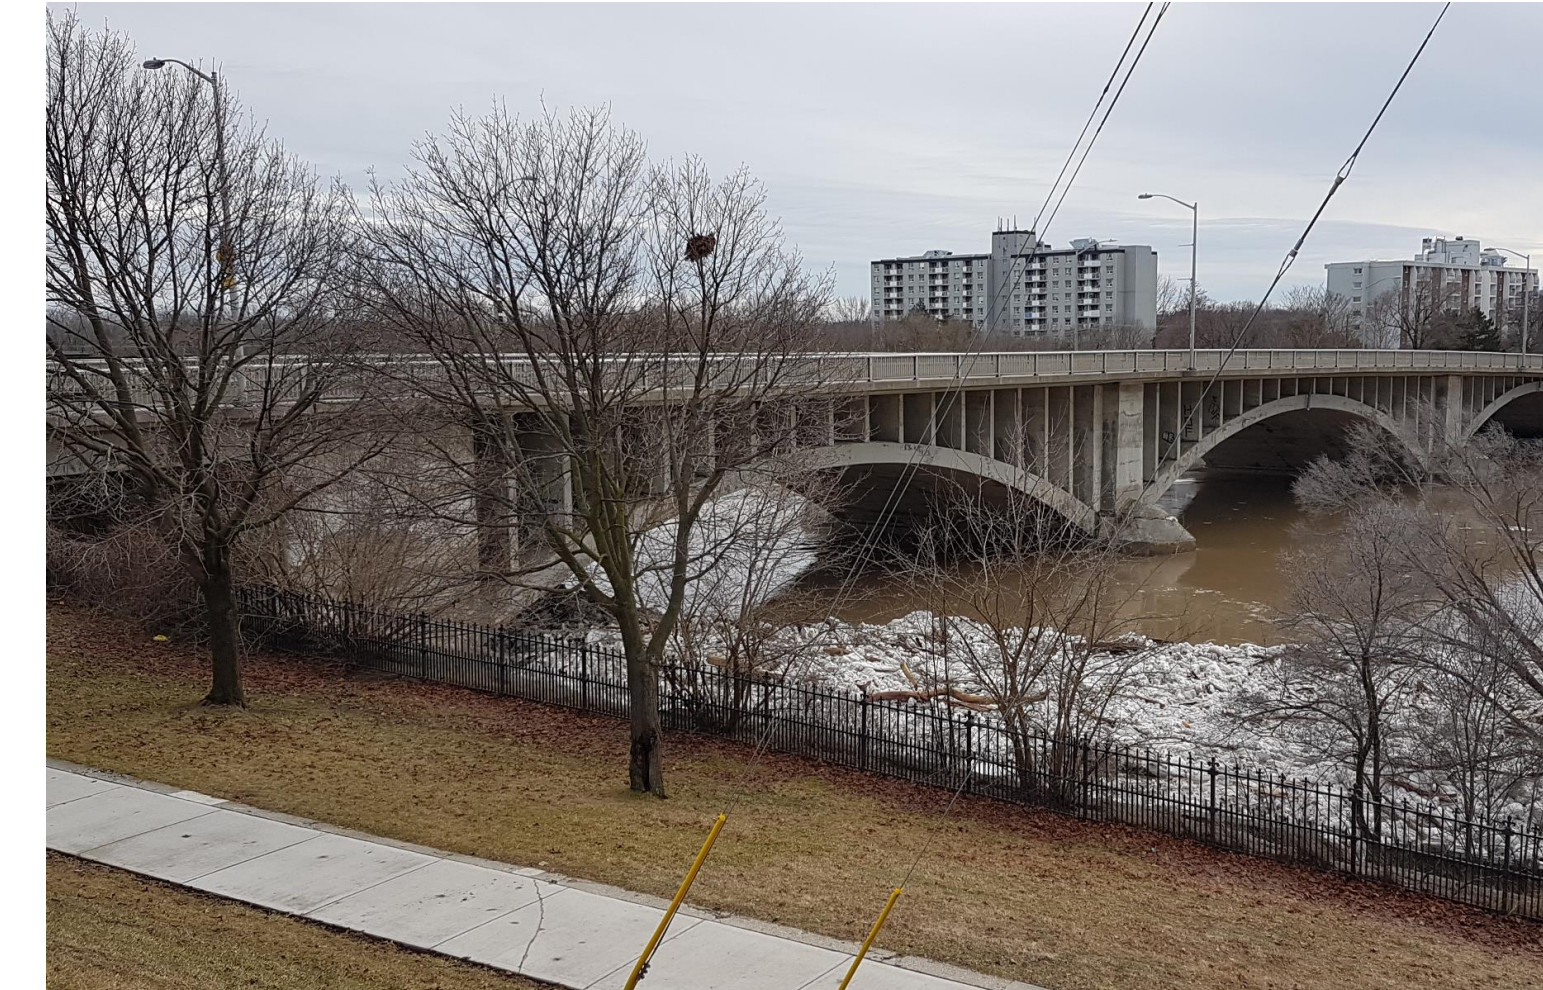
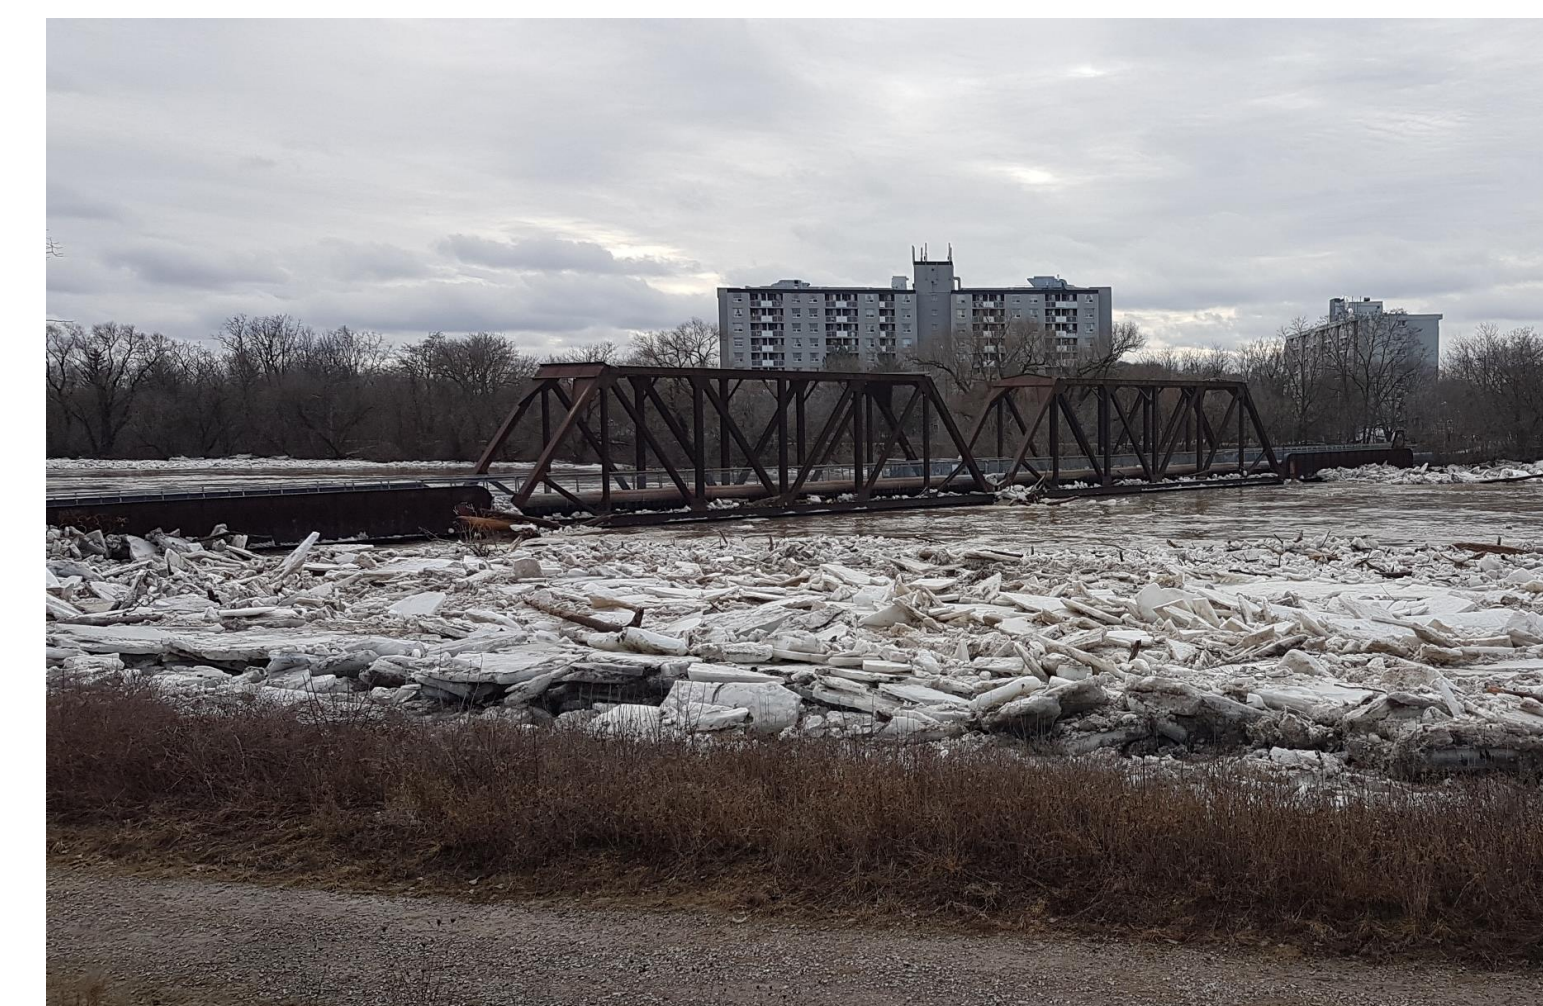
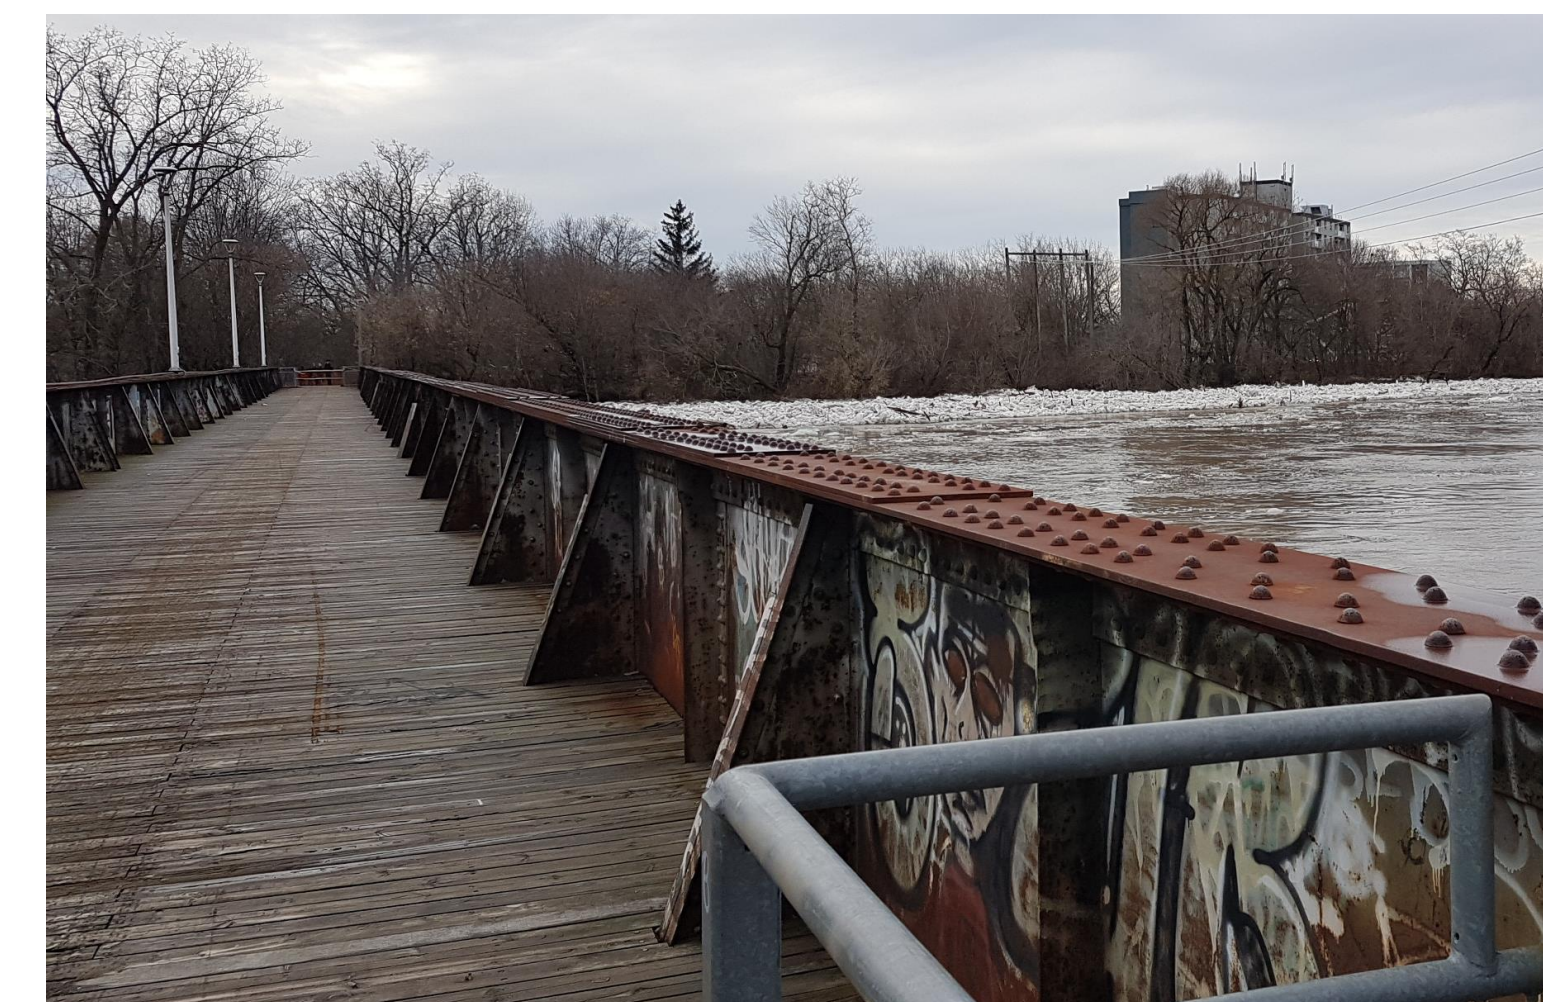
Photos from the 2018 Ice Jam Event

- A Hydraulic Impact Study was completed to review the flood behaviour of the Grand River in the vicinity of the three existing bridge crossings and to identify opportunities to enhance hydraulic function of each crossing.
- The Hydraulic Impact Study concluded that:
 - The **Lorne Bridge** meets hydraulic evaluation criteria under both 100-year return period for open water flow and ice jam events. No hydraulic improvement opportunities were present.
 - Both **Brant's Crossing and TH&B Crossing Bridges** are acceptable under 10-year return period open flow events, but not under ice jam conditions. Opportunity to enhance hydraulic performance during ice jam events by raising each bridge by approximately 0.8 m.

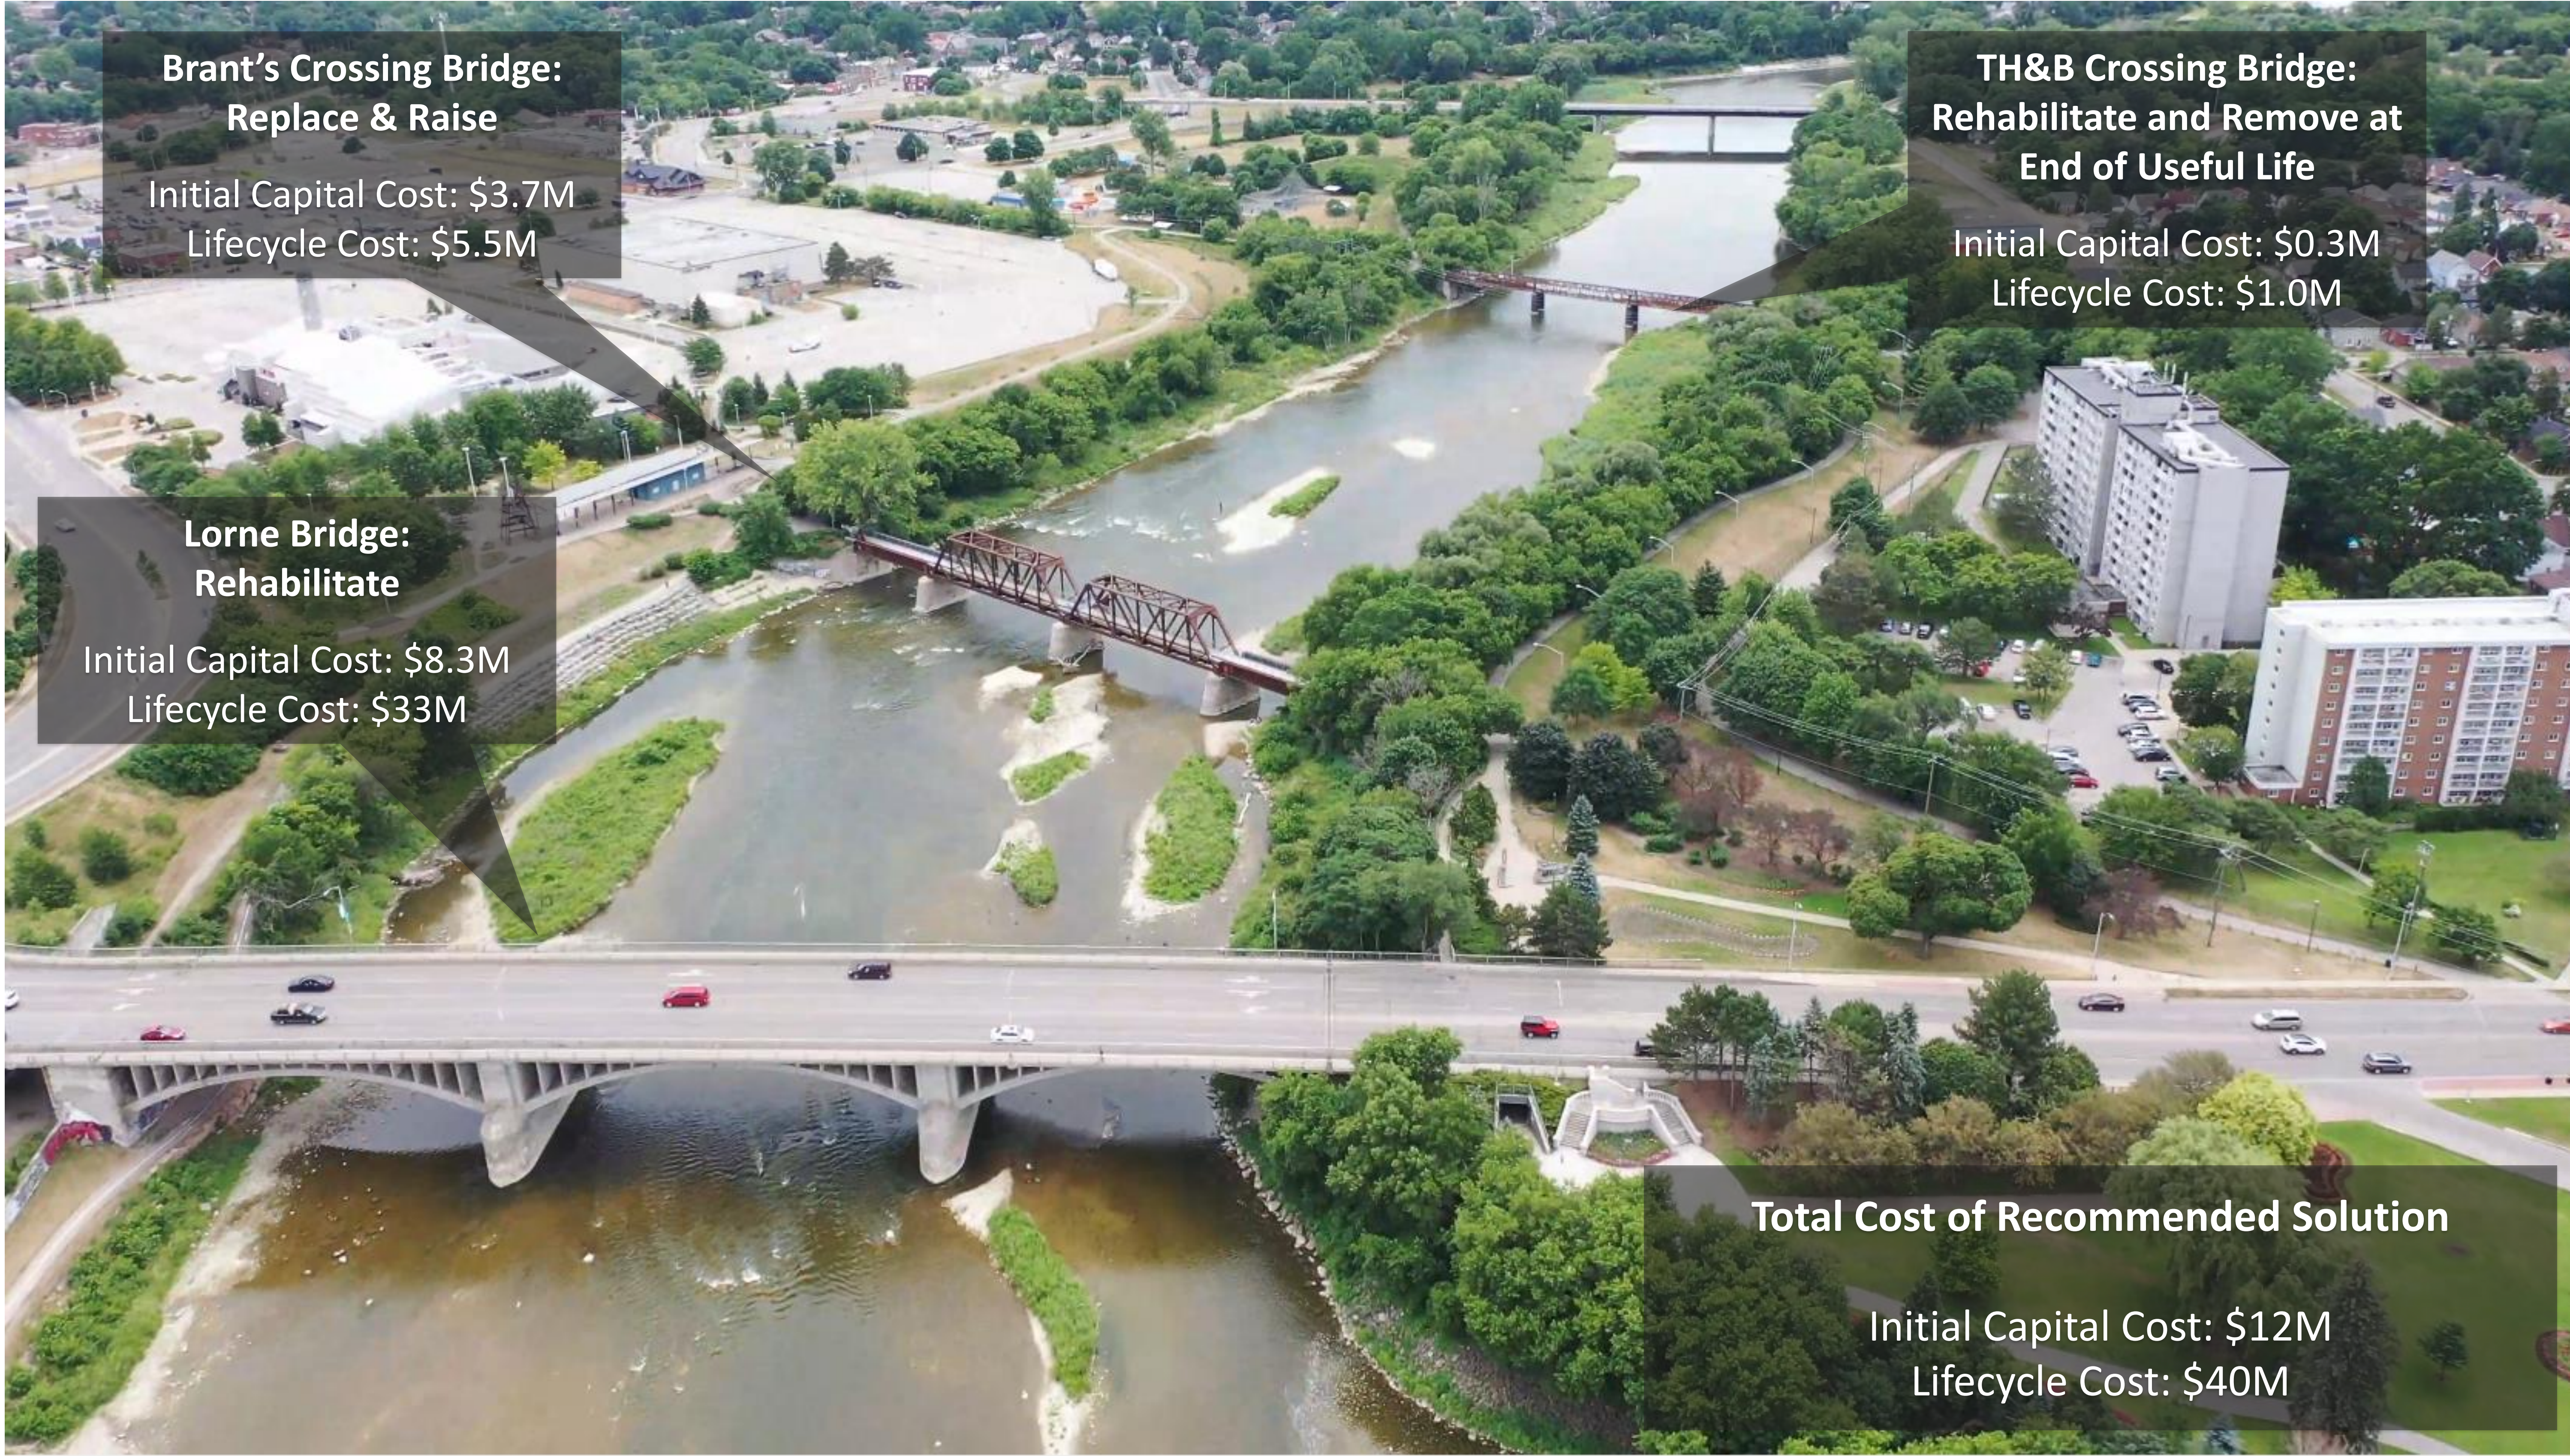
Recommended Solution: Strategy 7

**Brant's Crossing Bridge:
Replace & Raise**
Initial Capital Cost: \$3.7M
Lifecycle Cost: \$5.5M

**TH&B Crossing Bridge:
Rehabilitate and Remove at
End of Useful Life**
Initial Capital Cost: \$0.3M
Lifecycle Cost: \$1.0M

**Lorne Bridge:
Rehabilitate**
Initial Capital Cost: \$8.3M
Lifecycle Cost: \$33M

The replacement of the Brant's Crossing Bridge would include the removal of existing steel superstructure and major repairs to the concrete substructure, including adding additional height to account for flooding impacts. A new steel superstructure would then be installed on the repaired foundation. For the purposes of this study, a prefabricated steel truss has been considered as the replacement superstructure and would be somewhat similar to the existing truss structure. A staircase and ramp may be required at the east and west approaches to the bridge to provide access to the raised structure. The geometry and aesthetics of the crossing would be evaluated during the design phase of the project, following the completion of this EA.

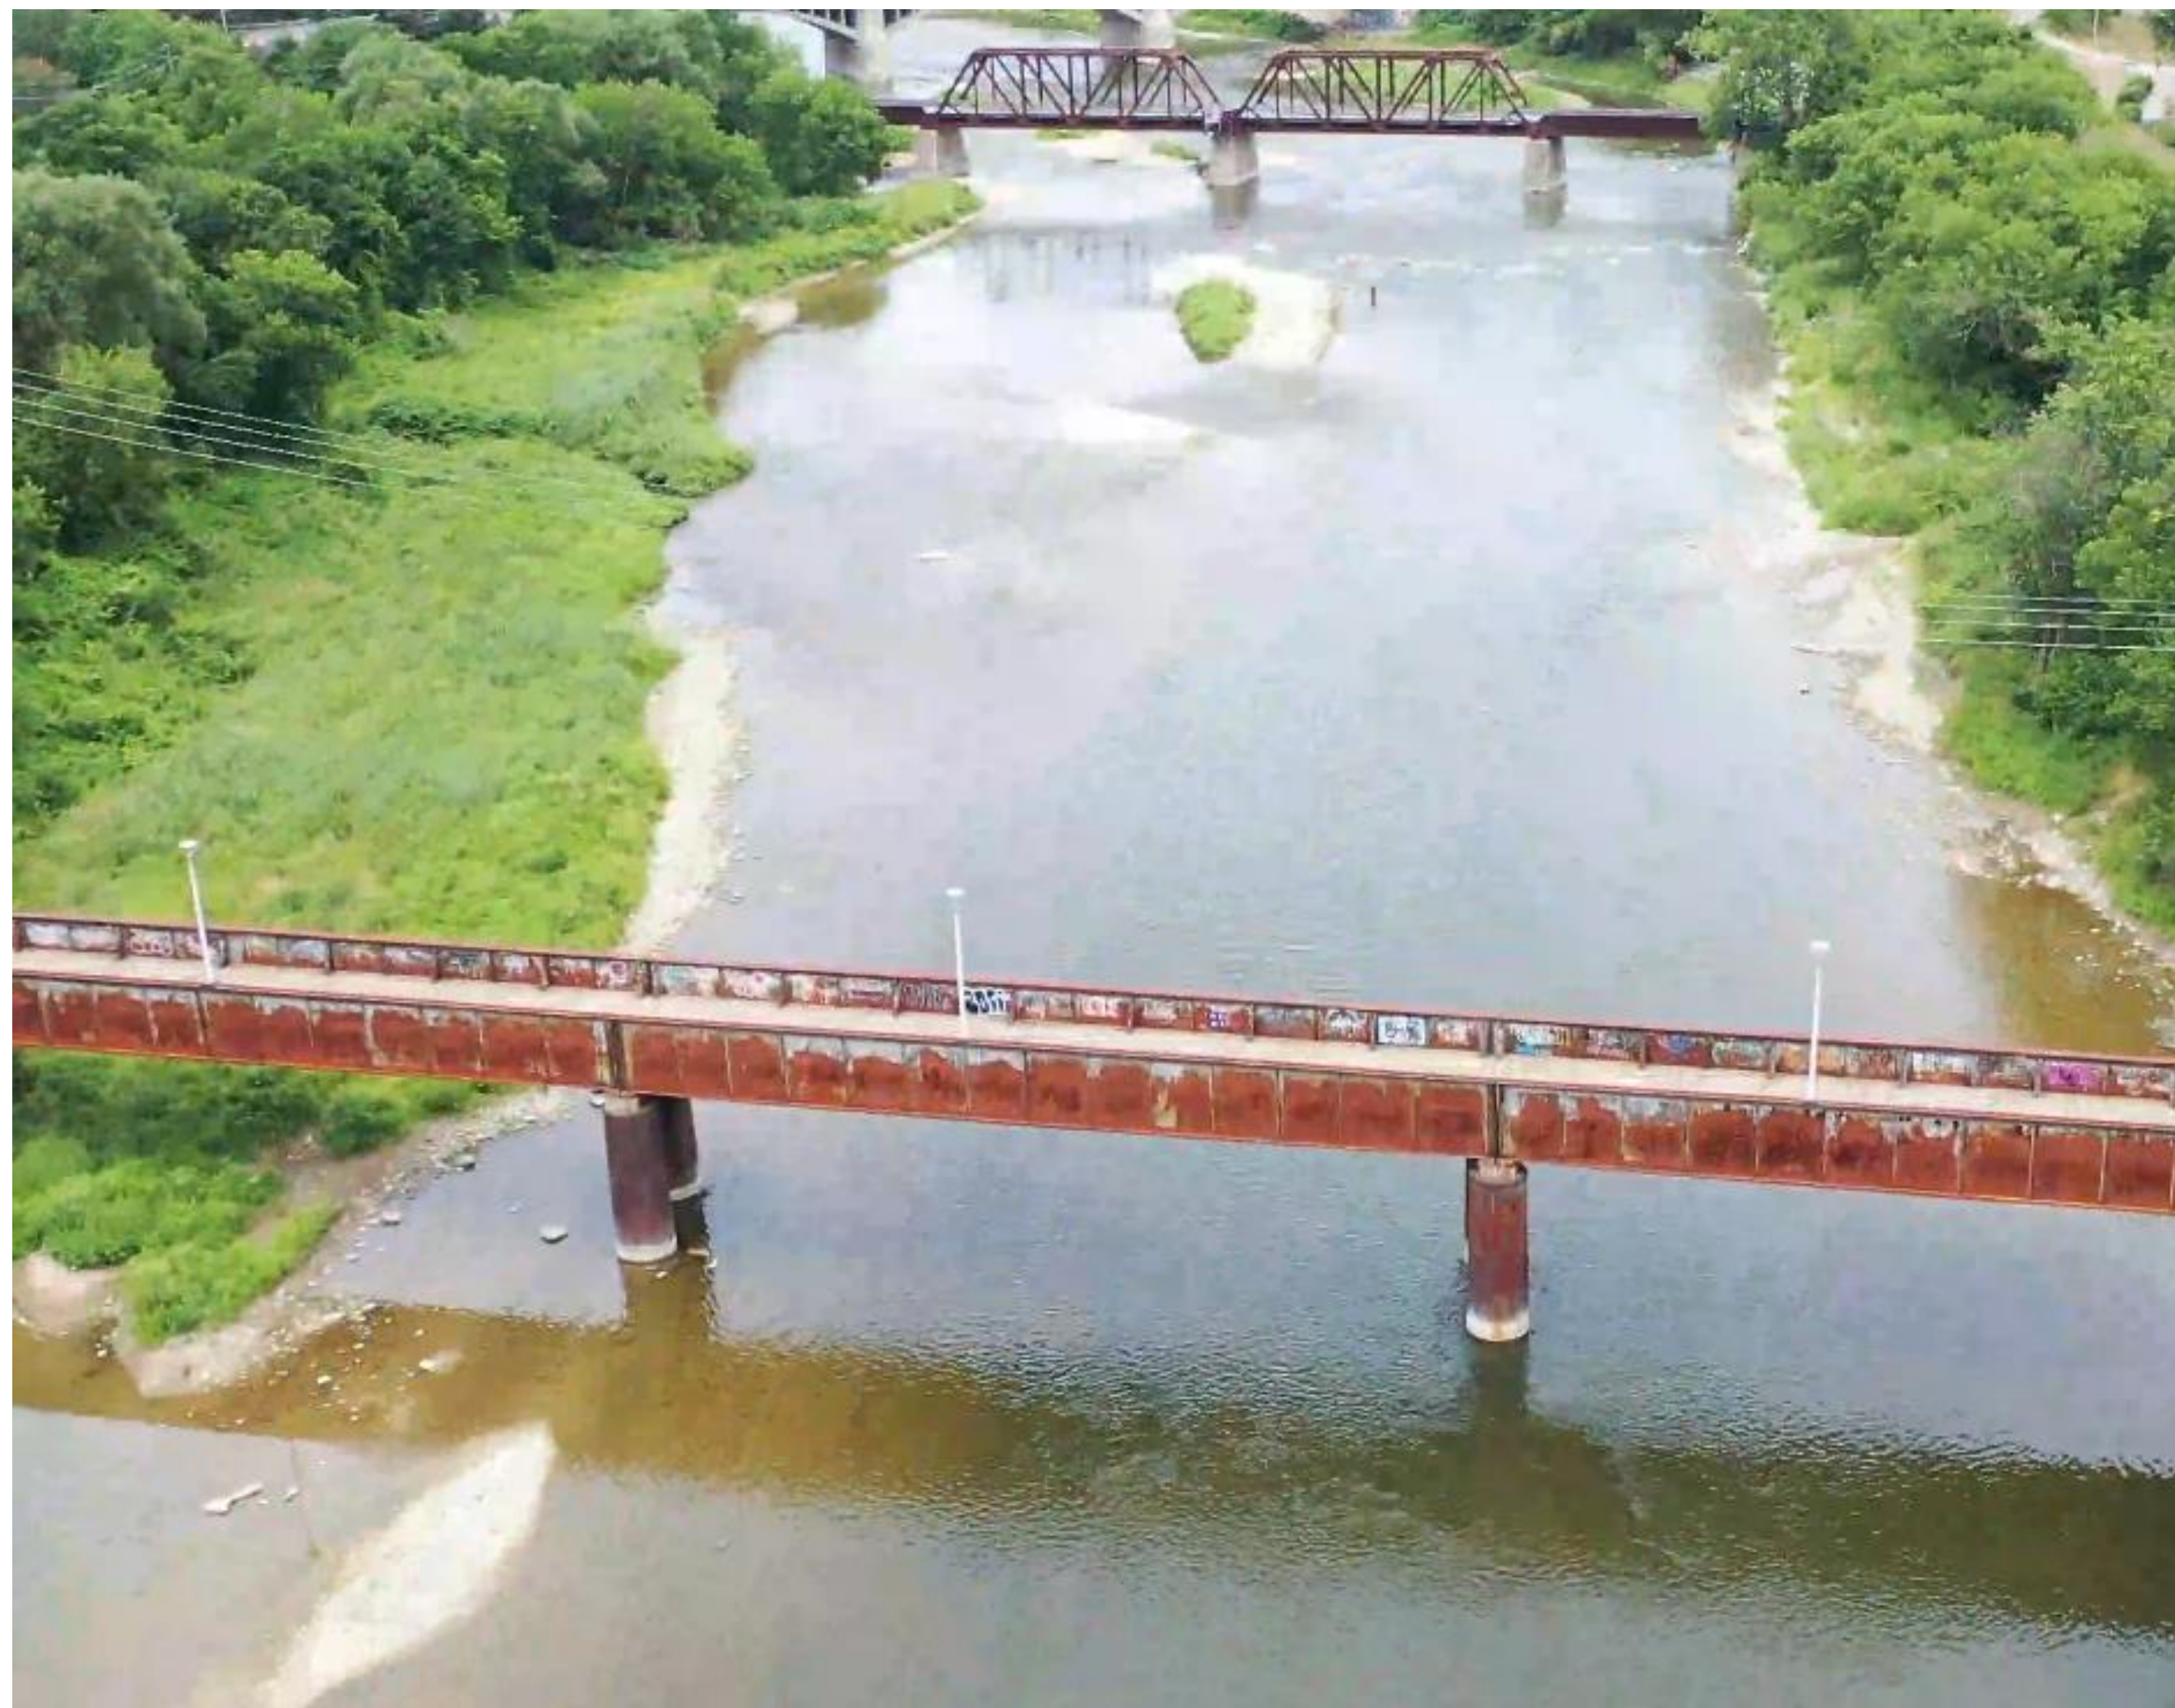
- According to records back to 1965, river water gauges indicate that in February of 1996 and February 2018 the underside of the bridges were submerged. Additionally, an event in February 1984 was very close to or may actually have risen to the undersides of the bridges.
