CITY OF BRANTFORD
**THREE GRAND
RIVER CROSSINGS**
MUNICIPAL CLASS EA

Virtual Public Information Centre

April 2021

FREQUENTLY ASKED QUESTIONS (FAQ) DOCUMENT

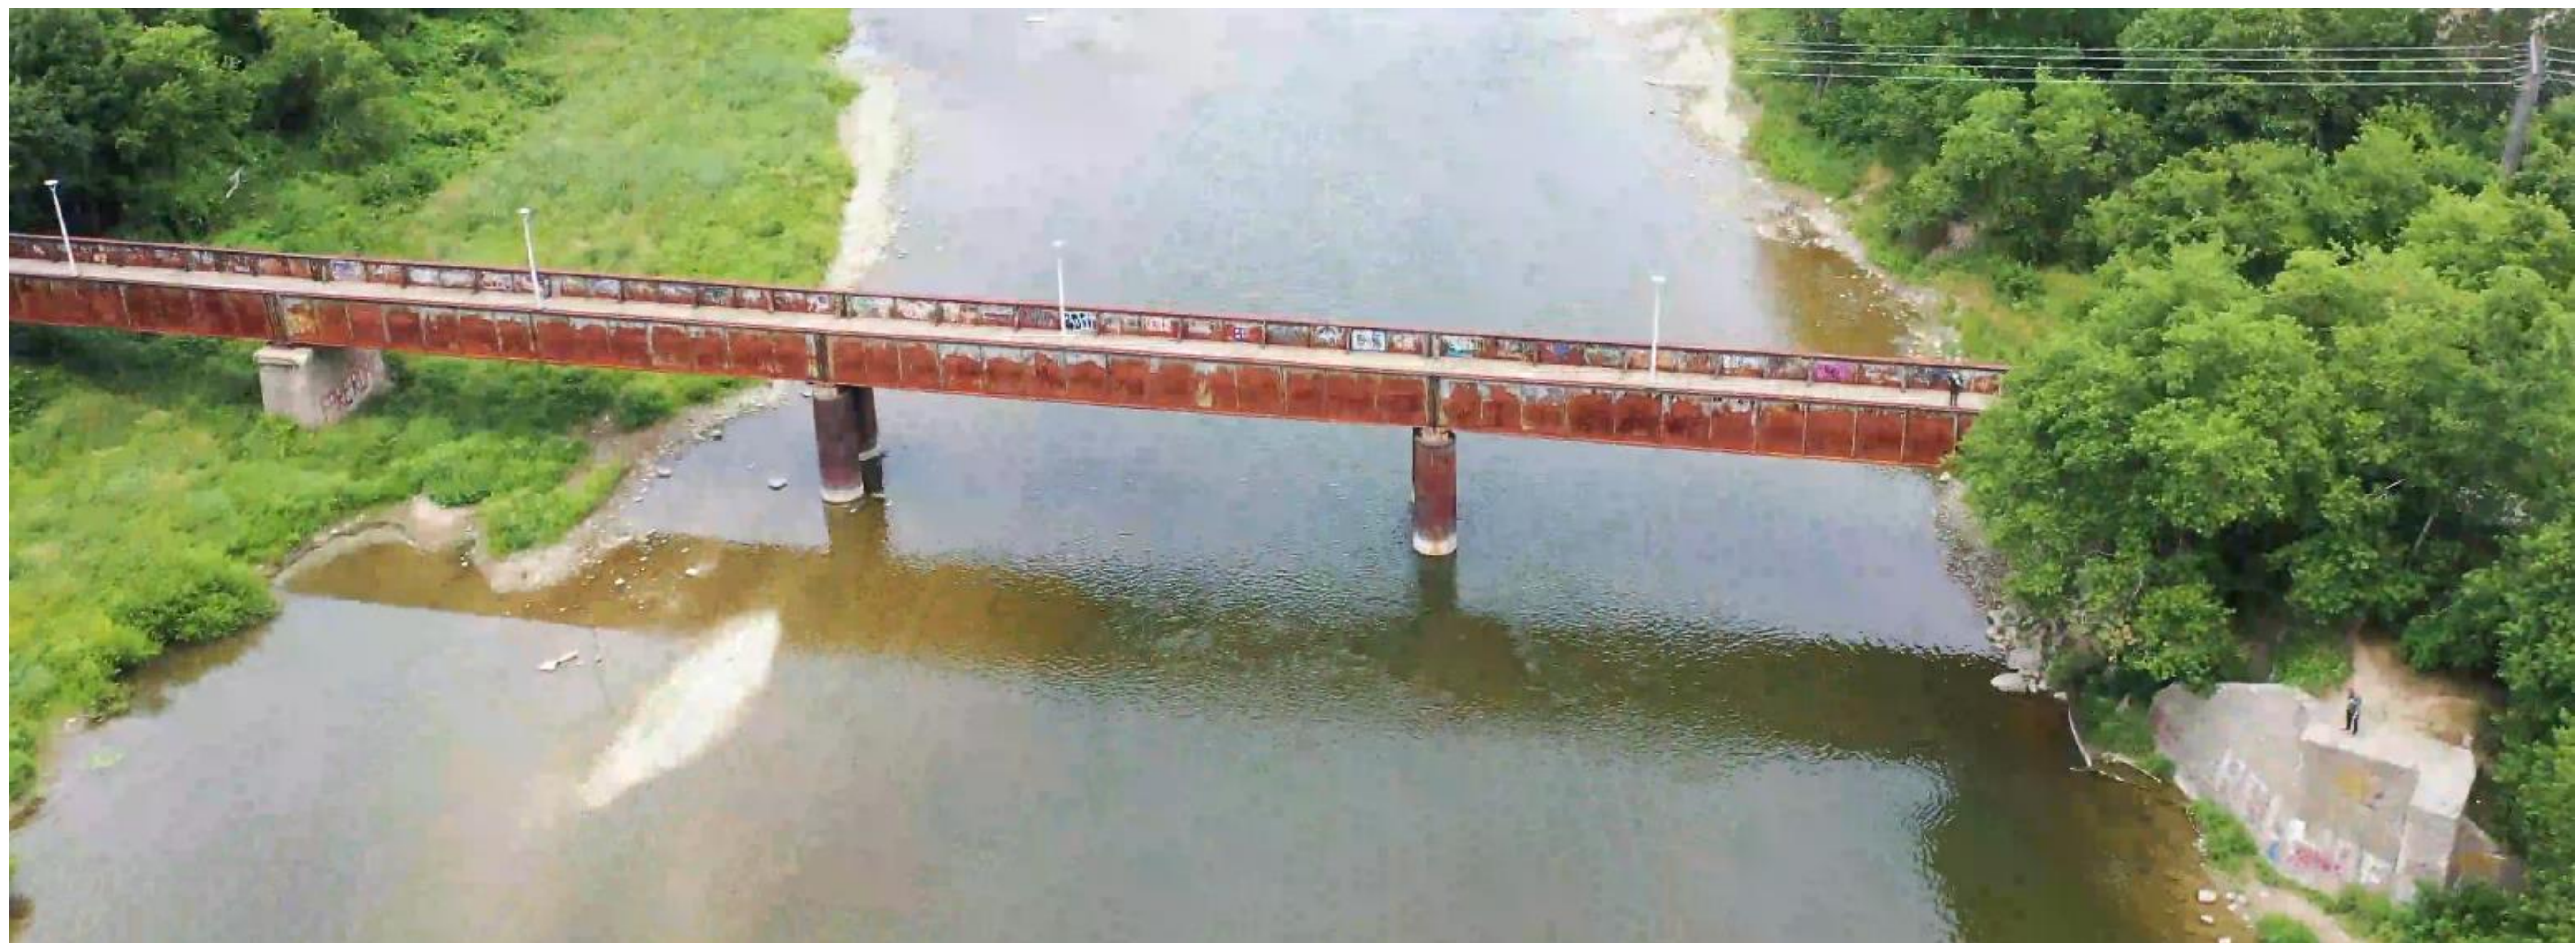
- Raising the two crossings by approximately 0.8 metres reduces the probability of an ice jam event occurring at the bridges to less than 1% in any given year (100-year event).

As part of the recommended Overall Crossing Strategy, Brant's Crossing Bridge will be replaced and raised to reduce the risk of flooding impacts at the crossing to less than 1% in any given year. The TH&B Crossing Bridge will eventually be removed at the end of its useful life, at which point risks associated with flooding impacts will be eliminated at the crossing.
