ENGINEERING AND OPERATIONAL SERVICES

January 6, 2009

SUBJECT: 2008 DOWNTOWN BRANTFORD PARKING STUDY

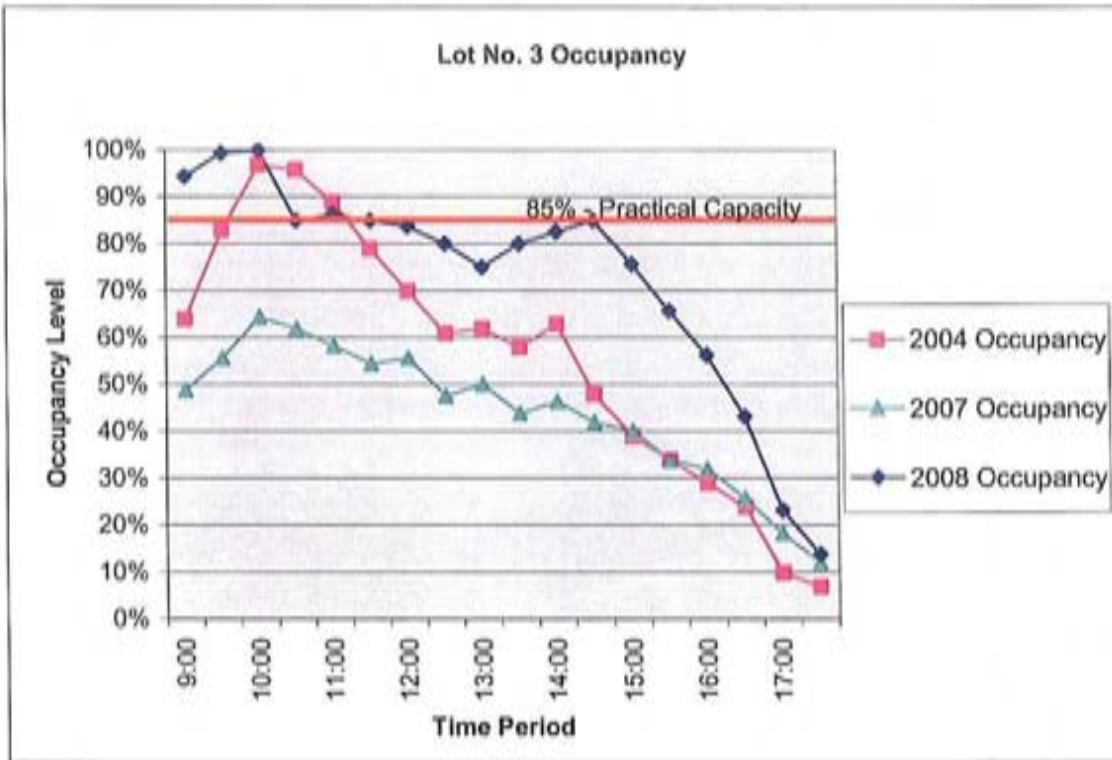
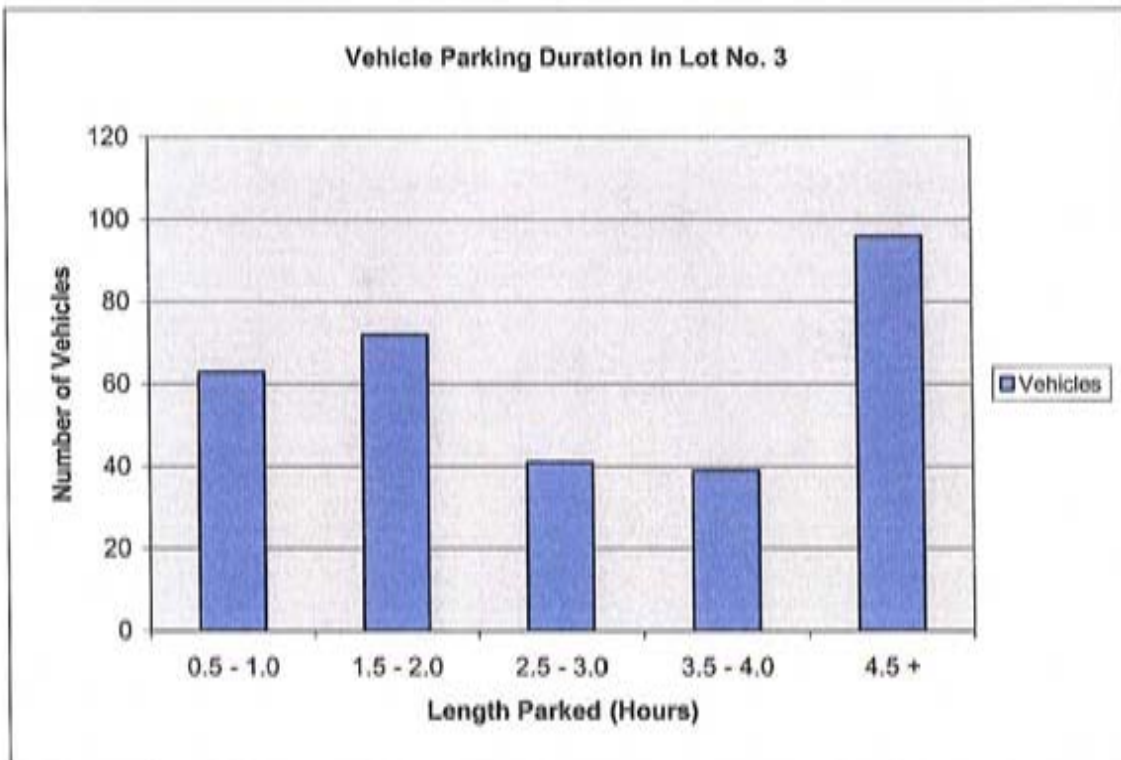
Figure 4 – Lot No. 3 Occupancy and Duration

Lot #3 has 160 spaces. The average duration is 203 minutes, has a maximum occupancy of 100% at 10:00 a.m., and an average turnover rate of 1.94 vehicles in nine (9) hours. The previous study conducted in 2007 resulted in an average duration of 204 minutes, maximum occupancy of 64% at 10:00 a.m., and the average turnover rate was 1.16 vehicles in nine (9) hours. The utilization of this lot has increased since 2007, and the turnover rate has improved.

Of the 311 vehicles using this lot, the majority (31%) were parked for over four (4) hours. This lot accommodates employees working in the downtown, including City employees of the Transit Terminal and Sanderson Centre. Figure 4 in Appendix "A" shows the occupancy plotted versus time in 2004, 2007 and 2008 for Lot #3, as well as a graph showing the parking duration levels.

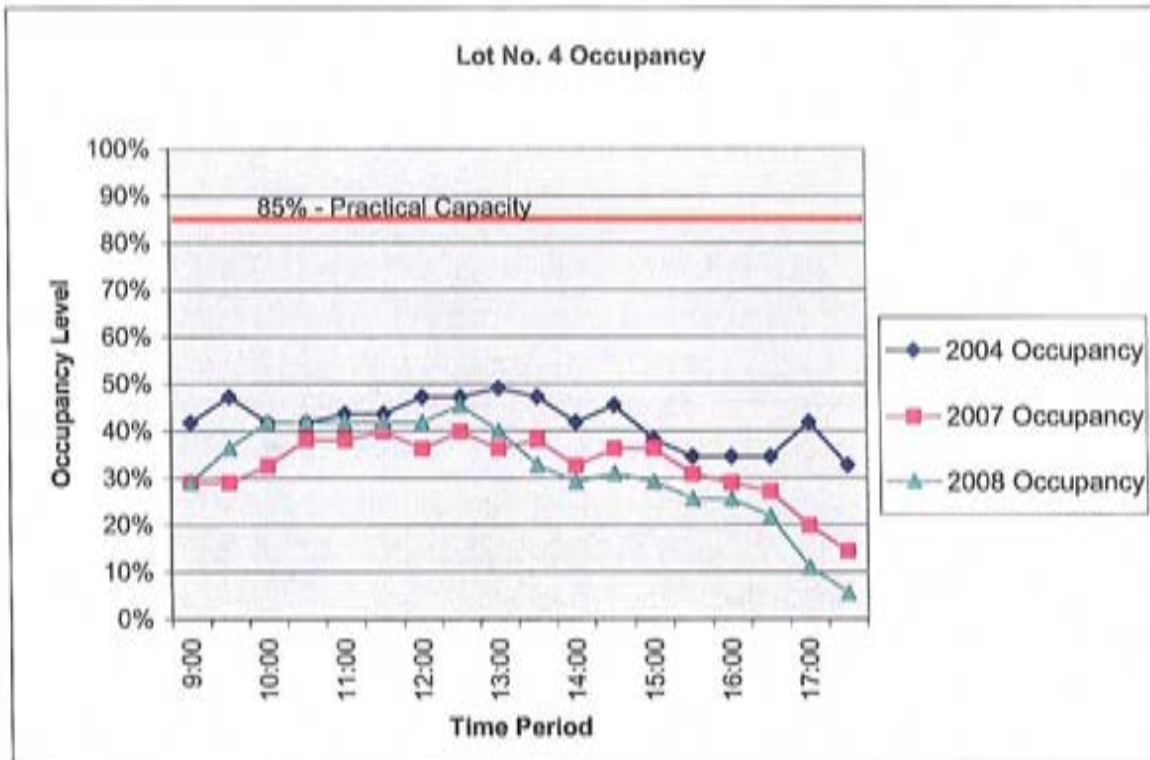
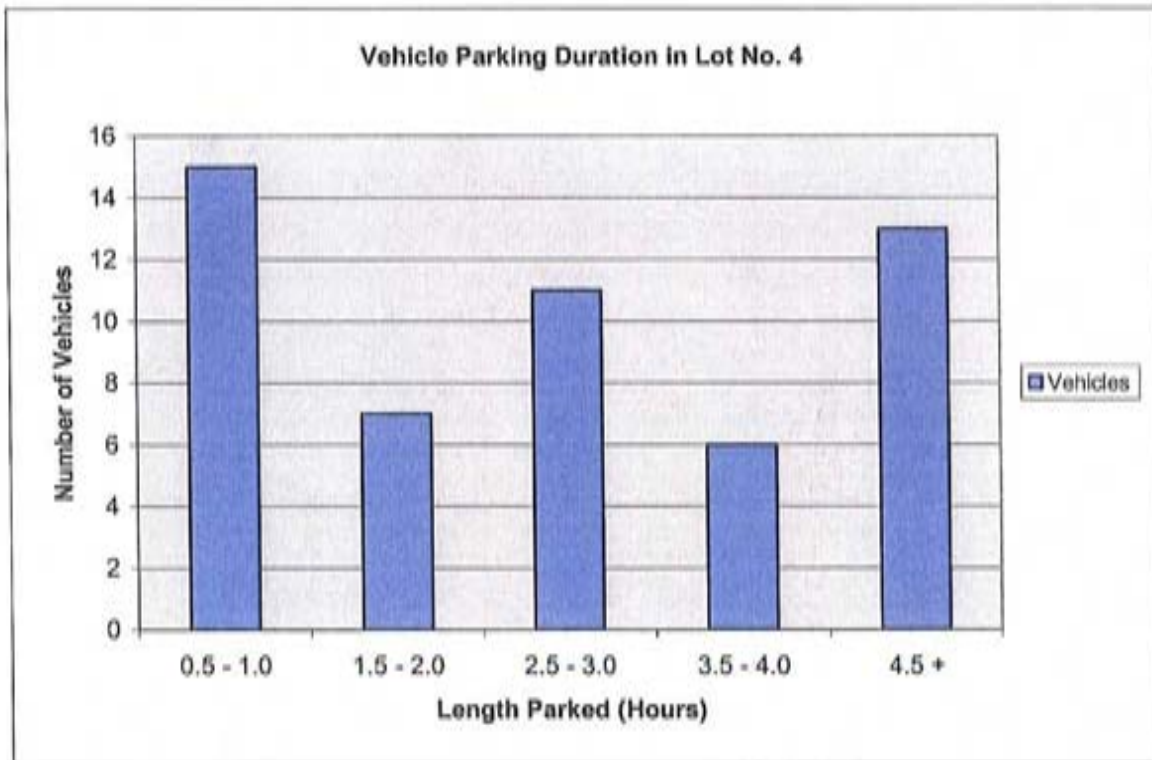
Figure 5 – Lot No. 4 Occupancy and Duration

This parking lot has 55 spaces. The average duration is 182 minutes, has a maximum occupancy of 45% at 12:30 a.m., and has an average turnover rate of 0.93 vehicles in nine (9) hours. In the 2007 study, the average duration was 225 minutes, maximum occupancy was 40% at 11:30 a.m. and 12:30 pm, and the average turnover rate was 0.78 vehicles/space.

Out of the fifty-one (51) vehicles that utilized this lot, 29% were parked for approximately thirty (30) minutes to one (1) hour and 25% parked for over four (4) hours. Figure 5 in Appendix "A" shows the occupancy plotted versus time in 2004, 2007 and 2008 for Lot No. 4, as well as a graph showing the parking duration levels.

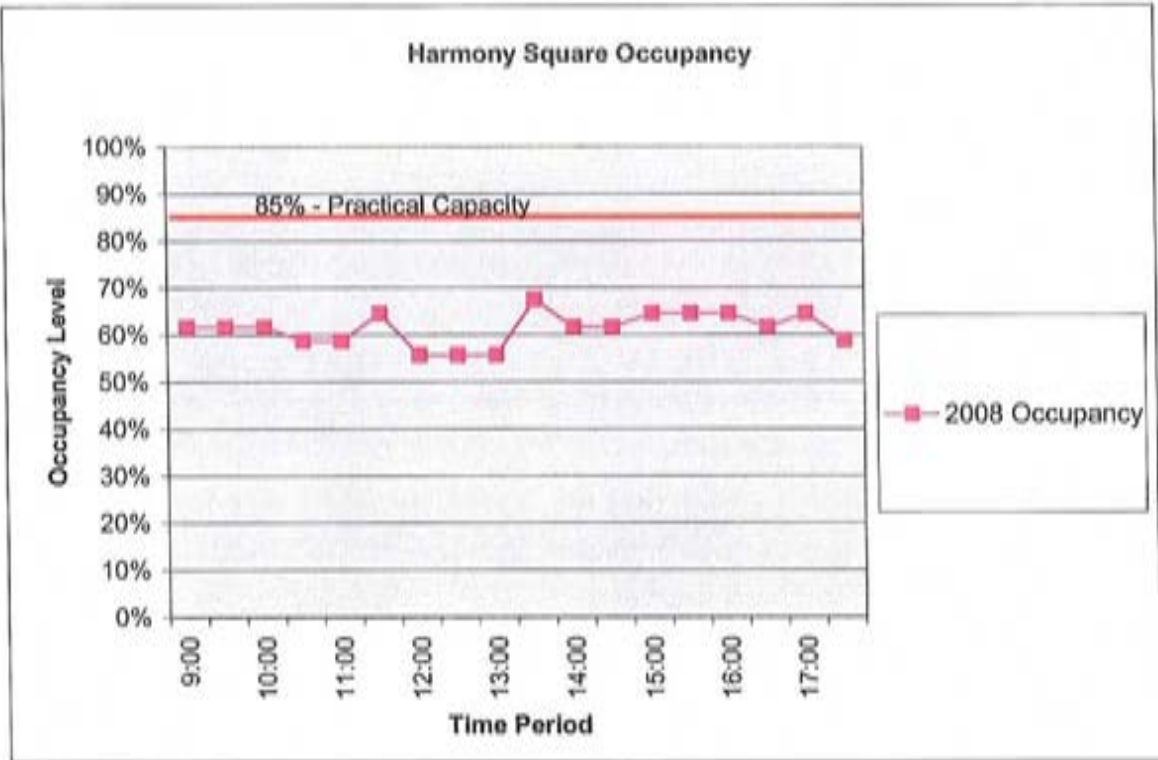
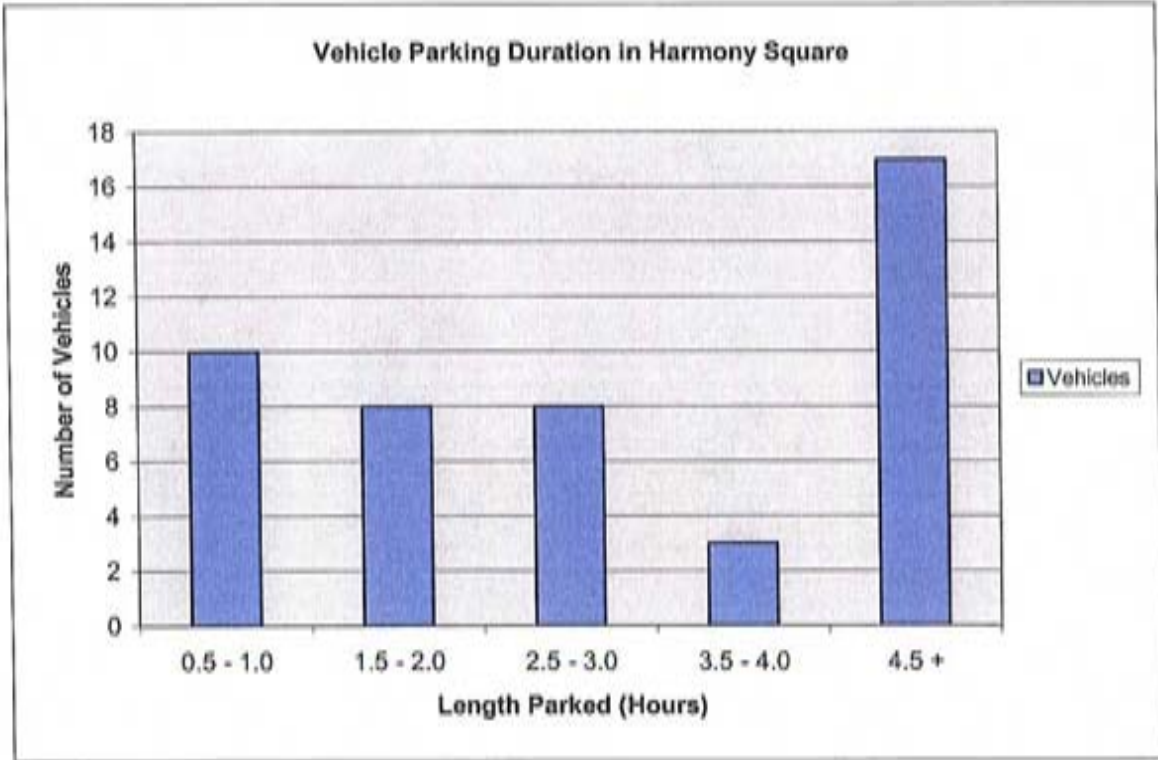
Figure 6 – Harmony Square Parking Lot Occupancy and Duration

The Harmony Square Parking Lot has 34 spaces. The average parking duration in this lot is 247 minutes, the maximum occupancy was 68% at 1:30 p.m., and the average turnover rate was 1.35 vehicles in nine (9) hours. The Harmony Square parking lot was not open in 2007, therefore, no comparison data is available for this report.

Of the 46 vehicles using this lot, the majority (37%) were parked for over four (4) hours. Figure 6 in Appendix "A" shows the occupancy plotted versus time for the Harmony Square Parking Lot, as well as a graph showing the parking duration levels.

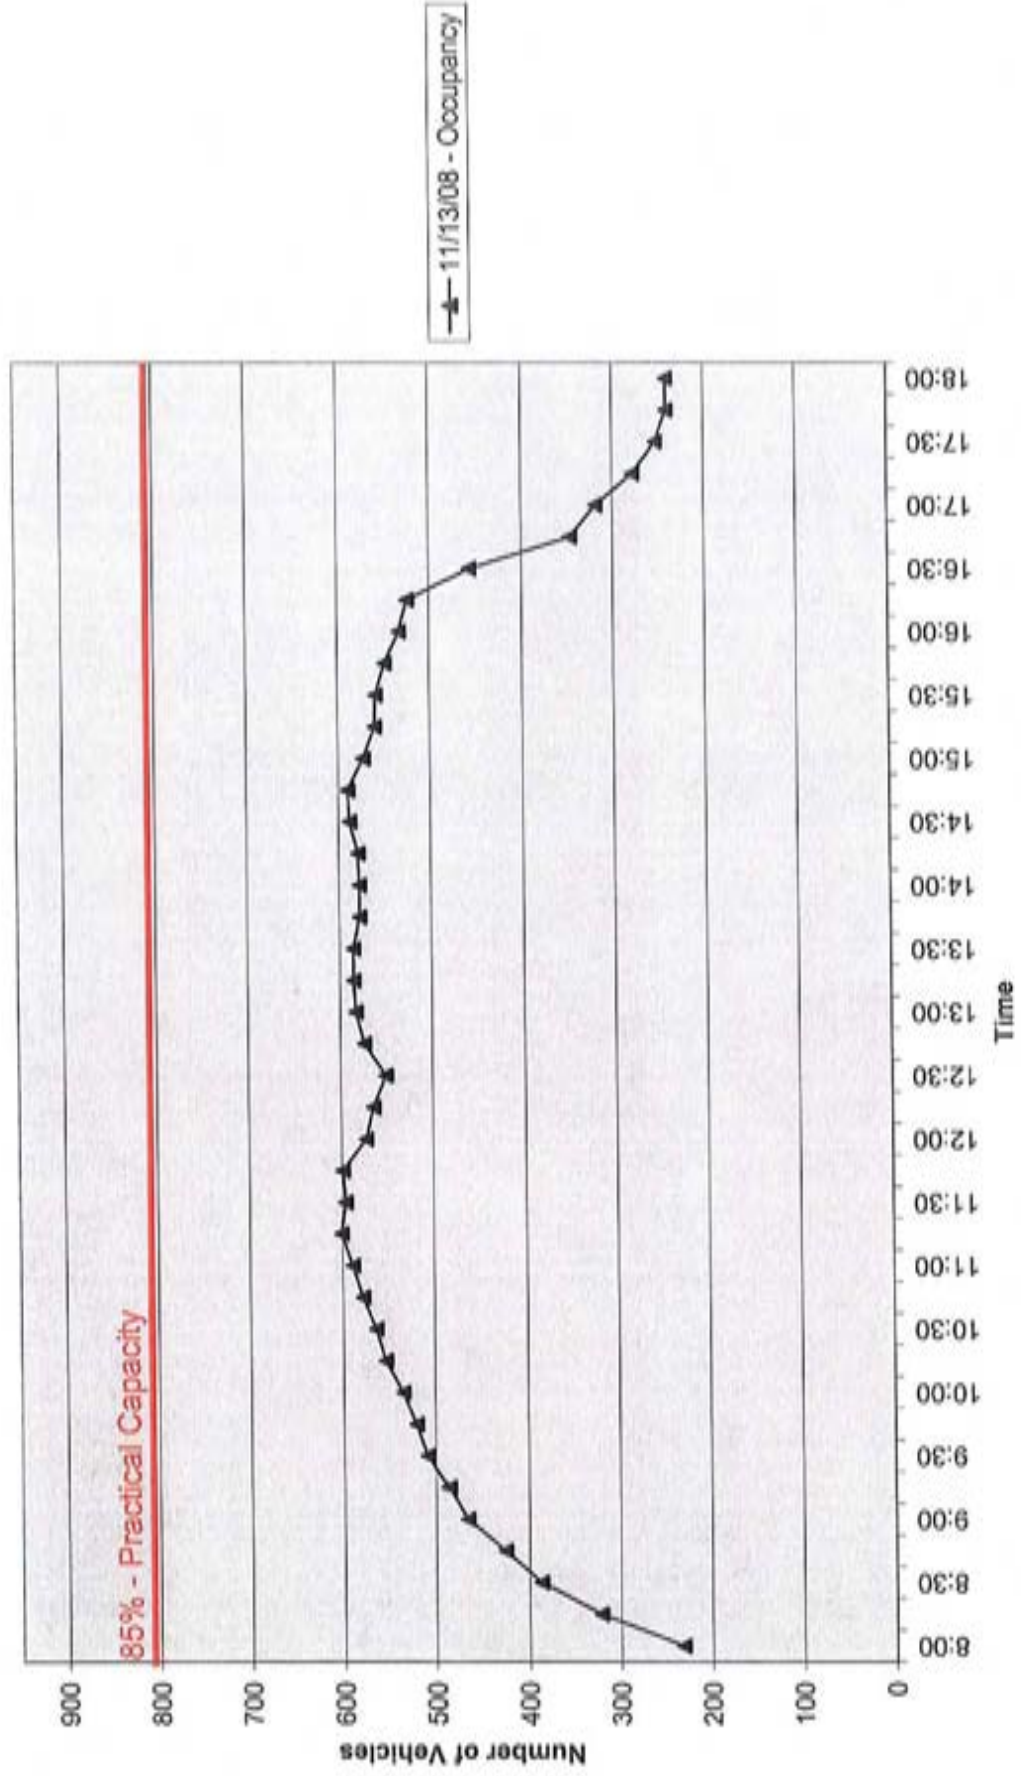
Figure 7: Market Centre Parkade Occupancy - Thursday, November 13, 2008

Figure 7 in Appendix "A" shows the occupancy levels on Thursday, November 13, 2008. Peak occupancy of 63% occurred at 11:15 a.m. The average turnover rate was calculated to be approximately 1.15 vehicles/space in a 24-hour period. The low turnover rate is the result of the majority of vehicles parking in the parkade being employees parking long-term. There is a large increase in occupancy at the Market Centre Parkade in the morning between 8:00 a.m. and 11:00 a.m., and decreases drastically after 4:00 p.m. Table 6 below shows the peak occupancy in the parkade in the past five (5) years.

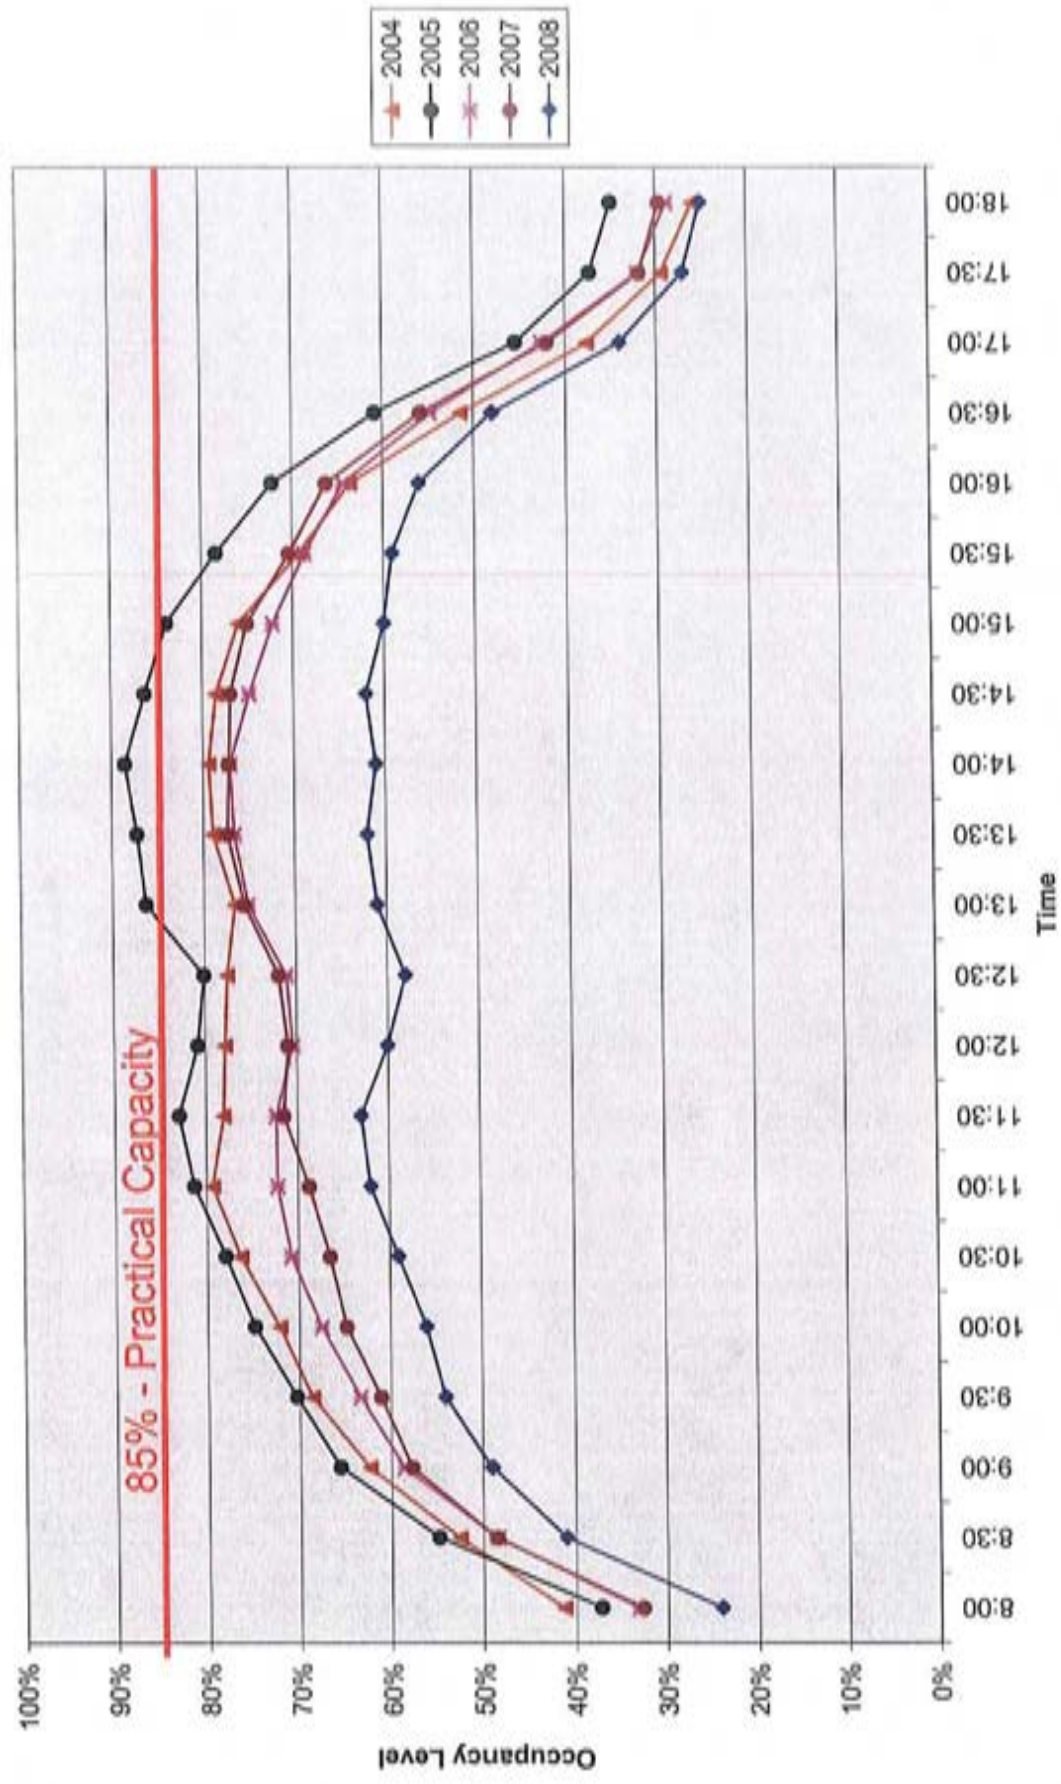
Figure 8 - Market Centre Parkade Occupancy Five Year Comparison

Figure 8 in Appendix "A" shows a comparison of the occupancy in the Market Centre Parkade over the past five (5) years.

Study Year	Peak Occupancy
2008	63%
2007	77%
2006	77%
2005	89%
2004	79%

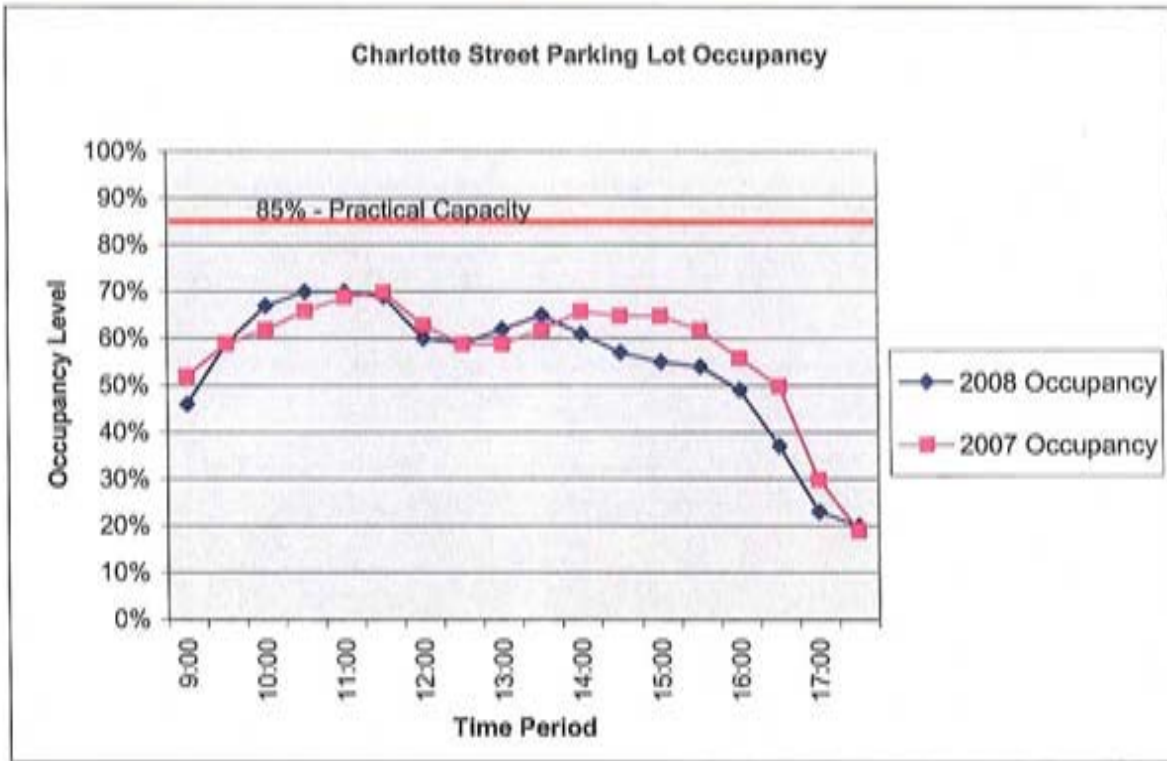
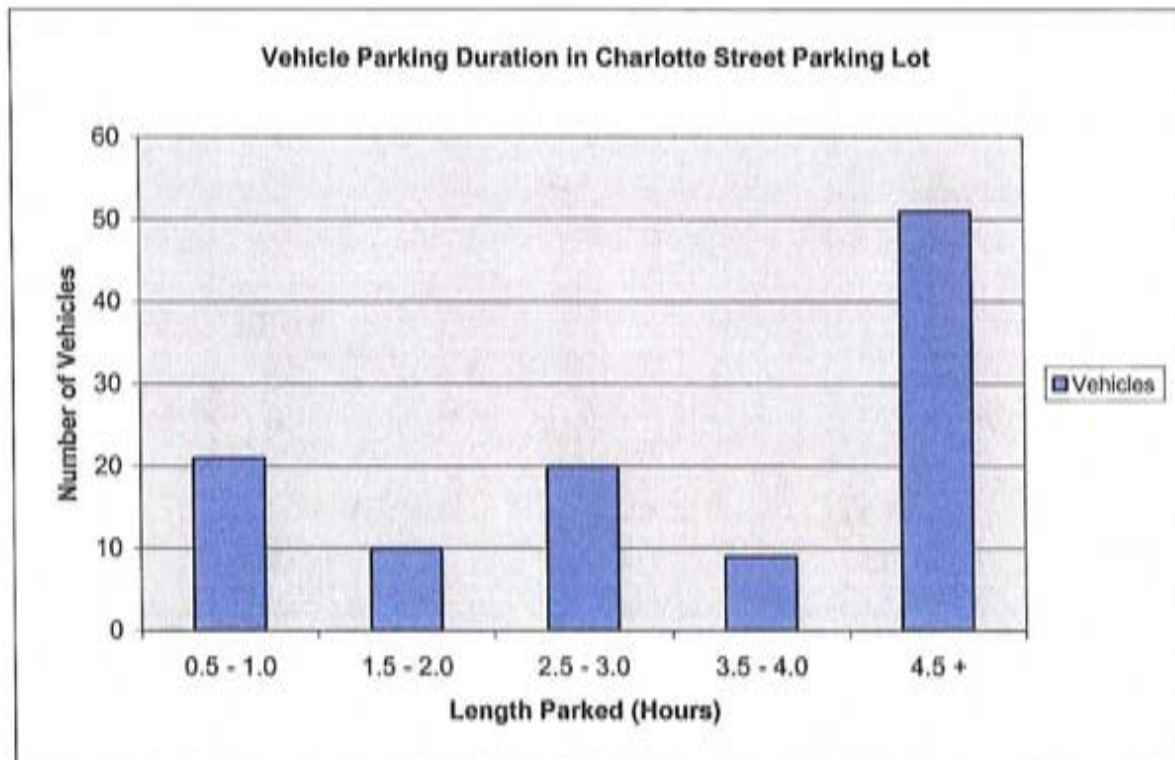
Figure 9 – Charlotte Street Private Parking Lot Occupancy and Duration

The Charlotte Street Parking Lot, privately owned, was analyzed for the first time in the 2007 parking study. This parking lot has a total of 100 spaces. The average parking duration is 267 minutes, maximum occupancy is 70% at 11:00 a.m., and the average turnover rate was 1.11 vehicles/space in 9 hours. In 2007 the average parking duration was 277 minutes, maximum occupancy was 70% at 11:30 a.m., and the average turnover rate was 1.12 vehicles/space in 9 hours. Forty-six percent (46%) of the vehicles were parked for over four (4) hours. This indicates that the majority of vehicles using this lot are long-term employees and student parking. Figure 9 in Appendix "A" shows the occupancy plotted versus time for the Charlotte Street Parking Lot, as well as a graph showing the parking duration levels.
