**Colborne Street (East) Slope Stabilization  
Municipal Class Environmental Assessment**

**Public Information Centre No. 1**

**September 13, 2018**

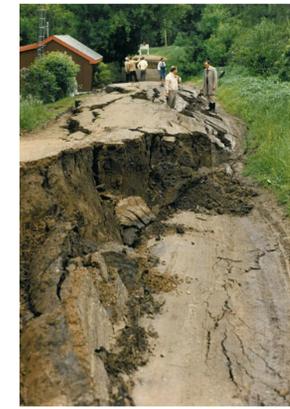
Beach Road after 1986 landslide

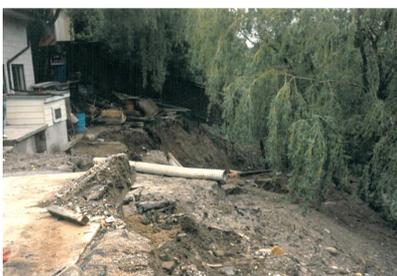
951 Colborne Street (East) after 1986 landslide

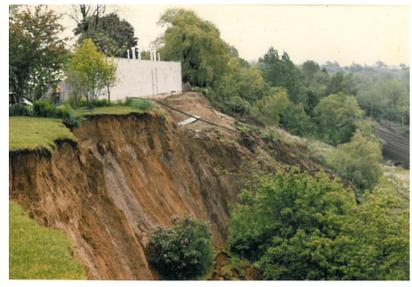
929 Colborne Street (East) after 1986 landslide

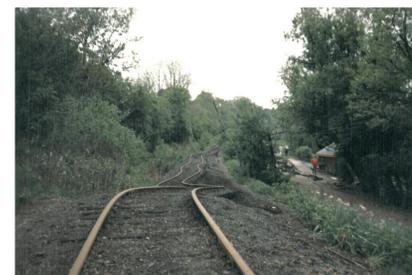
Railway along Beach Road after 1986 landslide

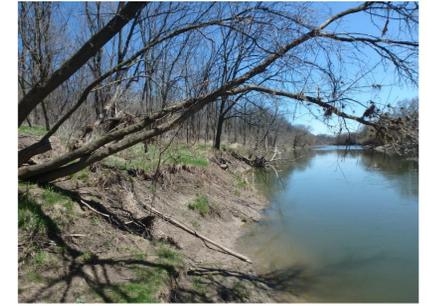
Evidence of toe erosion, including bare banks and fallen trees, April 2016

Geomorphological
<b>Description:</b> Grand River impacts on slope
<b>Quick Facts:</b> <ul style="list-style-type: none"> <li>• Previous ESR suggests toe erosion from Grand River is a factor in slope instability.</li> <li>• Slope toe movement tends to be greater in lower zones due to erosion impacts.</li> <li>• Grand River width was reduced to half as a result of the 1986 slope failure. Since 2012 it has returned to its pre-failure width.</li> </ul>

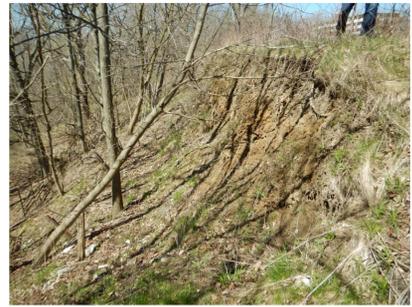
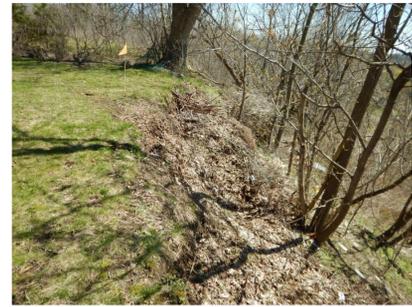
Slope monitoring in 2016, unstable slope evidence (left) and slumping near property line (right)
