City of Brantford

**Colborne Street East - Slope Stabilization
Municipal Class Environmental Assessment
September 2020**

Project Number: 1824

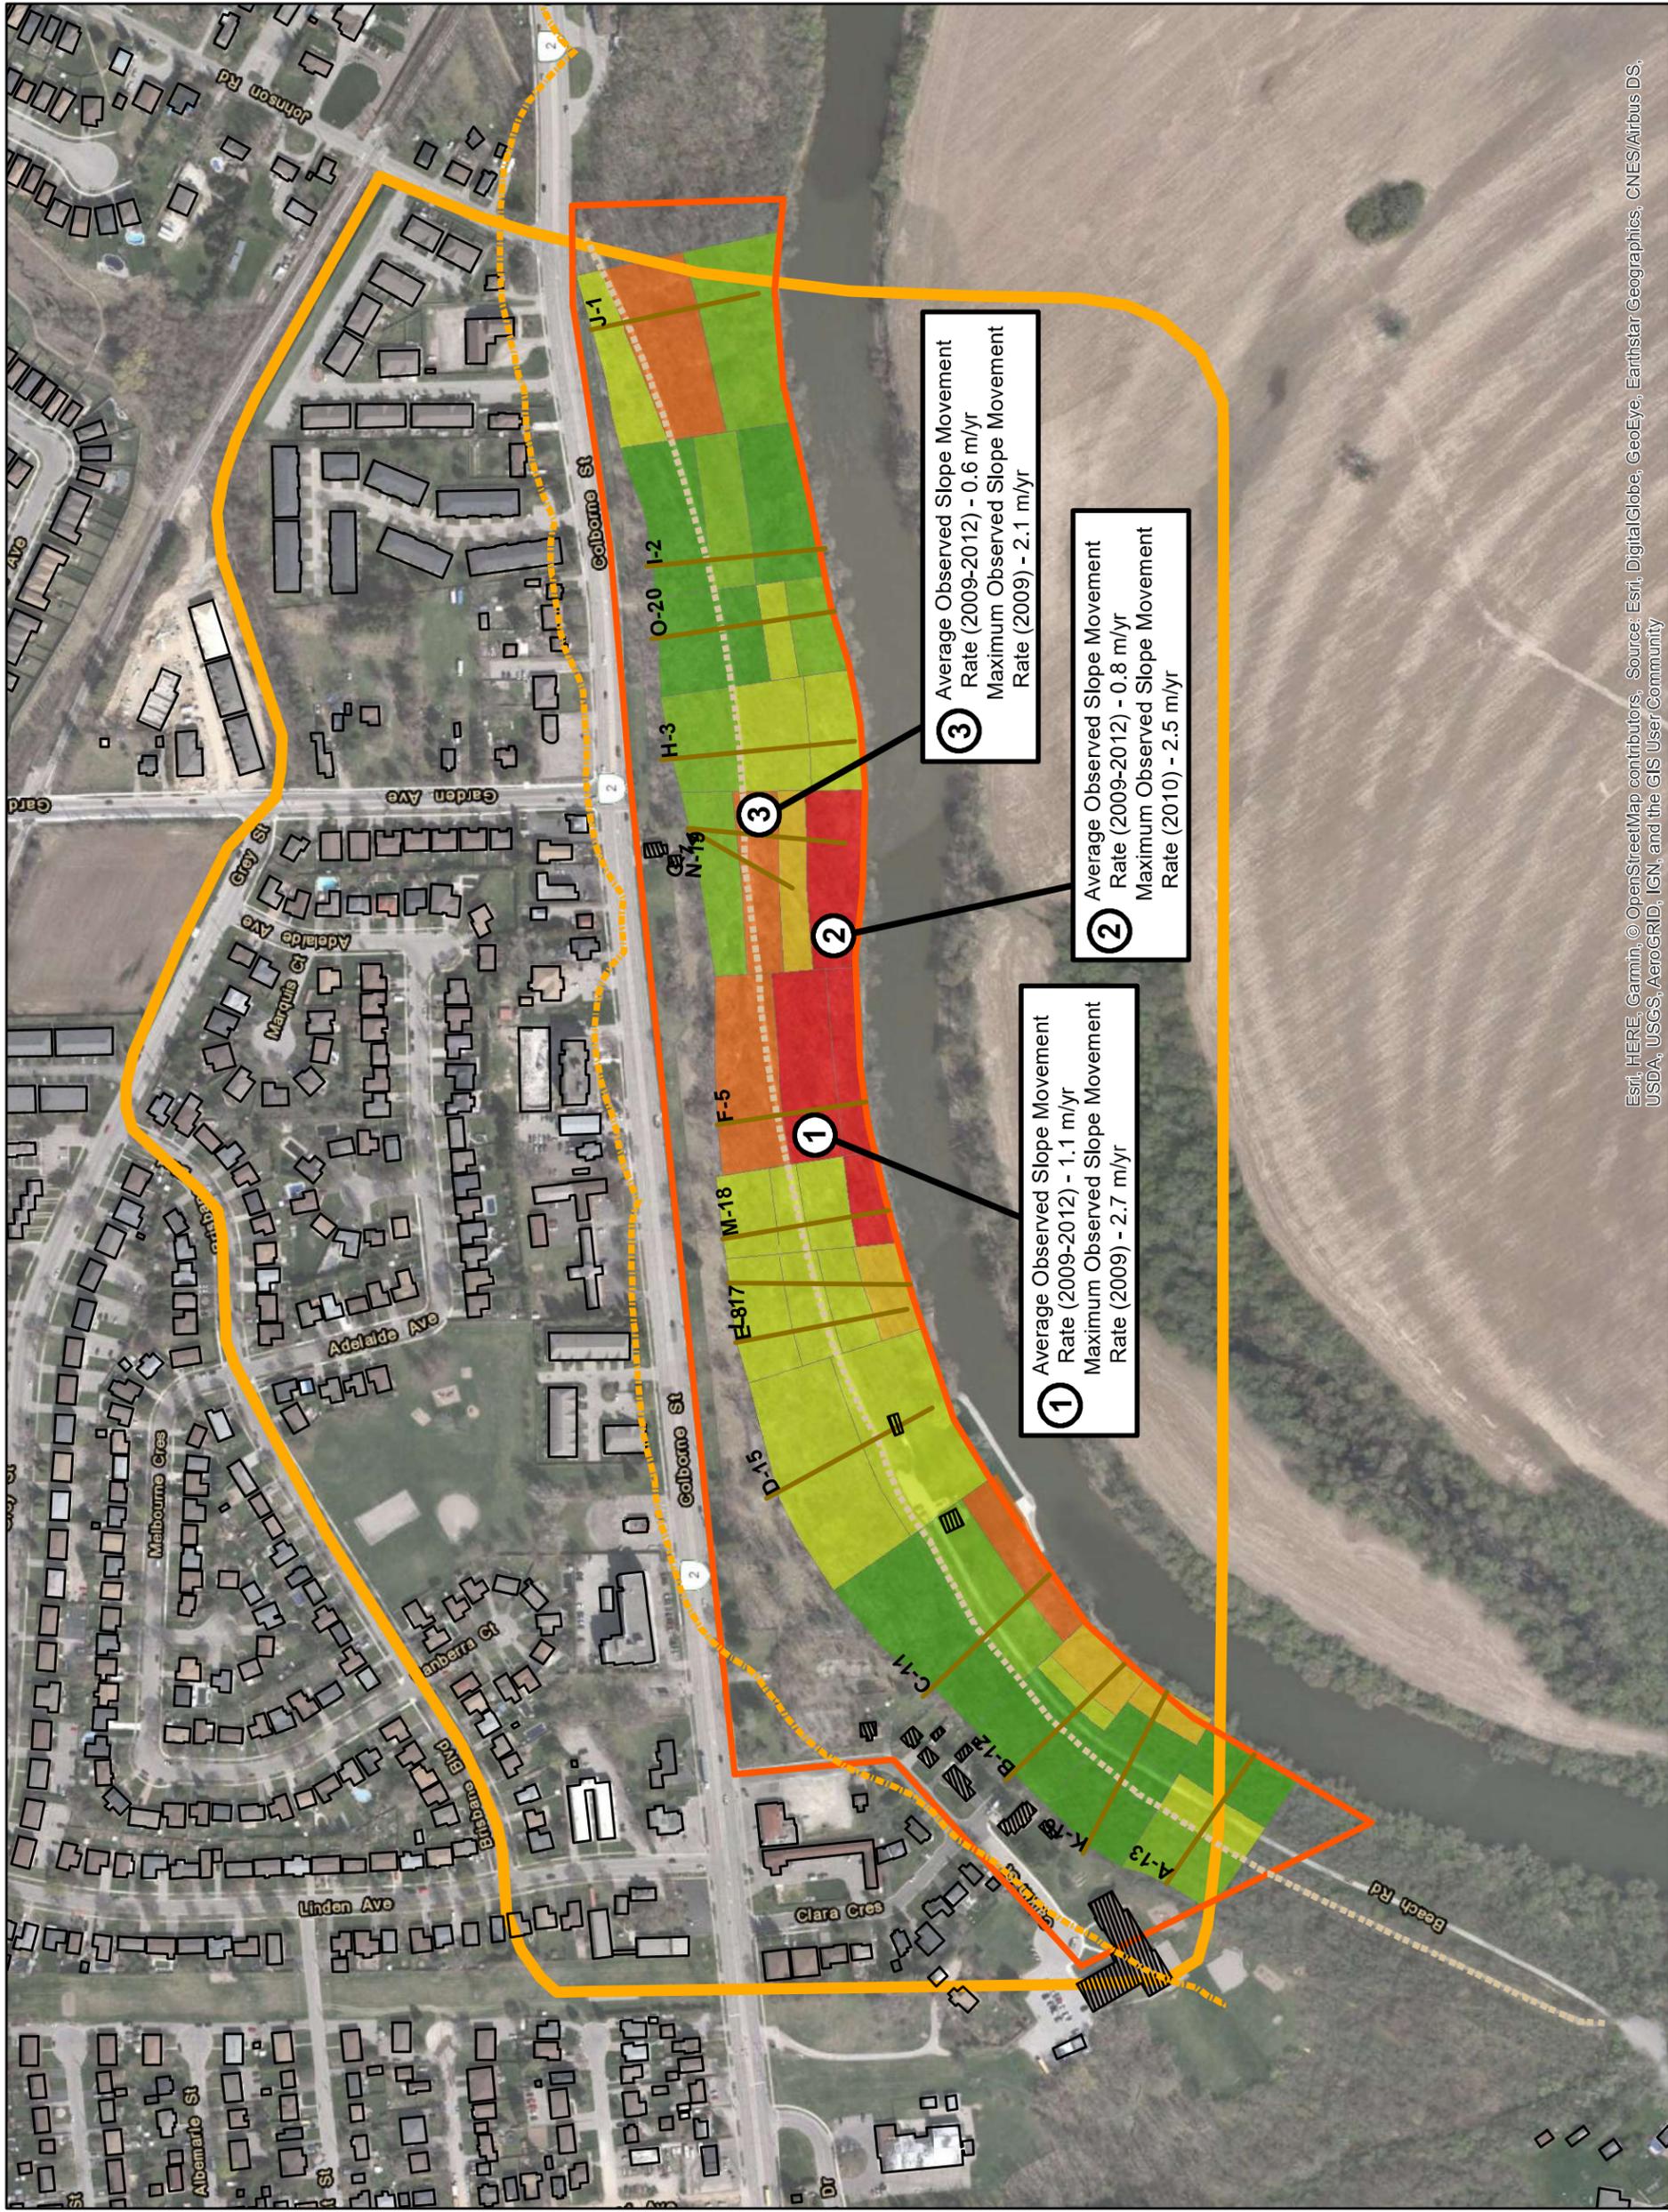
In addition to the Golder monitoring, the City of Brantford has continued the slope inclinometer monitoring program to the present date. This inclinometer data measures annual variations in surface movement in the slope area, collected over multiple monitoring lines in the study area. This data was spatially interpolated to generate estimates of slope movement rates from the provided data period of 2002 – 2018. This slope rate interpolation is provided in **Figure 3-1**.

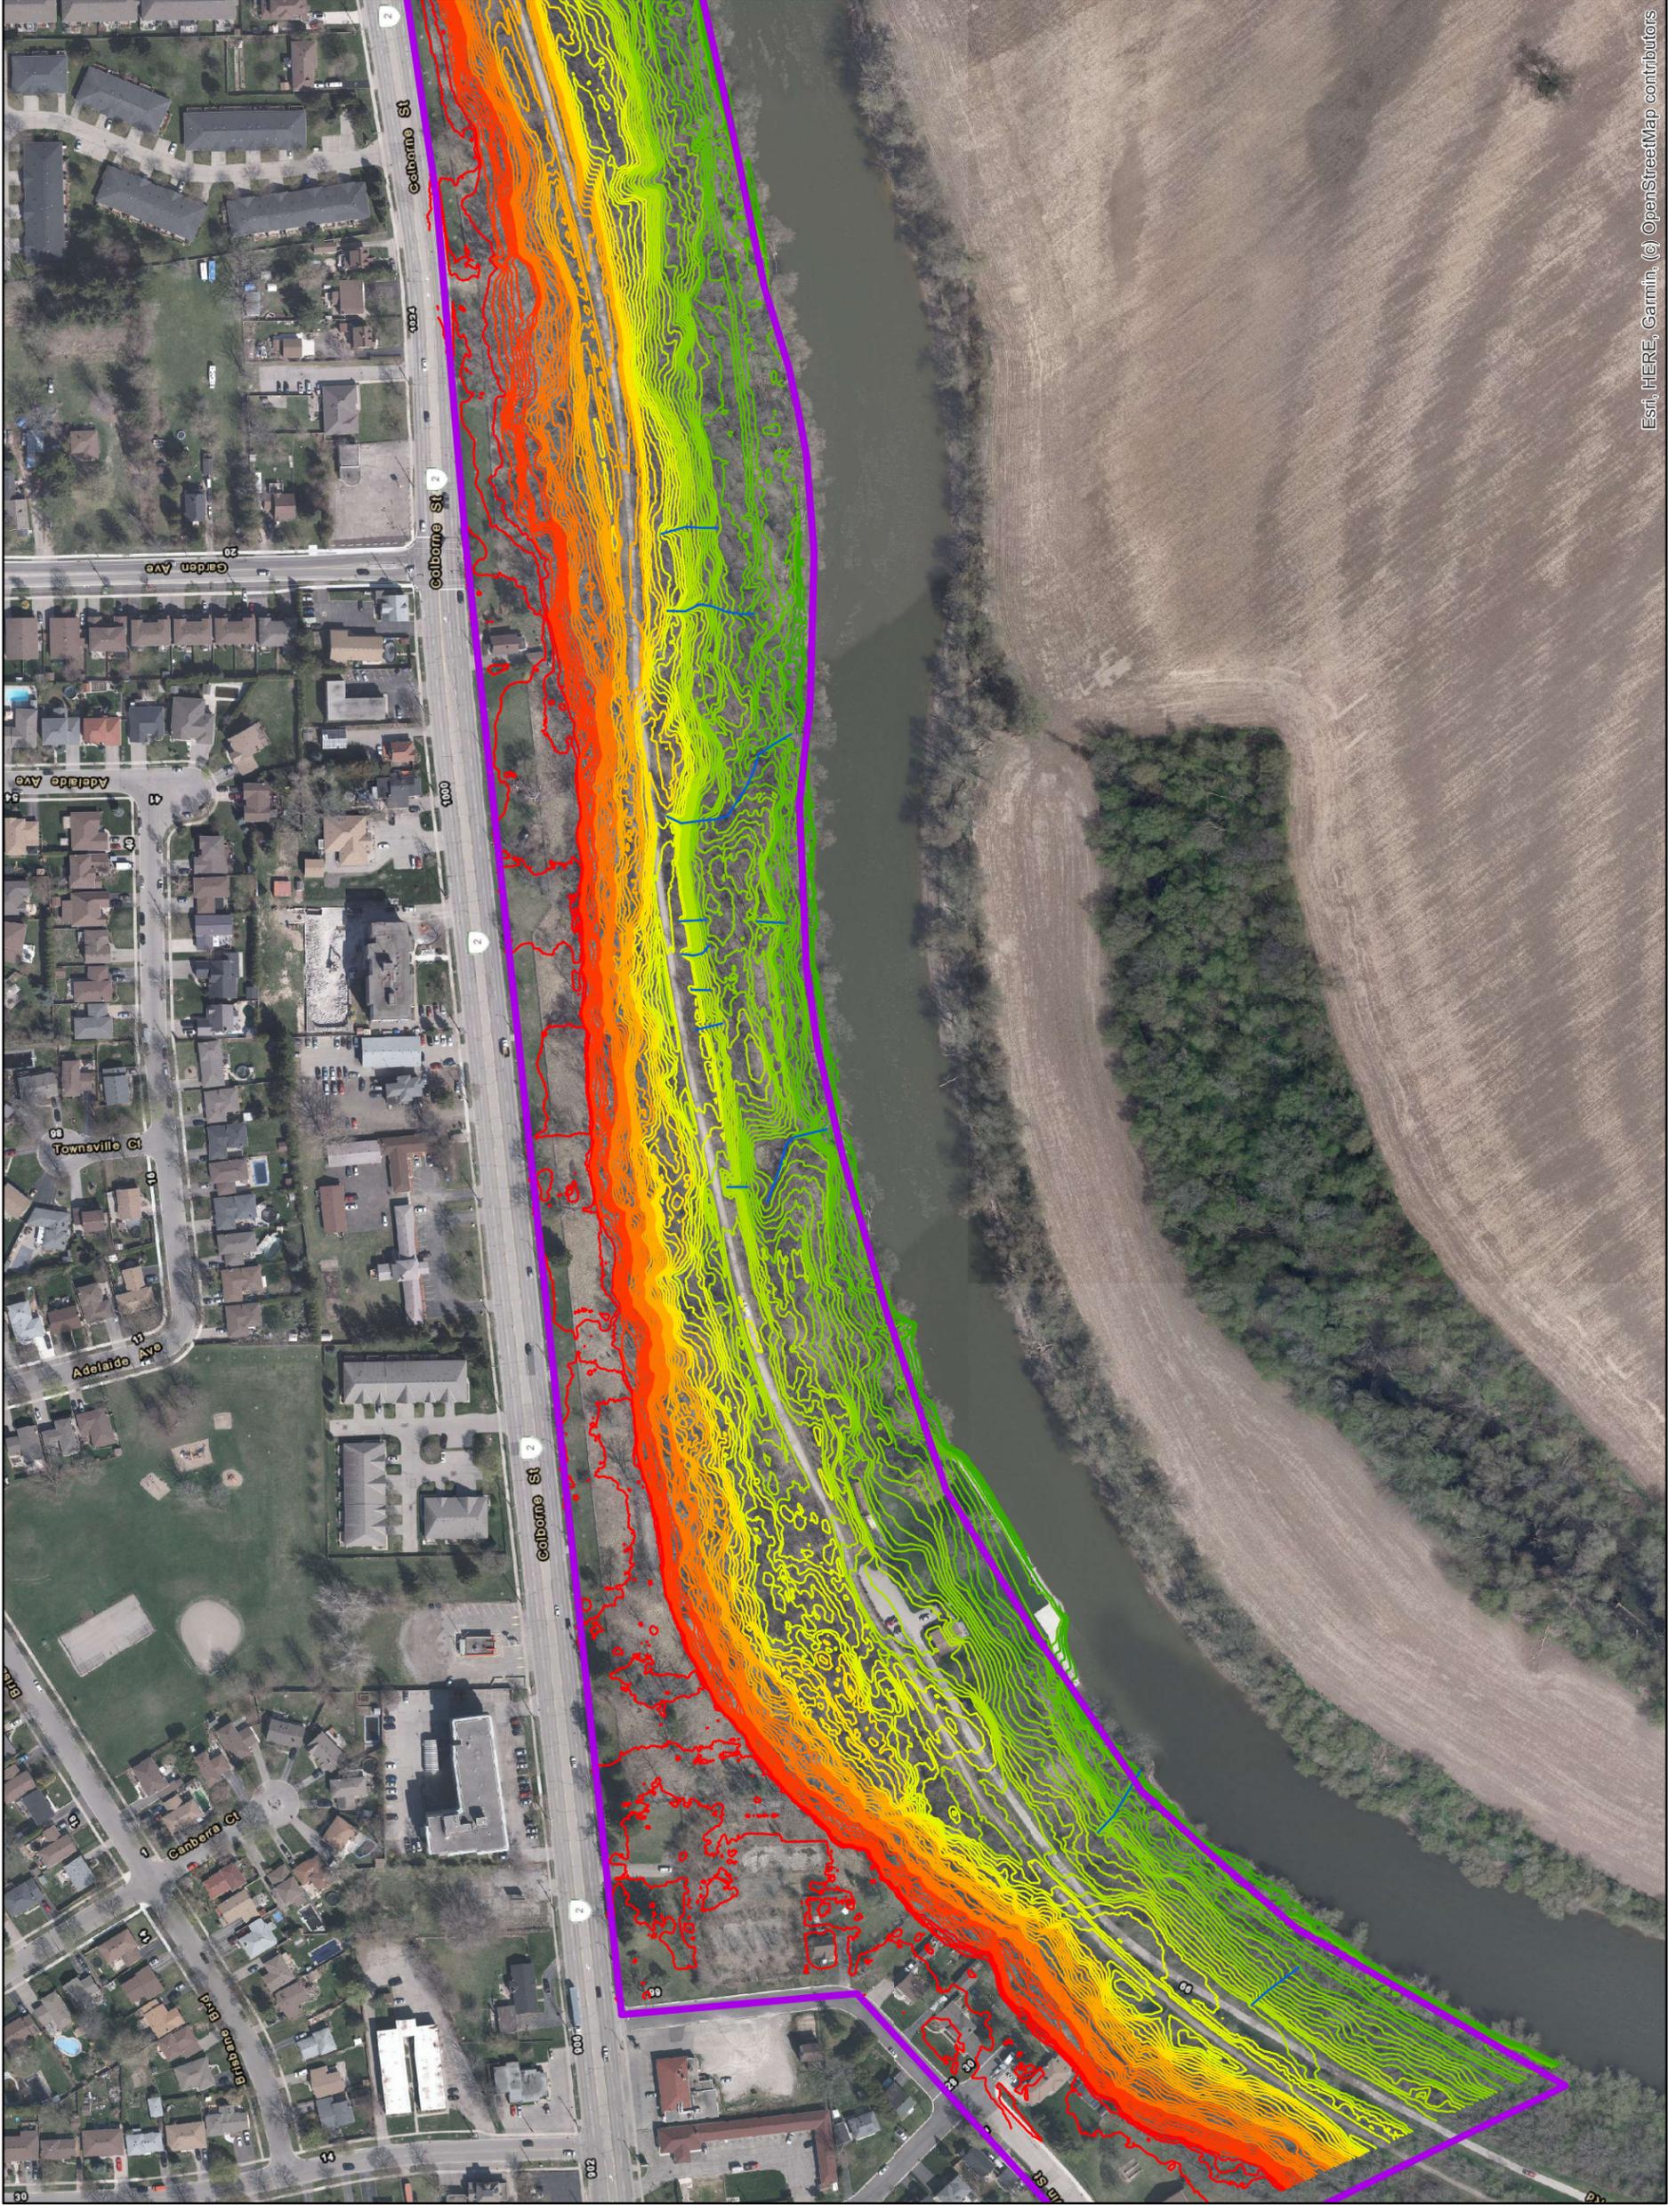
The topographic data collected by the 2018 drone survey is shown in **Figure 3-2**. The seepage paths along the slope were manually delineated based on the contour data. An overlay of the LiDAR data over multiple years of data collection may be used in future studies to determine slope failure areas and estimate slope movement rates with a high degree of spatial precision.

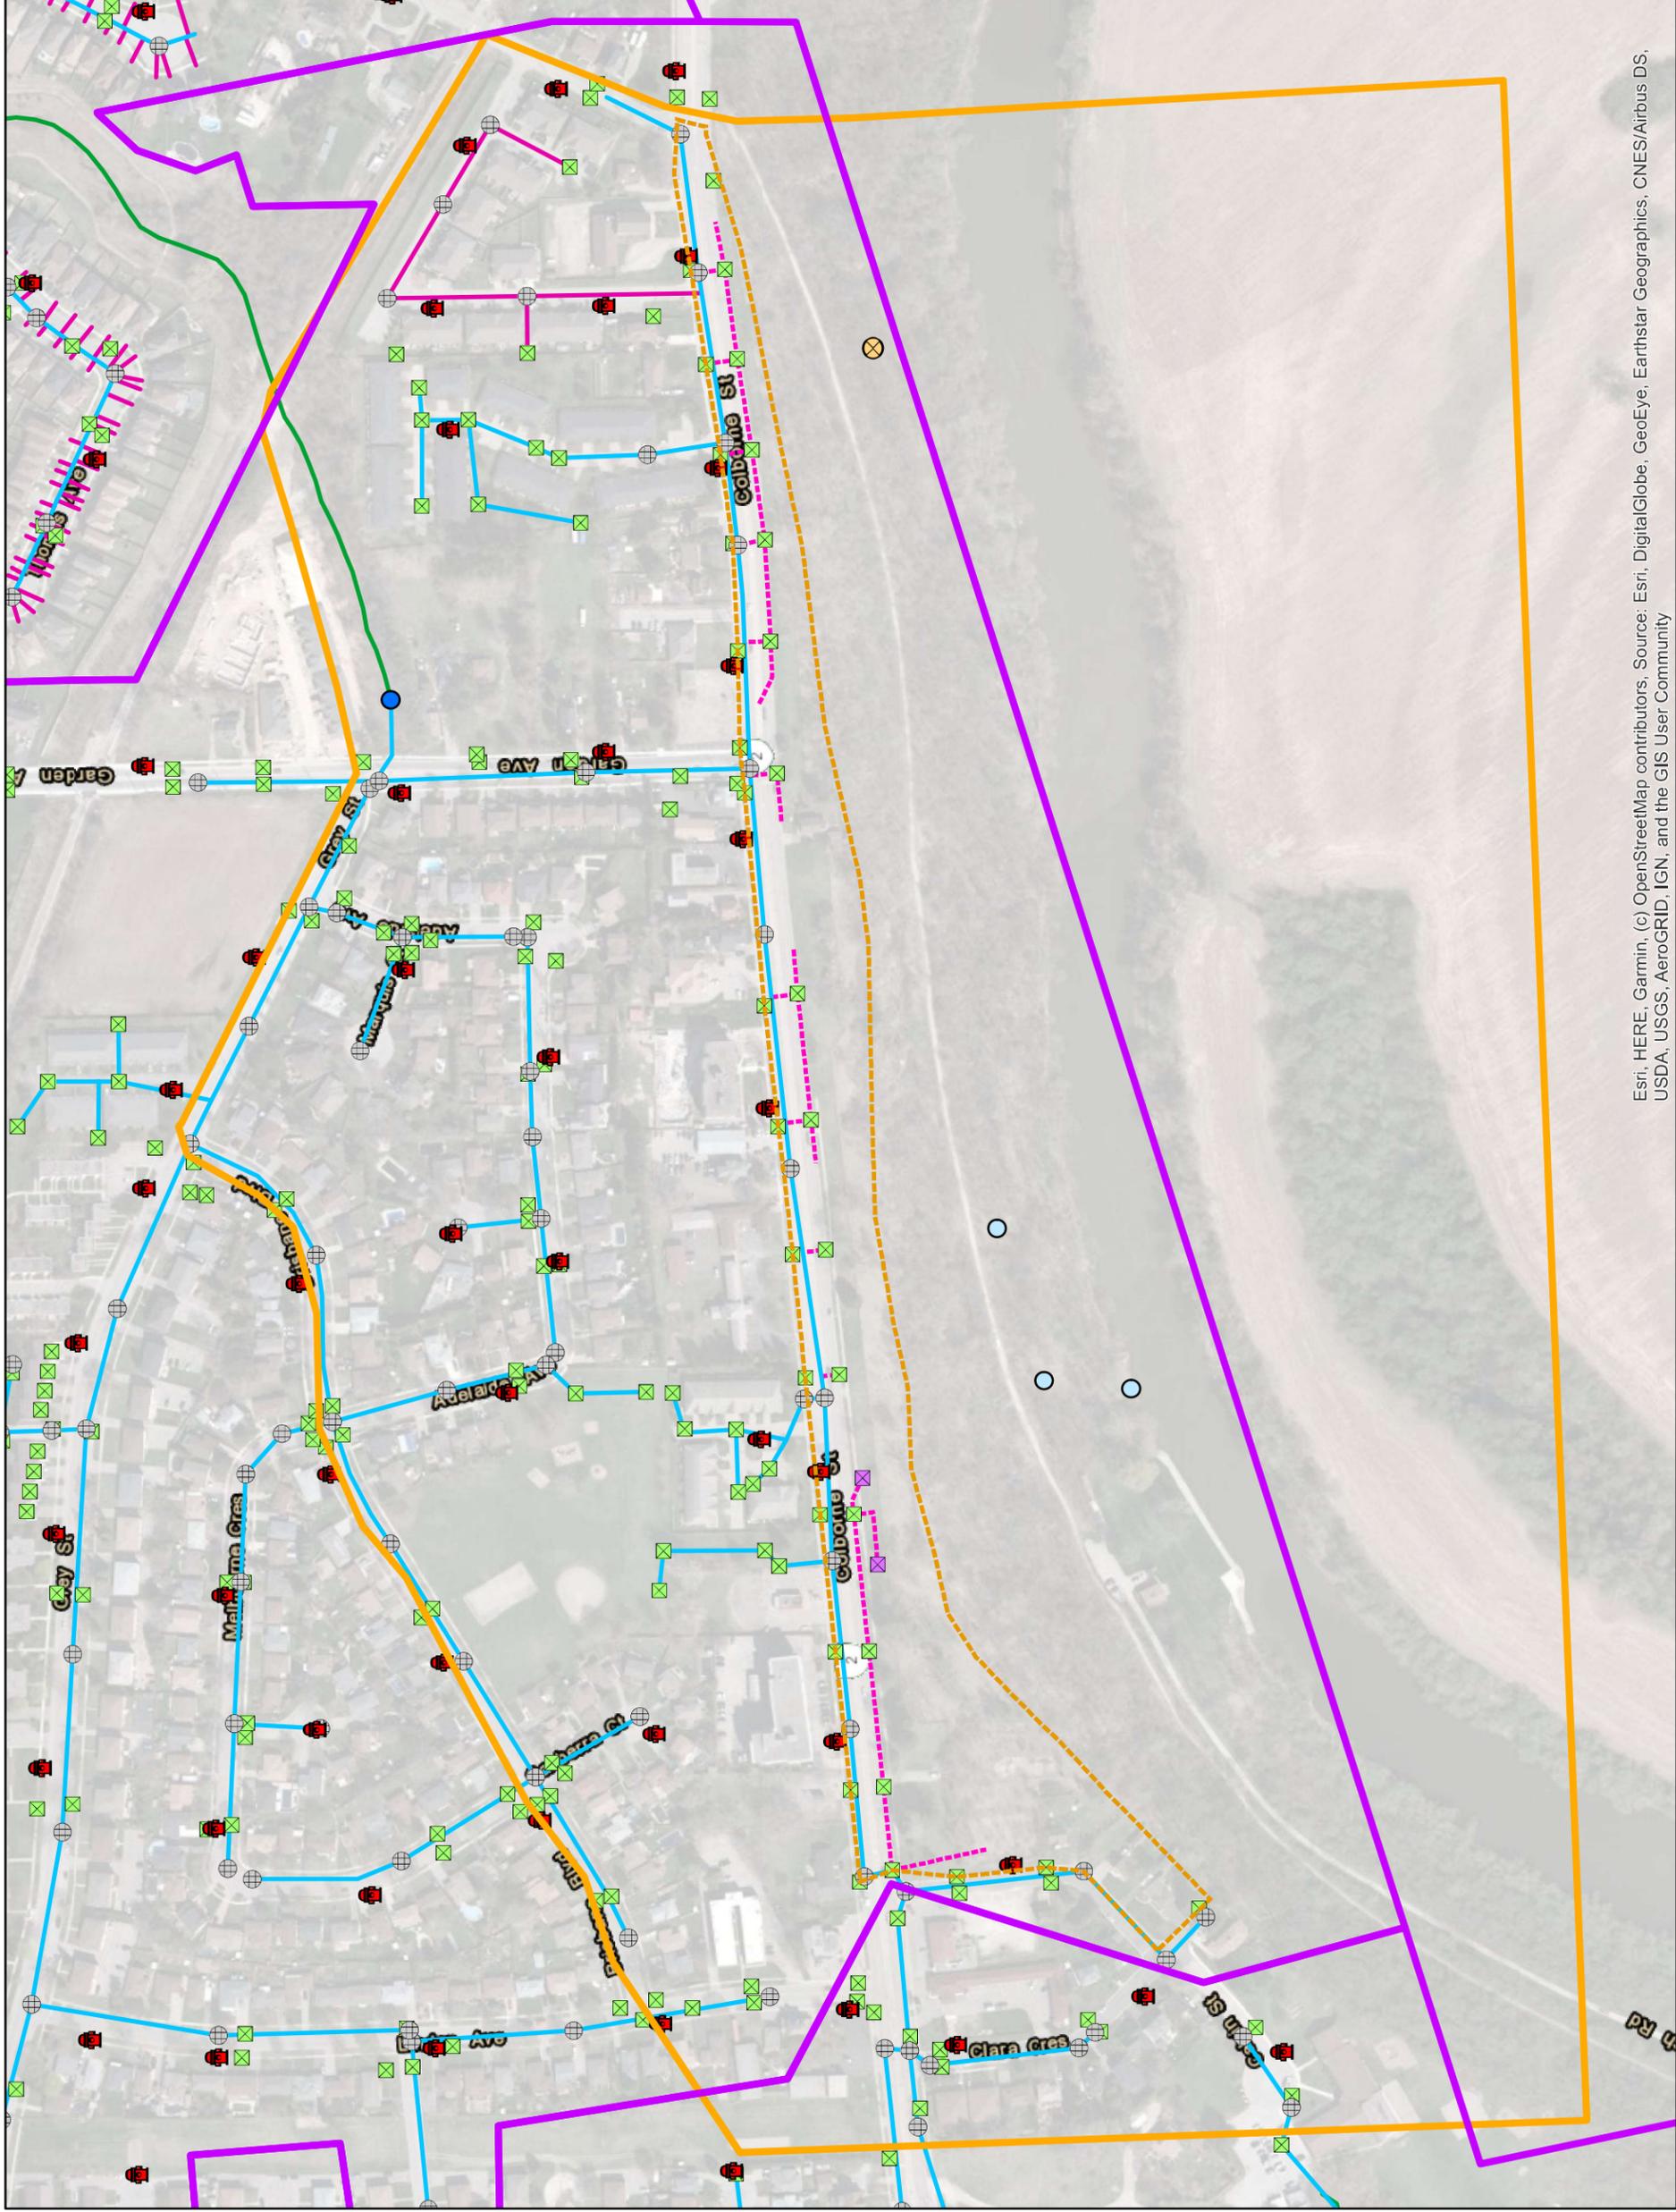
The major drainage system is defined by the MTO as the path of runoff that is followed when the minor drainage system is exceeded (i.e., for storms greater than the 2 to 10-year design of the minor system). This includes natural topography, roadside ditches, roadways, drainage swales, etc. The major flows catchment area was manually delineated for the study area to estimate the contribution area to the slope monitoring area during a major flow event using the SWOOP2015 contours available from the GRCA. The estimated major flow area is 0.58km². The major flow system is shown in **Figure 3-8**.

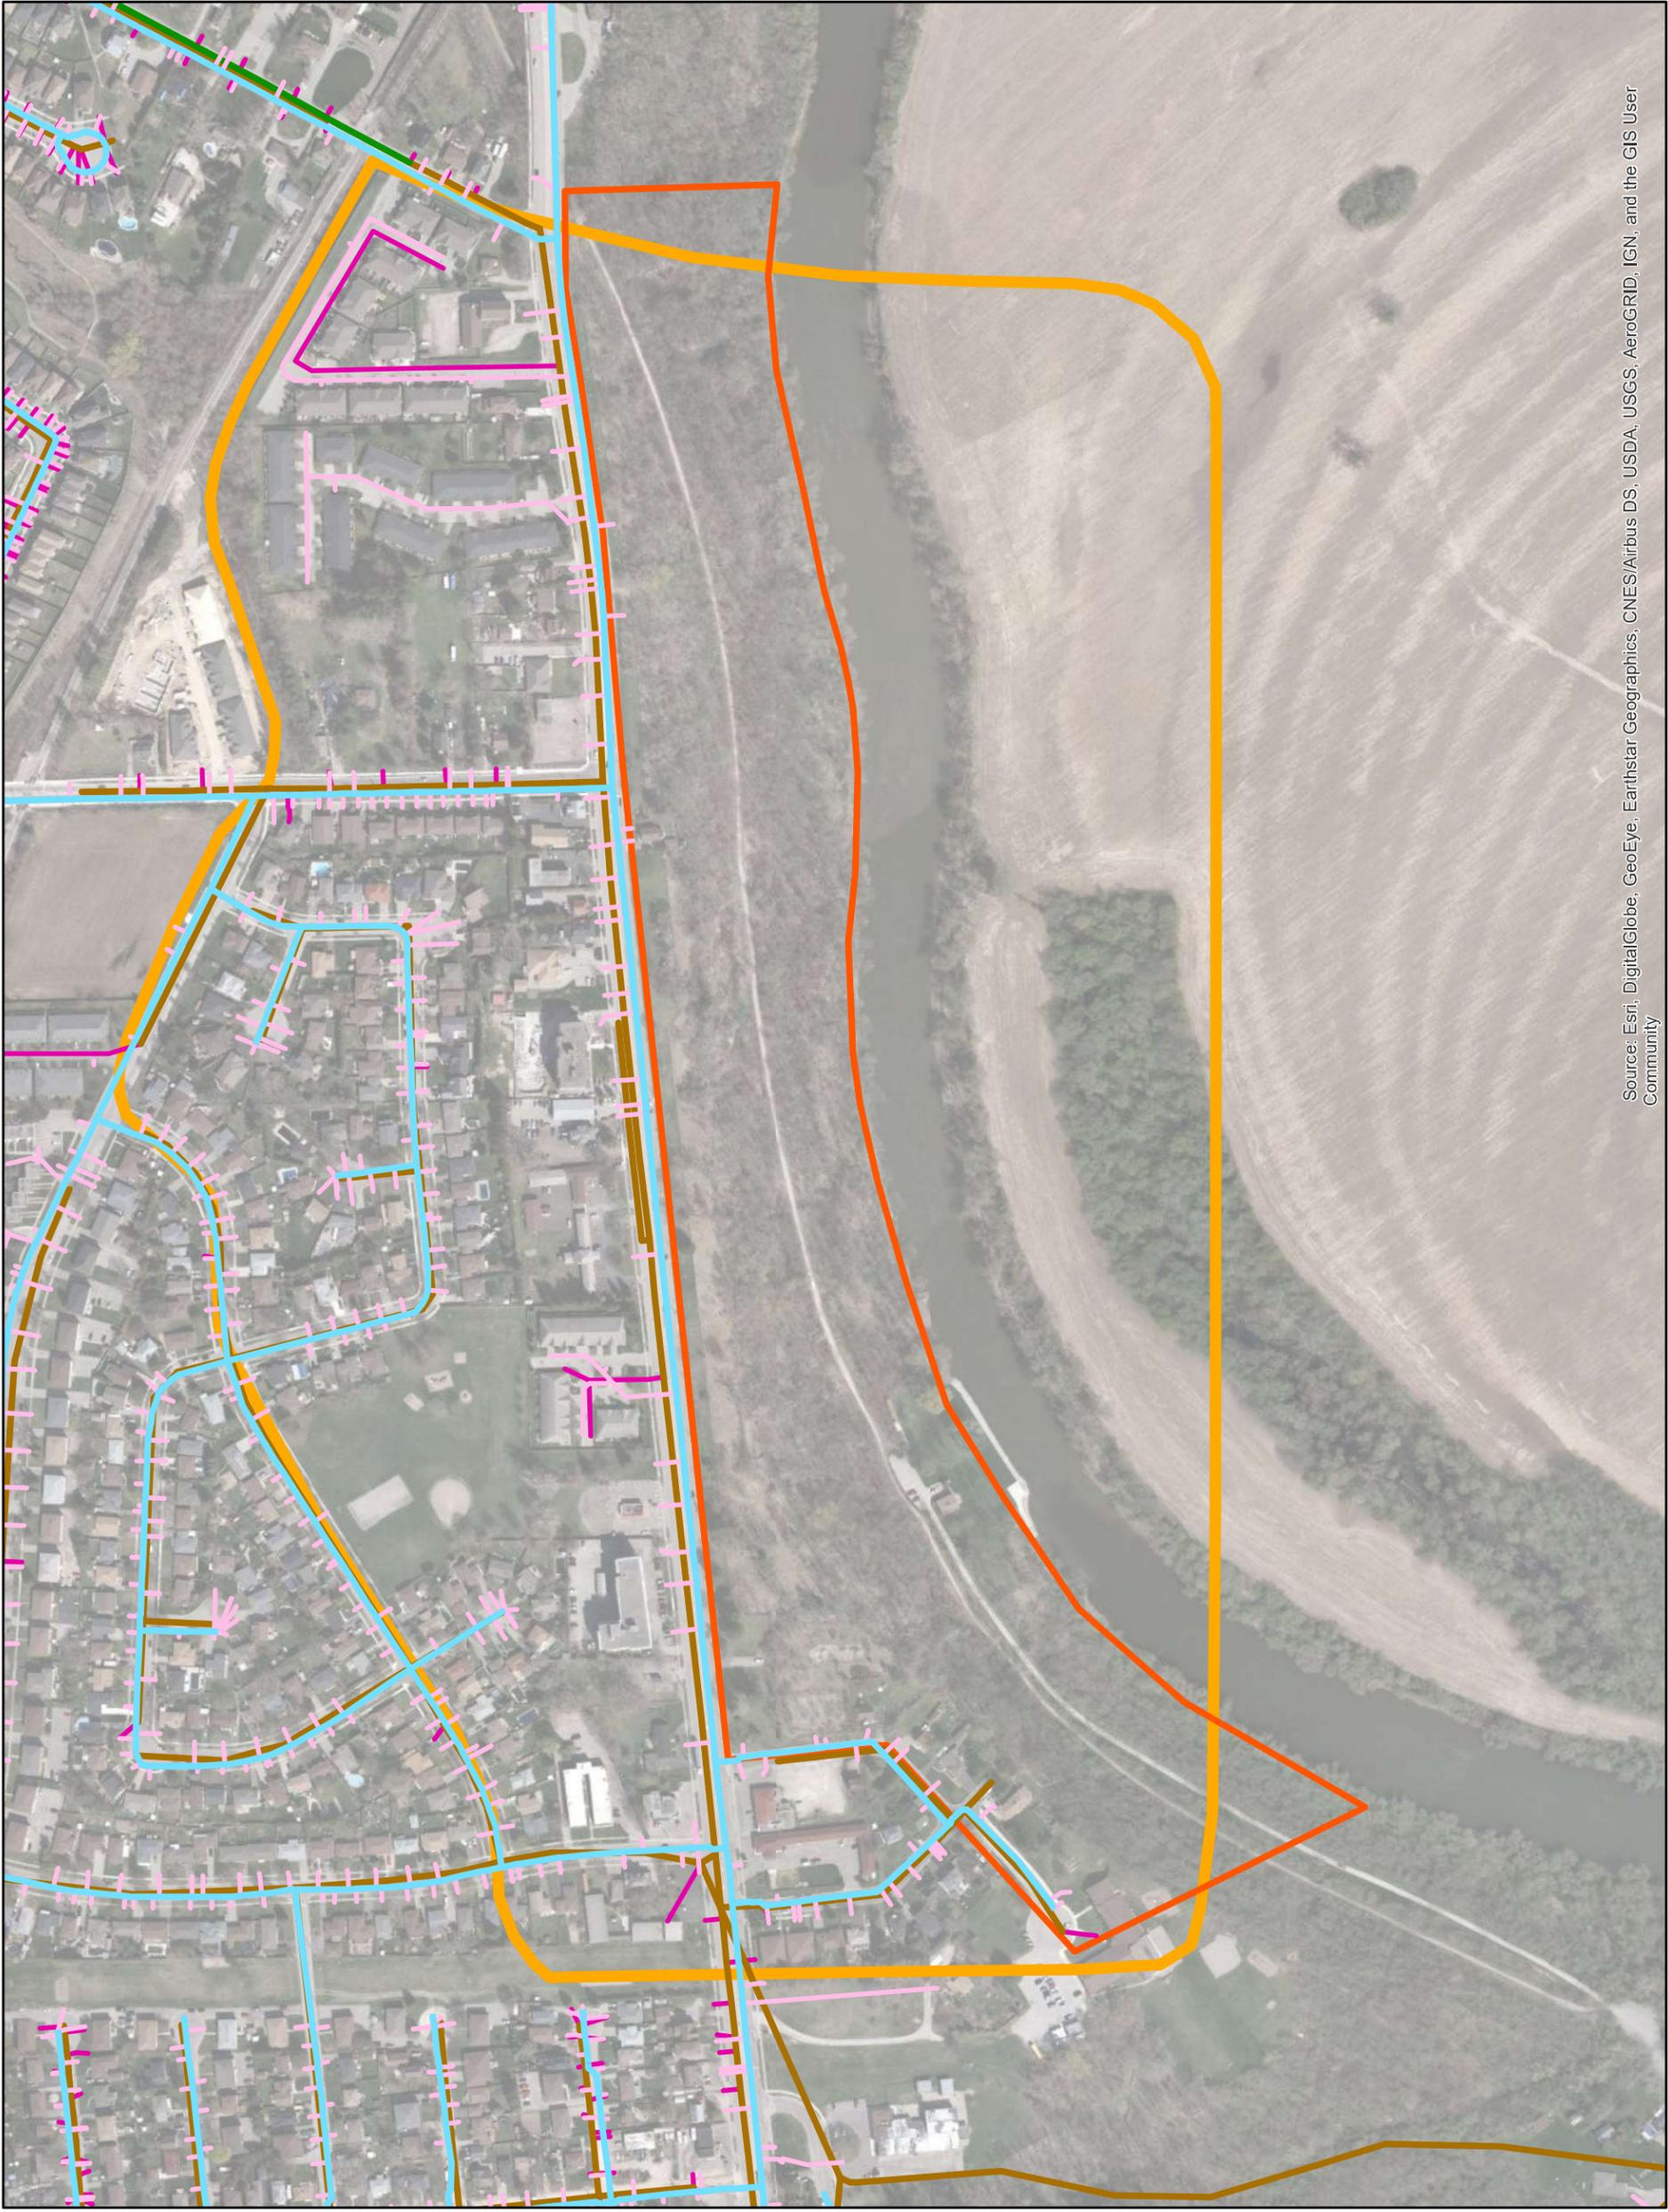
The water and sanitary municipal infrastructure data is provided visually in **Figure 3-14**. As noted above, there exist many laterals shown in this figure along Colborne Street (East) and Clara Crescent that are currently disconnected and inactive since the acquisition of private properties at those locations.

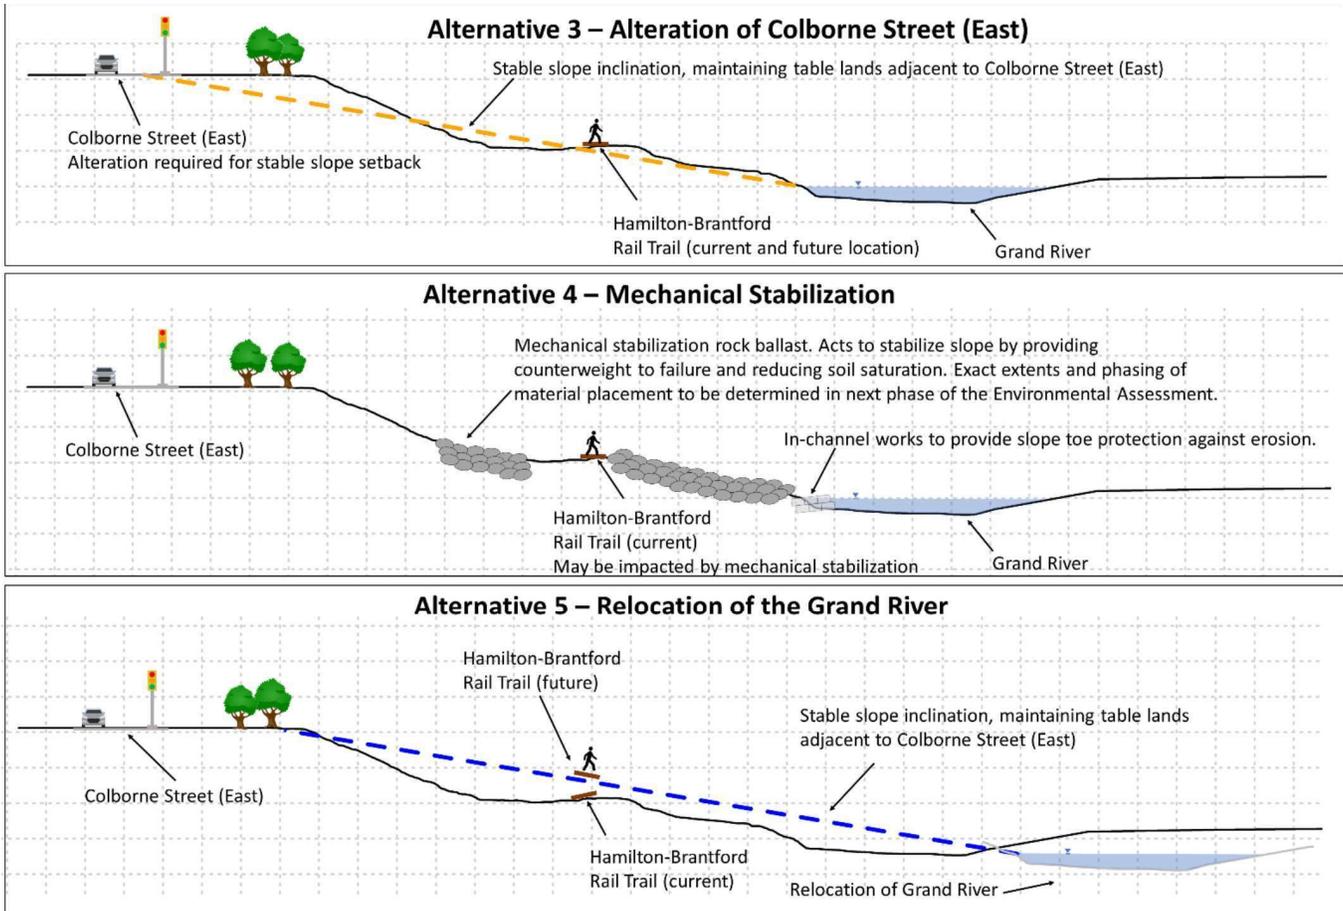
Figure 4-1. Alternative Solution Concepts in Profile for Alternative Solutions 3-5

The conceptual representations of alternative solutions for Alternatives 3-5 are presented in profile view in **Figure 4-1** and in plan view in **Figure 4-2**.

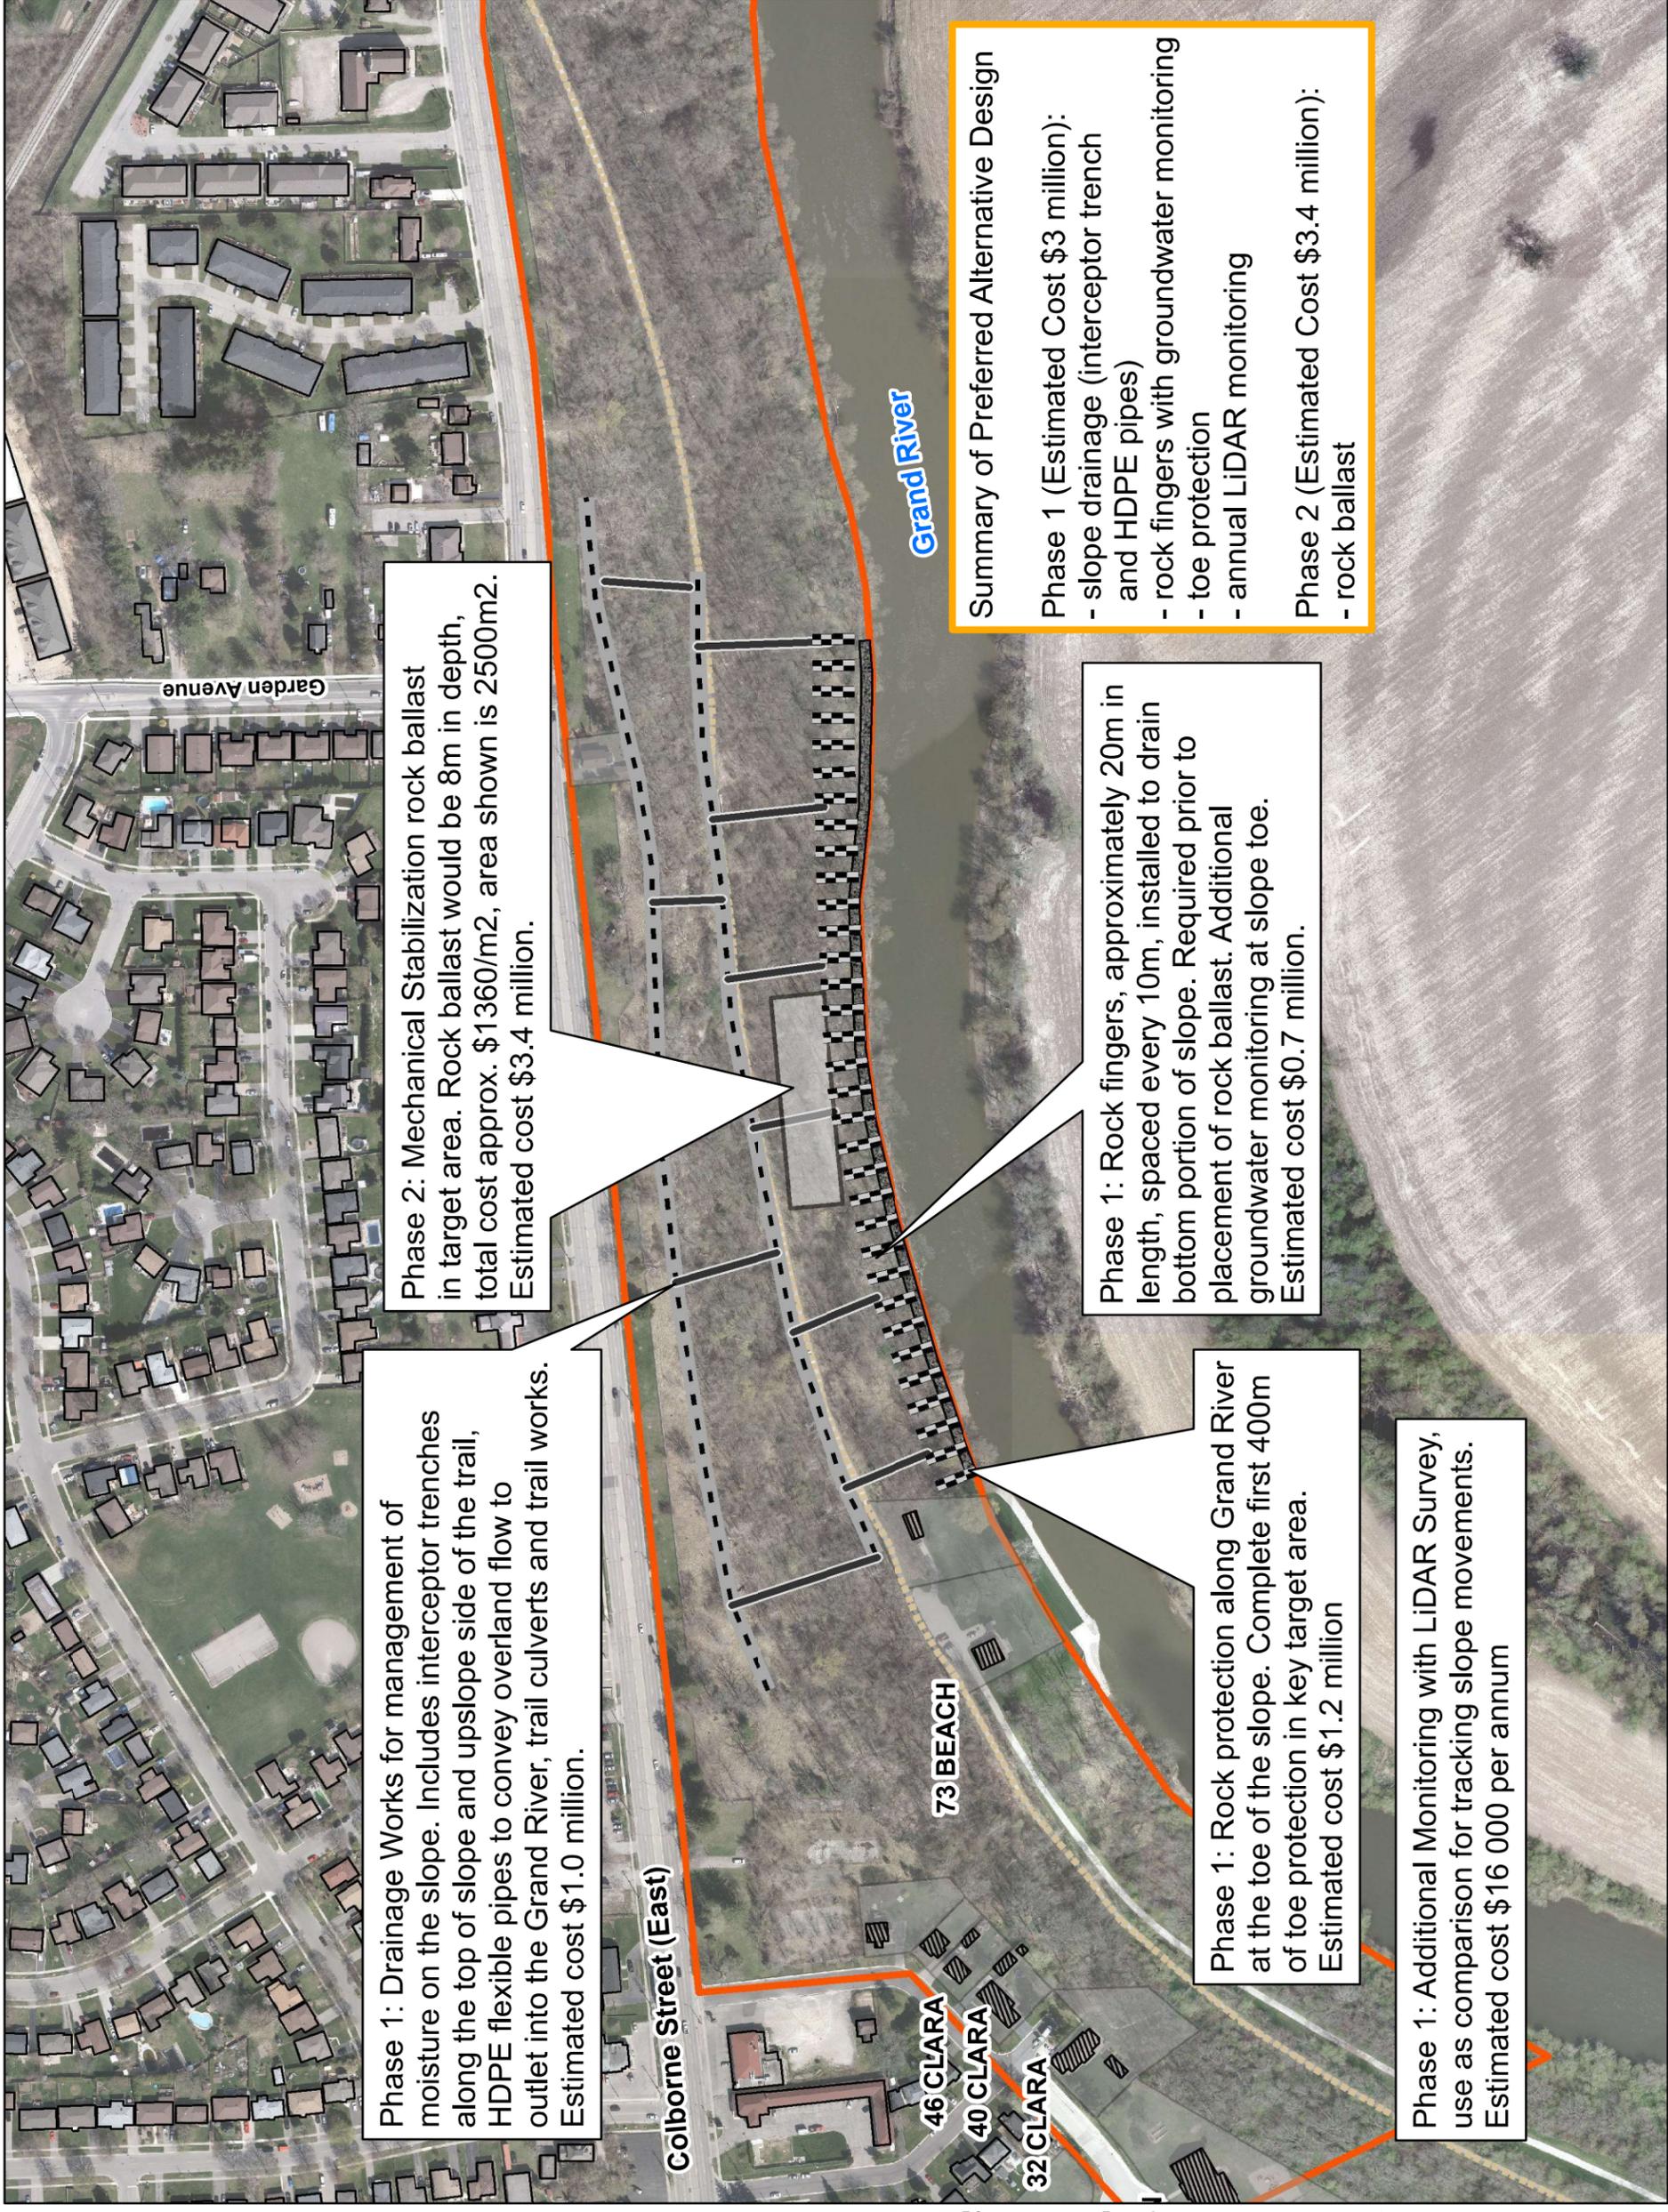
The rock ballast is a large mass of rock intended to resist the rotational failure of the slope. The ballast would essentially provide a counterweight to the soils above it and would need to be designed as such. The geotechnical assessment completed as part of this study indicated that the lower slope soils did not have the foundational stability to support the rock required to provide a ballast. As such, the effectiveness of the drainage elements of Phase 1 (interceptor trenches and rock fingers) in lowering the groundwater and improving the soil stability will need to be evaluated prior to the implementation of the rock ballast. The groundwater monitoring recommended as part of Phase 1 will inform the stability analysis necessary to ensure the soils will support the rock required.

Phase 1: Drainage Works for management of moisture on the slope. Includes interceptor trenches along the top of slope and upslope side of the trail, HDPE flexible pipes to convey overland flow to outlet into the Grand River, trail culverts and trail works. Estimated cost \$1.0 million.

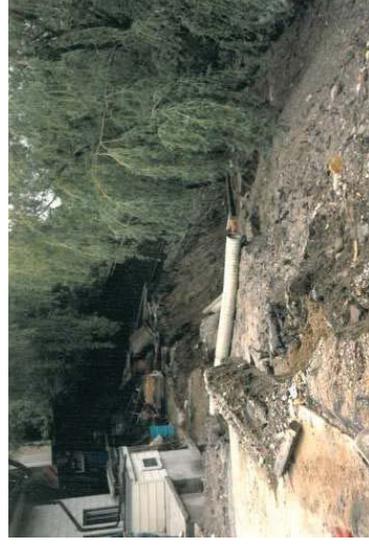
951 Colborne Street (East) after 1986 landslide

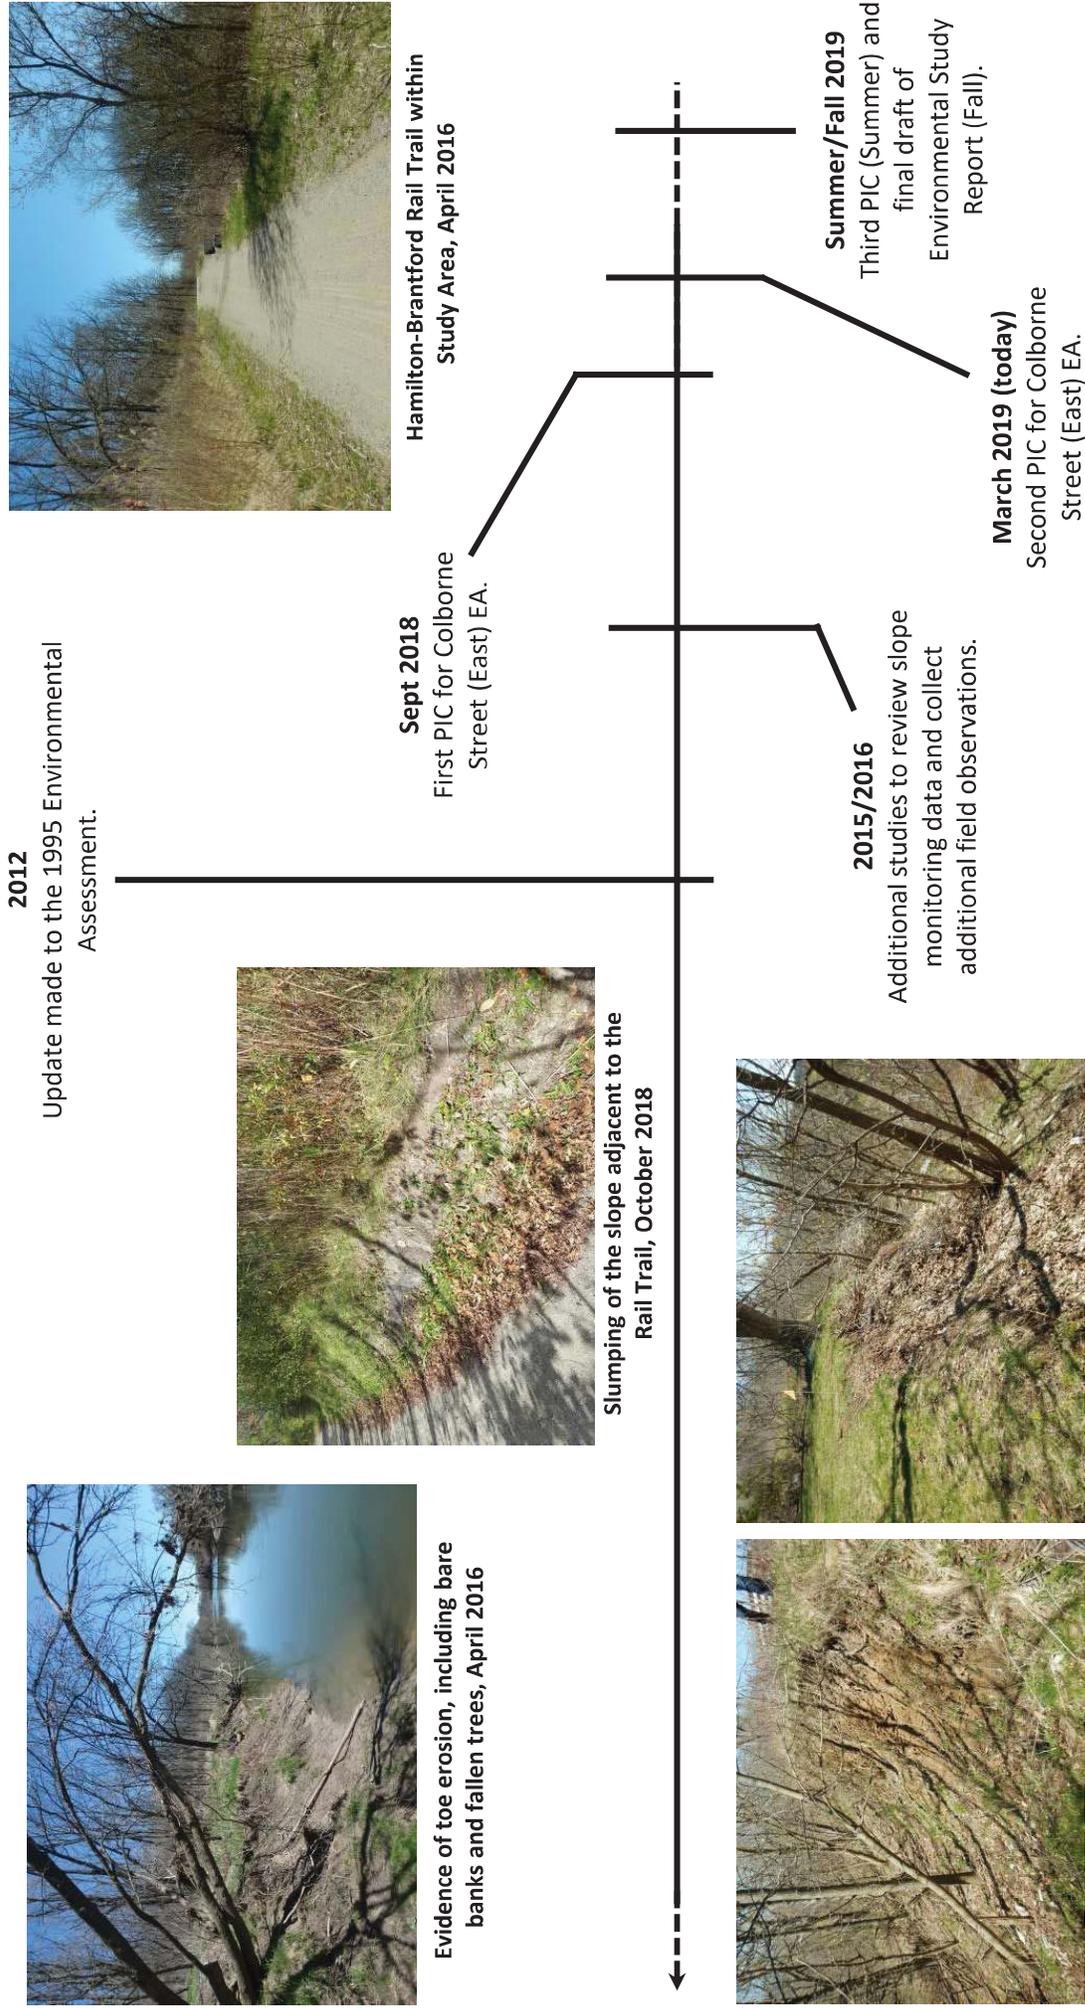
Evidence of toe erosion, including bare banks and fallen trees, April 2016
