City of Brantford

**Colborne Street East - Slope Stabilization
Municipal Class Environmental Assessment
September 2020**

Project Number: 1824

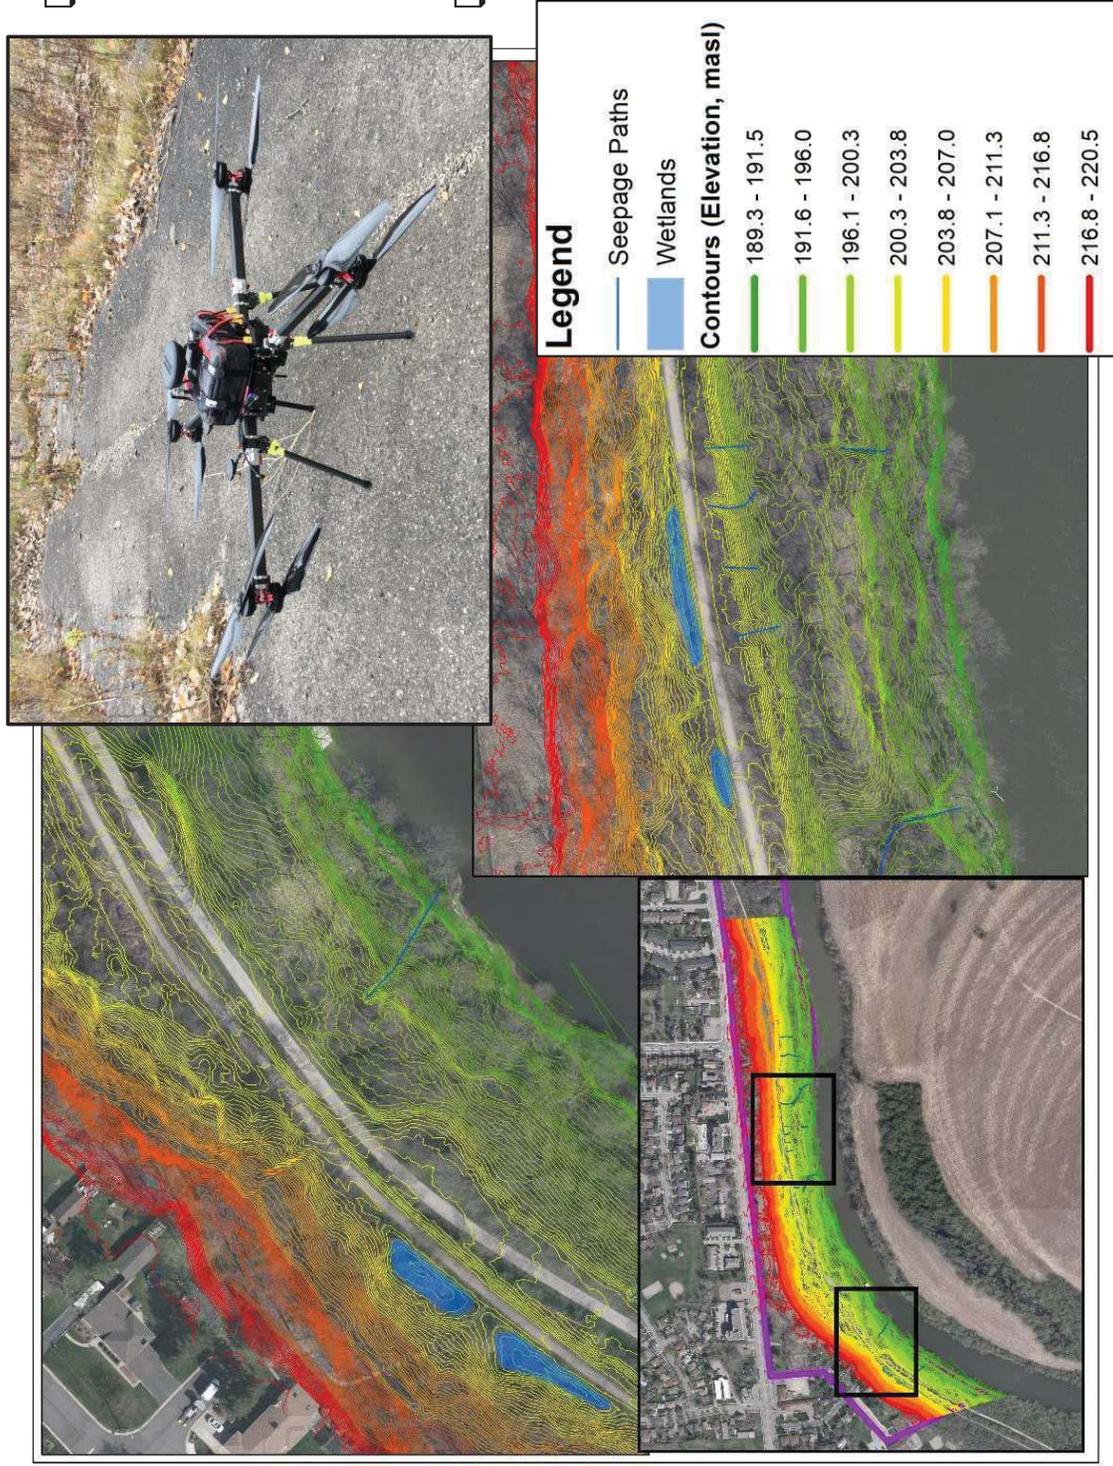
- ❑ Light Detection and Ranging (LiDAR) survey completed using a drone in November 2018
- ❑ Drone collected 40-80 elevation points per square metre, which was used to build a bare earth digital terrain model (DTM) and elevation contours of the site

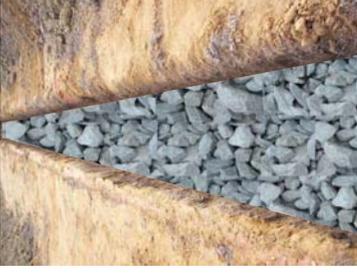
<p>Series of rock drainage features on the lower slope to reduce soil moisture. Would be required to support mechanical stabilization.</p>
<p>Trail Culverts</p>

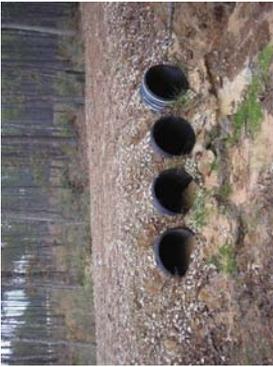
<p>Culverts installed at locations along the trail to drain pooled water along the trail. Would reduce soil moisture on the slope.</p>	<p>Interceptor Trench</p>

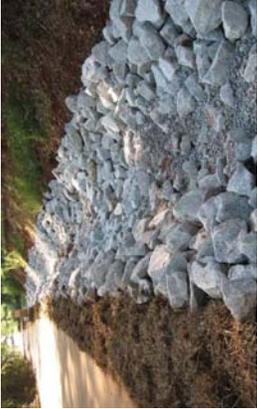
<p>Interceptor Trench to collect and drain near-surface water at the top of slope and at the trail.</p>
