City of Brantford

**Colborne Street East - Slope Stabilization
Municipal Class Environmental Assessment
September 2020**

Project Number: 1824

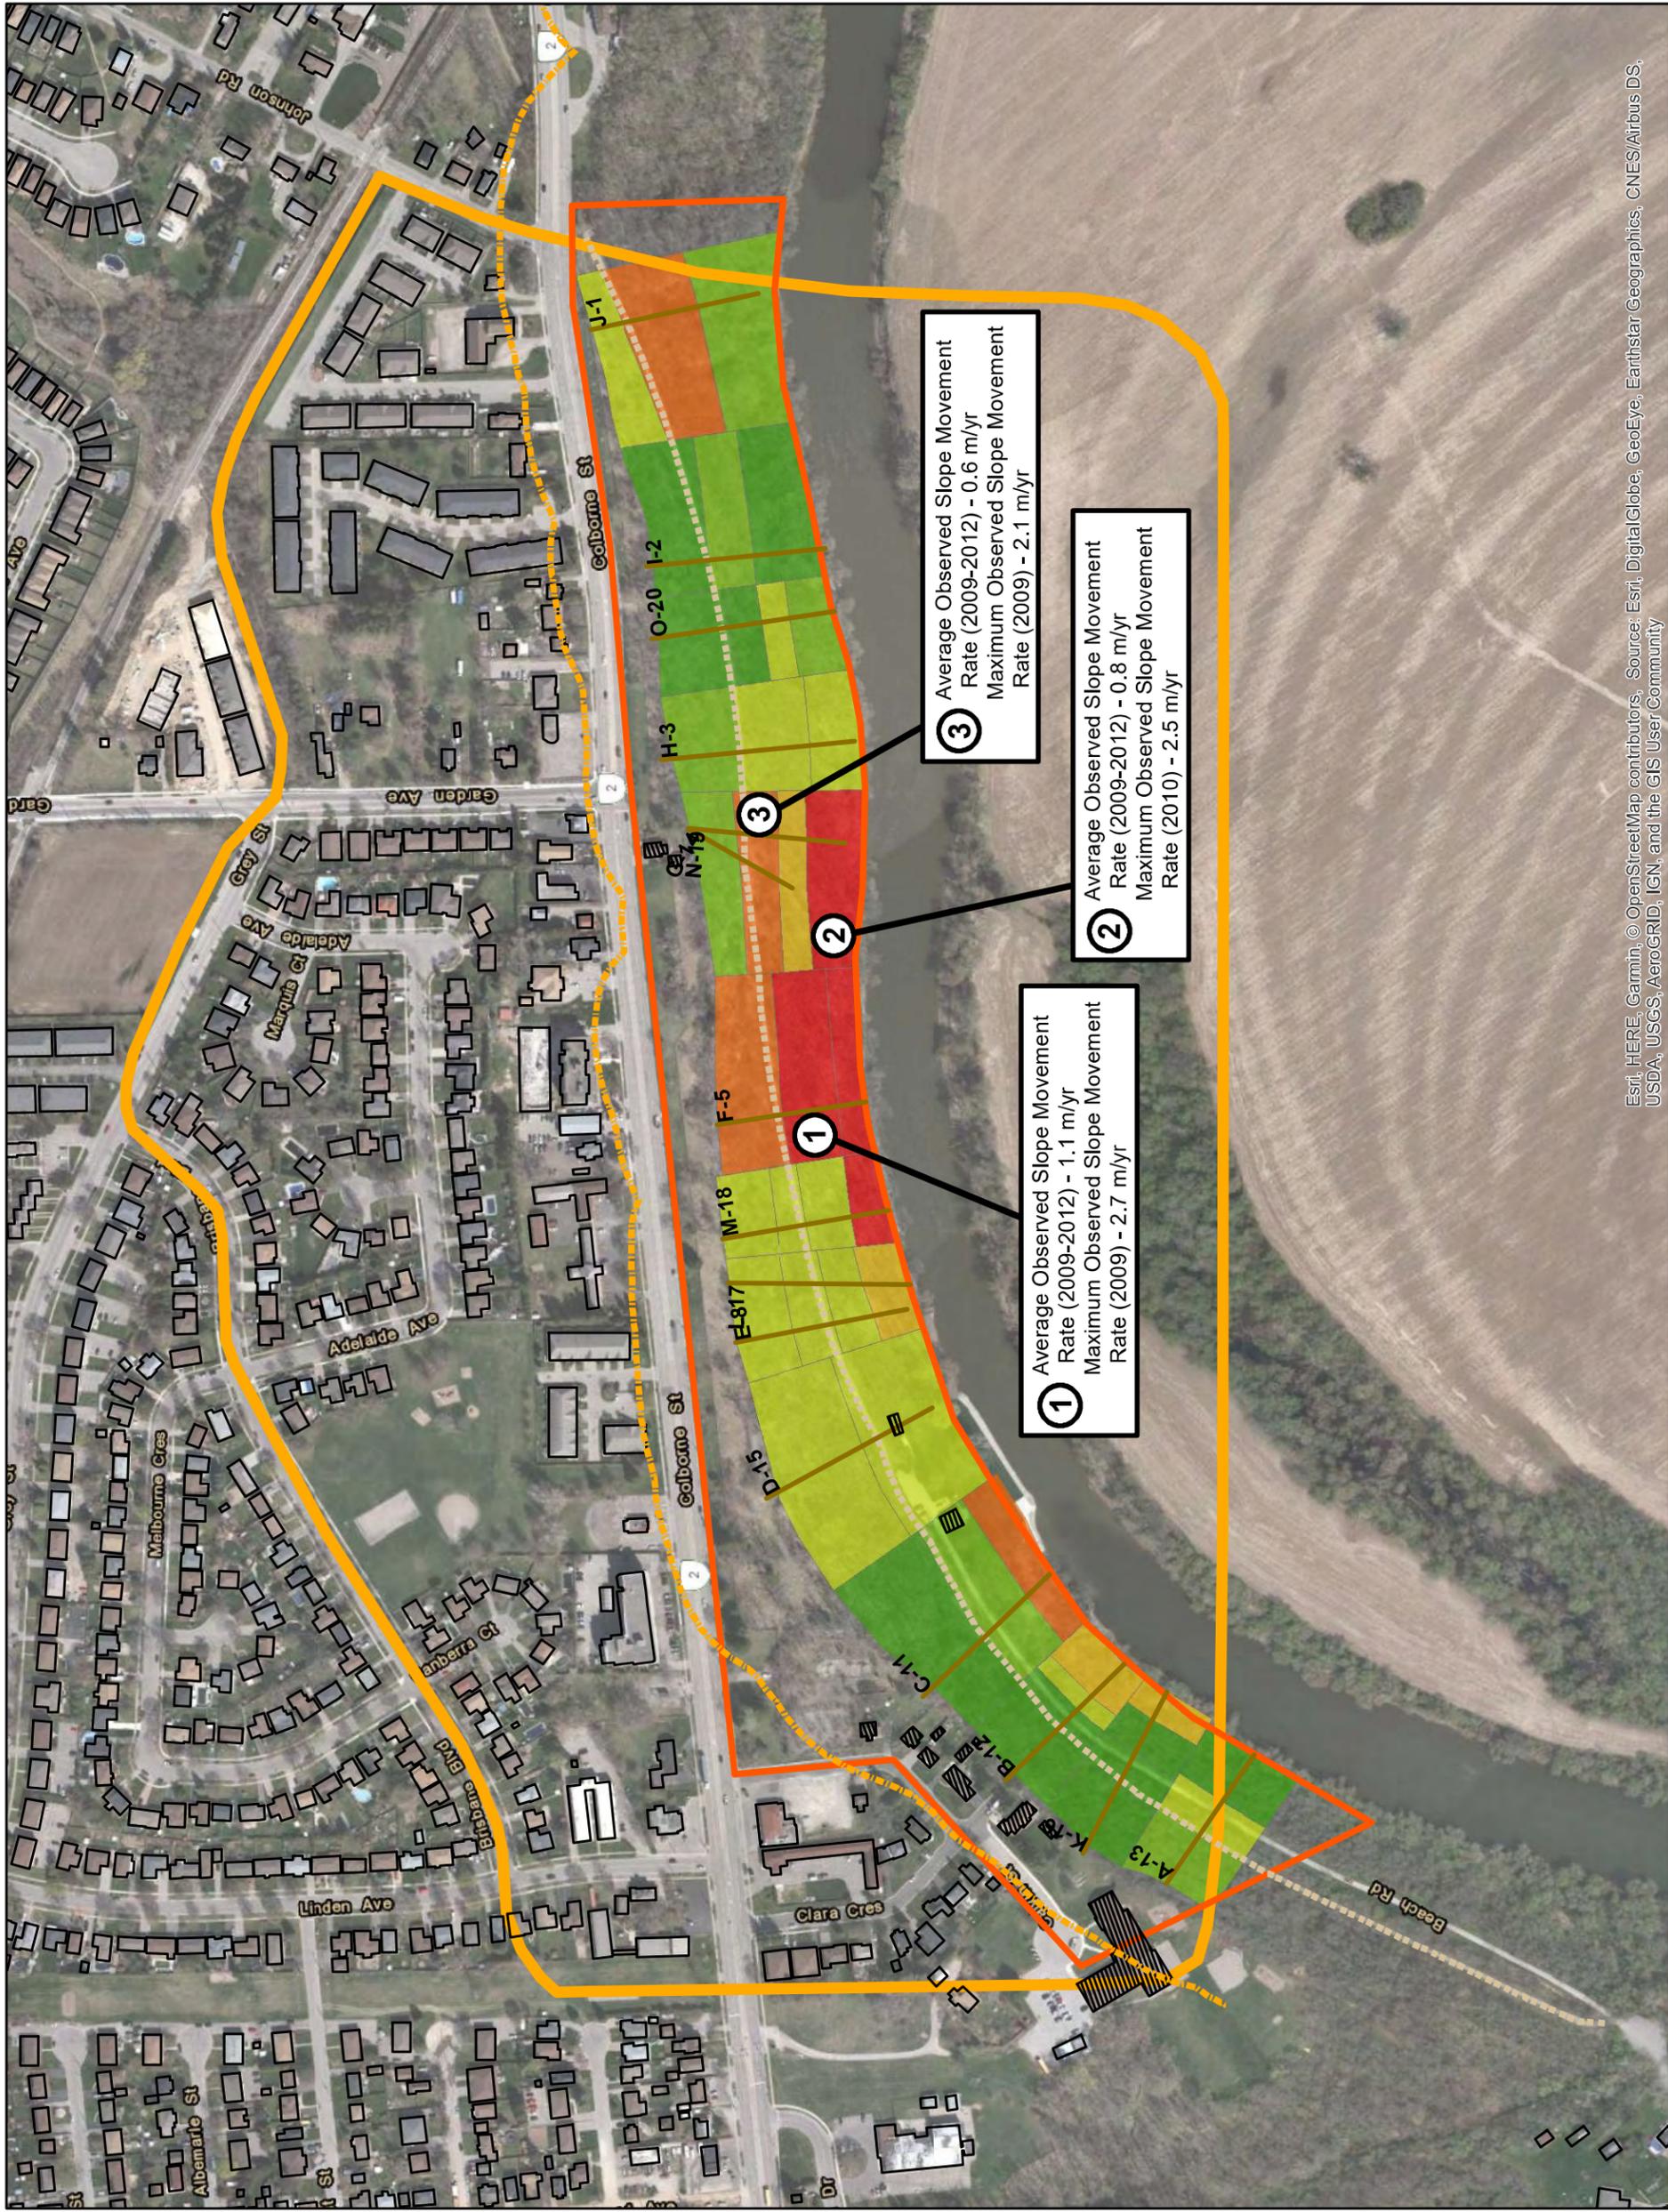
In addition to the Golder monitoring, the City of Brantford has continued the slope inclinometer monitoring program to the present date. This inclinometer data measures annual variations in surface movement in the slope area, collected over multiple monitoring lines in the study area. This data was spatially interpolated to generate estimates of slope movement rates from the provided data period of 2002 – 2018. This slope rate interpolation is provided in **Figure 3-1**.

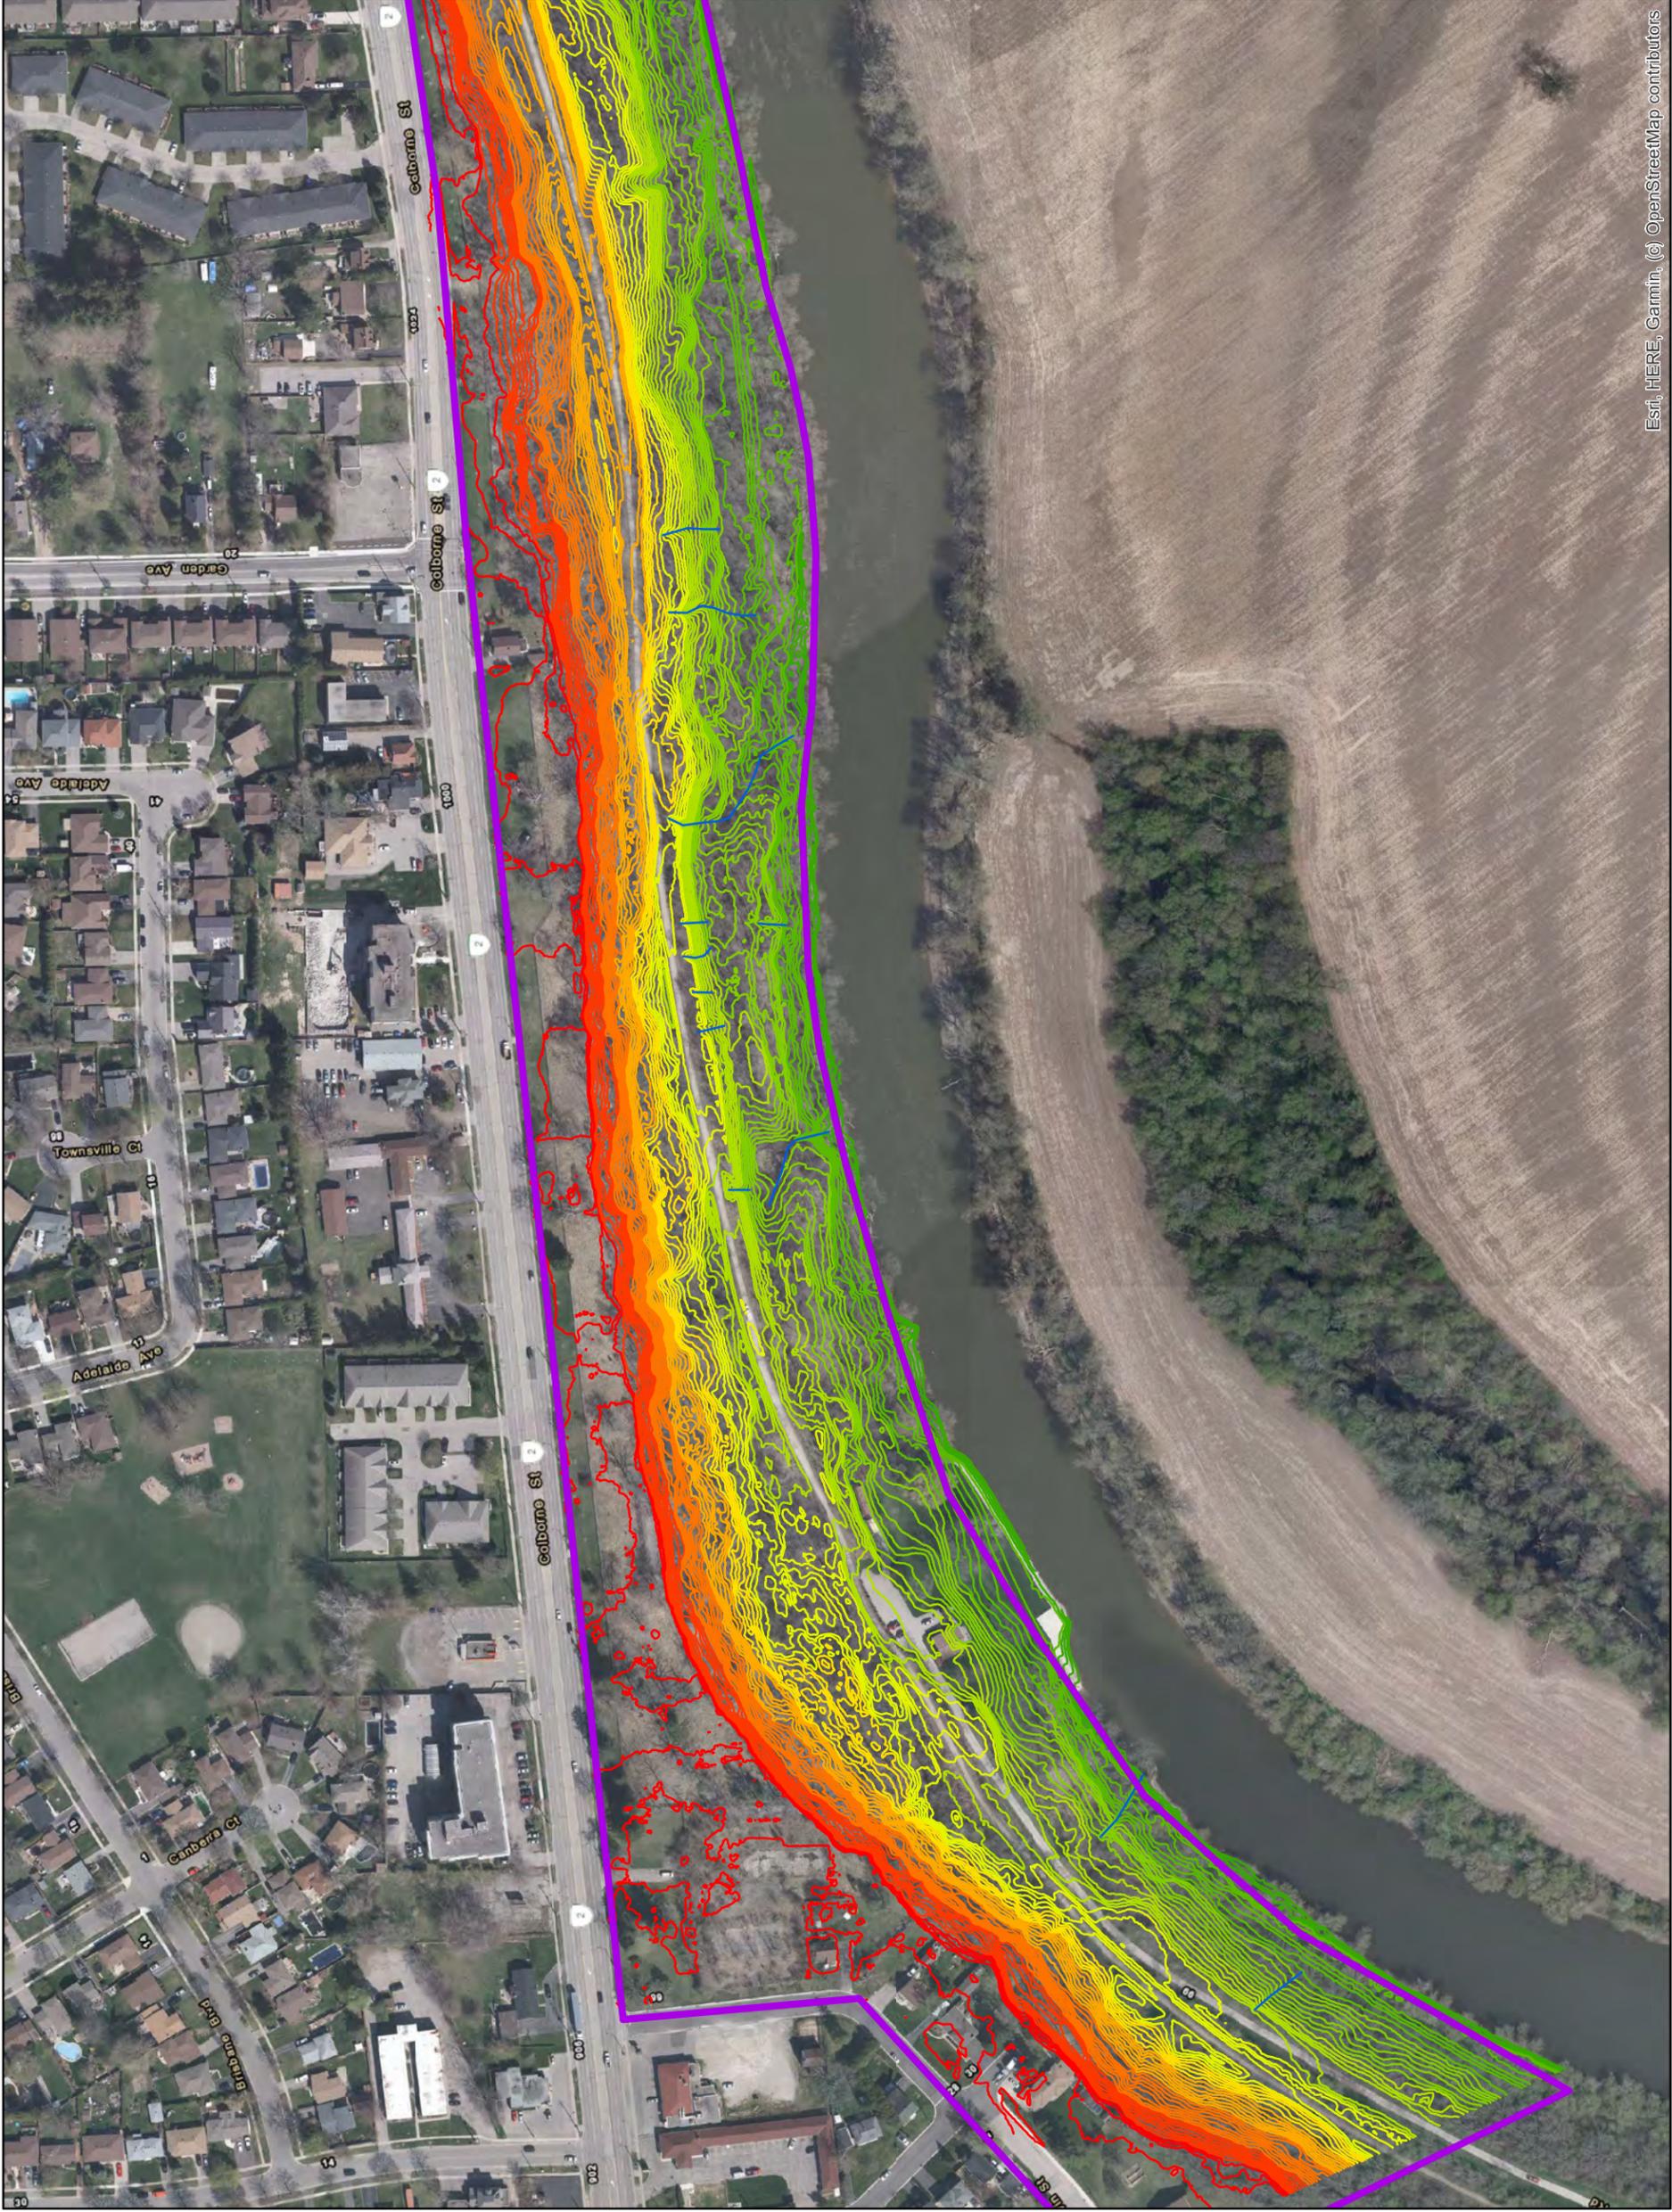
The topographic data collected by the 2018 drone survey is shown in **Figure 3-2**. The seepage paths along the slope were manually delineated based on the contour data. An overlay of the LiDAR data over multiple years of data collection may be used in future studies to determine slope failure areas and estimate slope movement rates with a high degree of spatial precision.

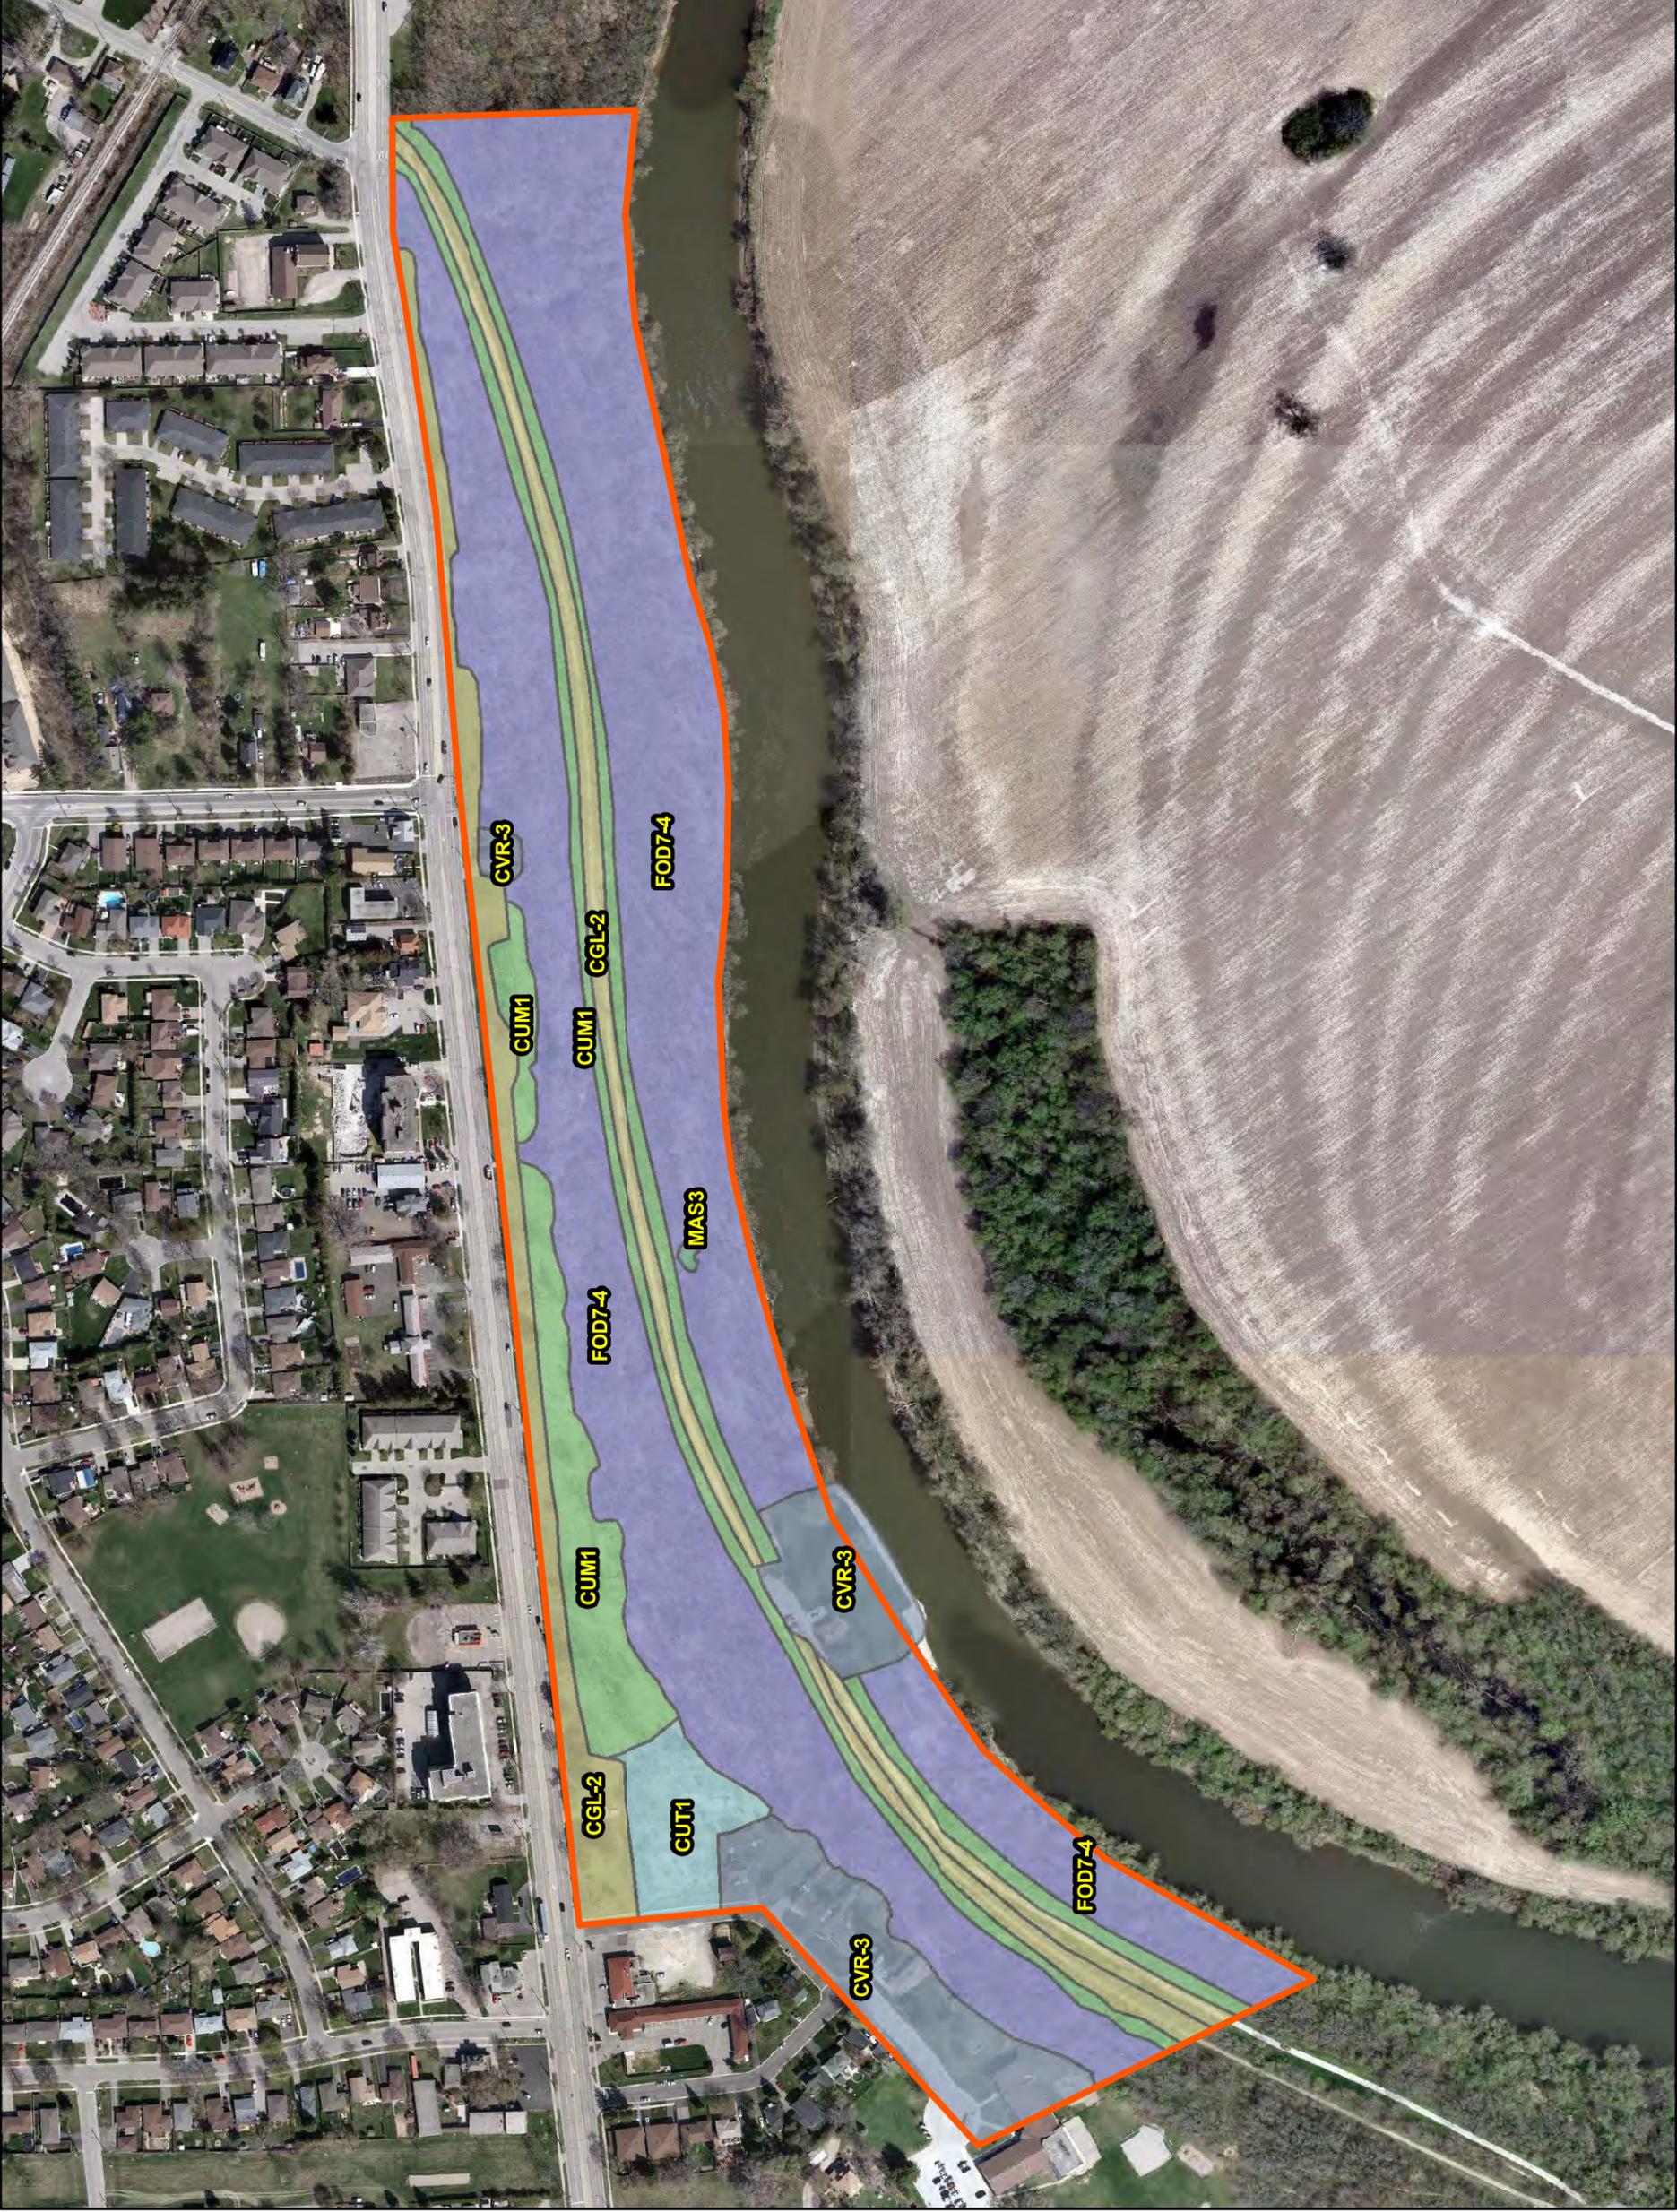
Figure 3-4 Ecological Land Classification

- CGL-2: Parkland
- CUM1: Mineral Cultural Meadow
- CUT1: Mineral Cultural Thicket
- CVR-3: Single Family Residential
- FOD7-4: Fresh-Moist Black Walnut Deciduous Forest
- MAS3: Organic Shallow Marsh

ERI conducted a vegetation inventory and Ecological Land Classification (ELC) of the study area. The inventory and classification were refined over the course of multiple field visits and build upon the 1995 ESR for the area. ELC mapping of the study area was prepared following Ecological Land Classification for Southern Ontario: A First Approximation (Lee et al., 1998) and is present in **Figure 3-4**. To complete the classification, an ELC certified ecologist conducted two site visits to assess the landform and parent material, soil, and vegetation present on site. Six ELC community classes are represented within the study area, including forest and

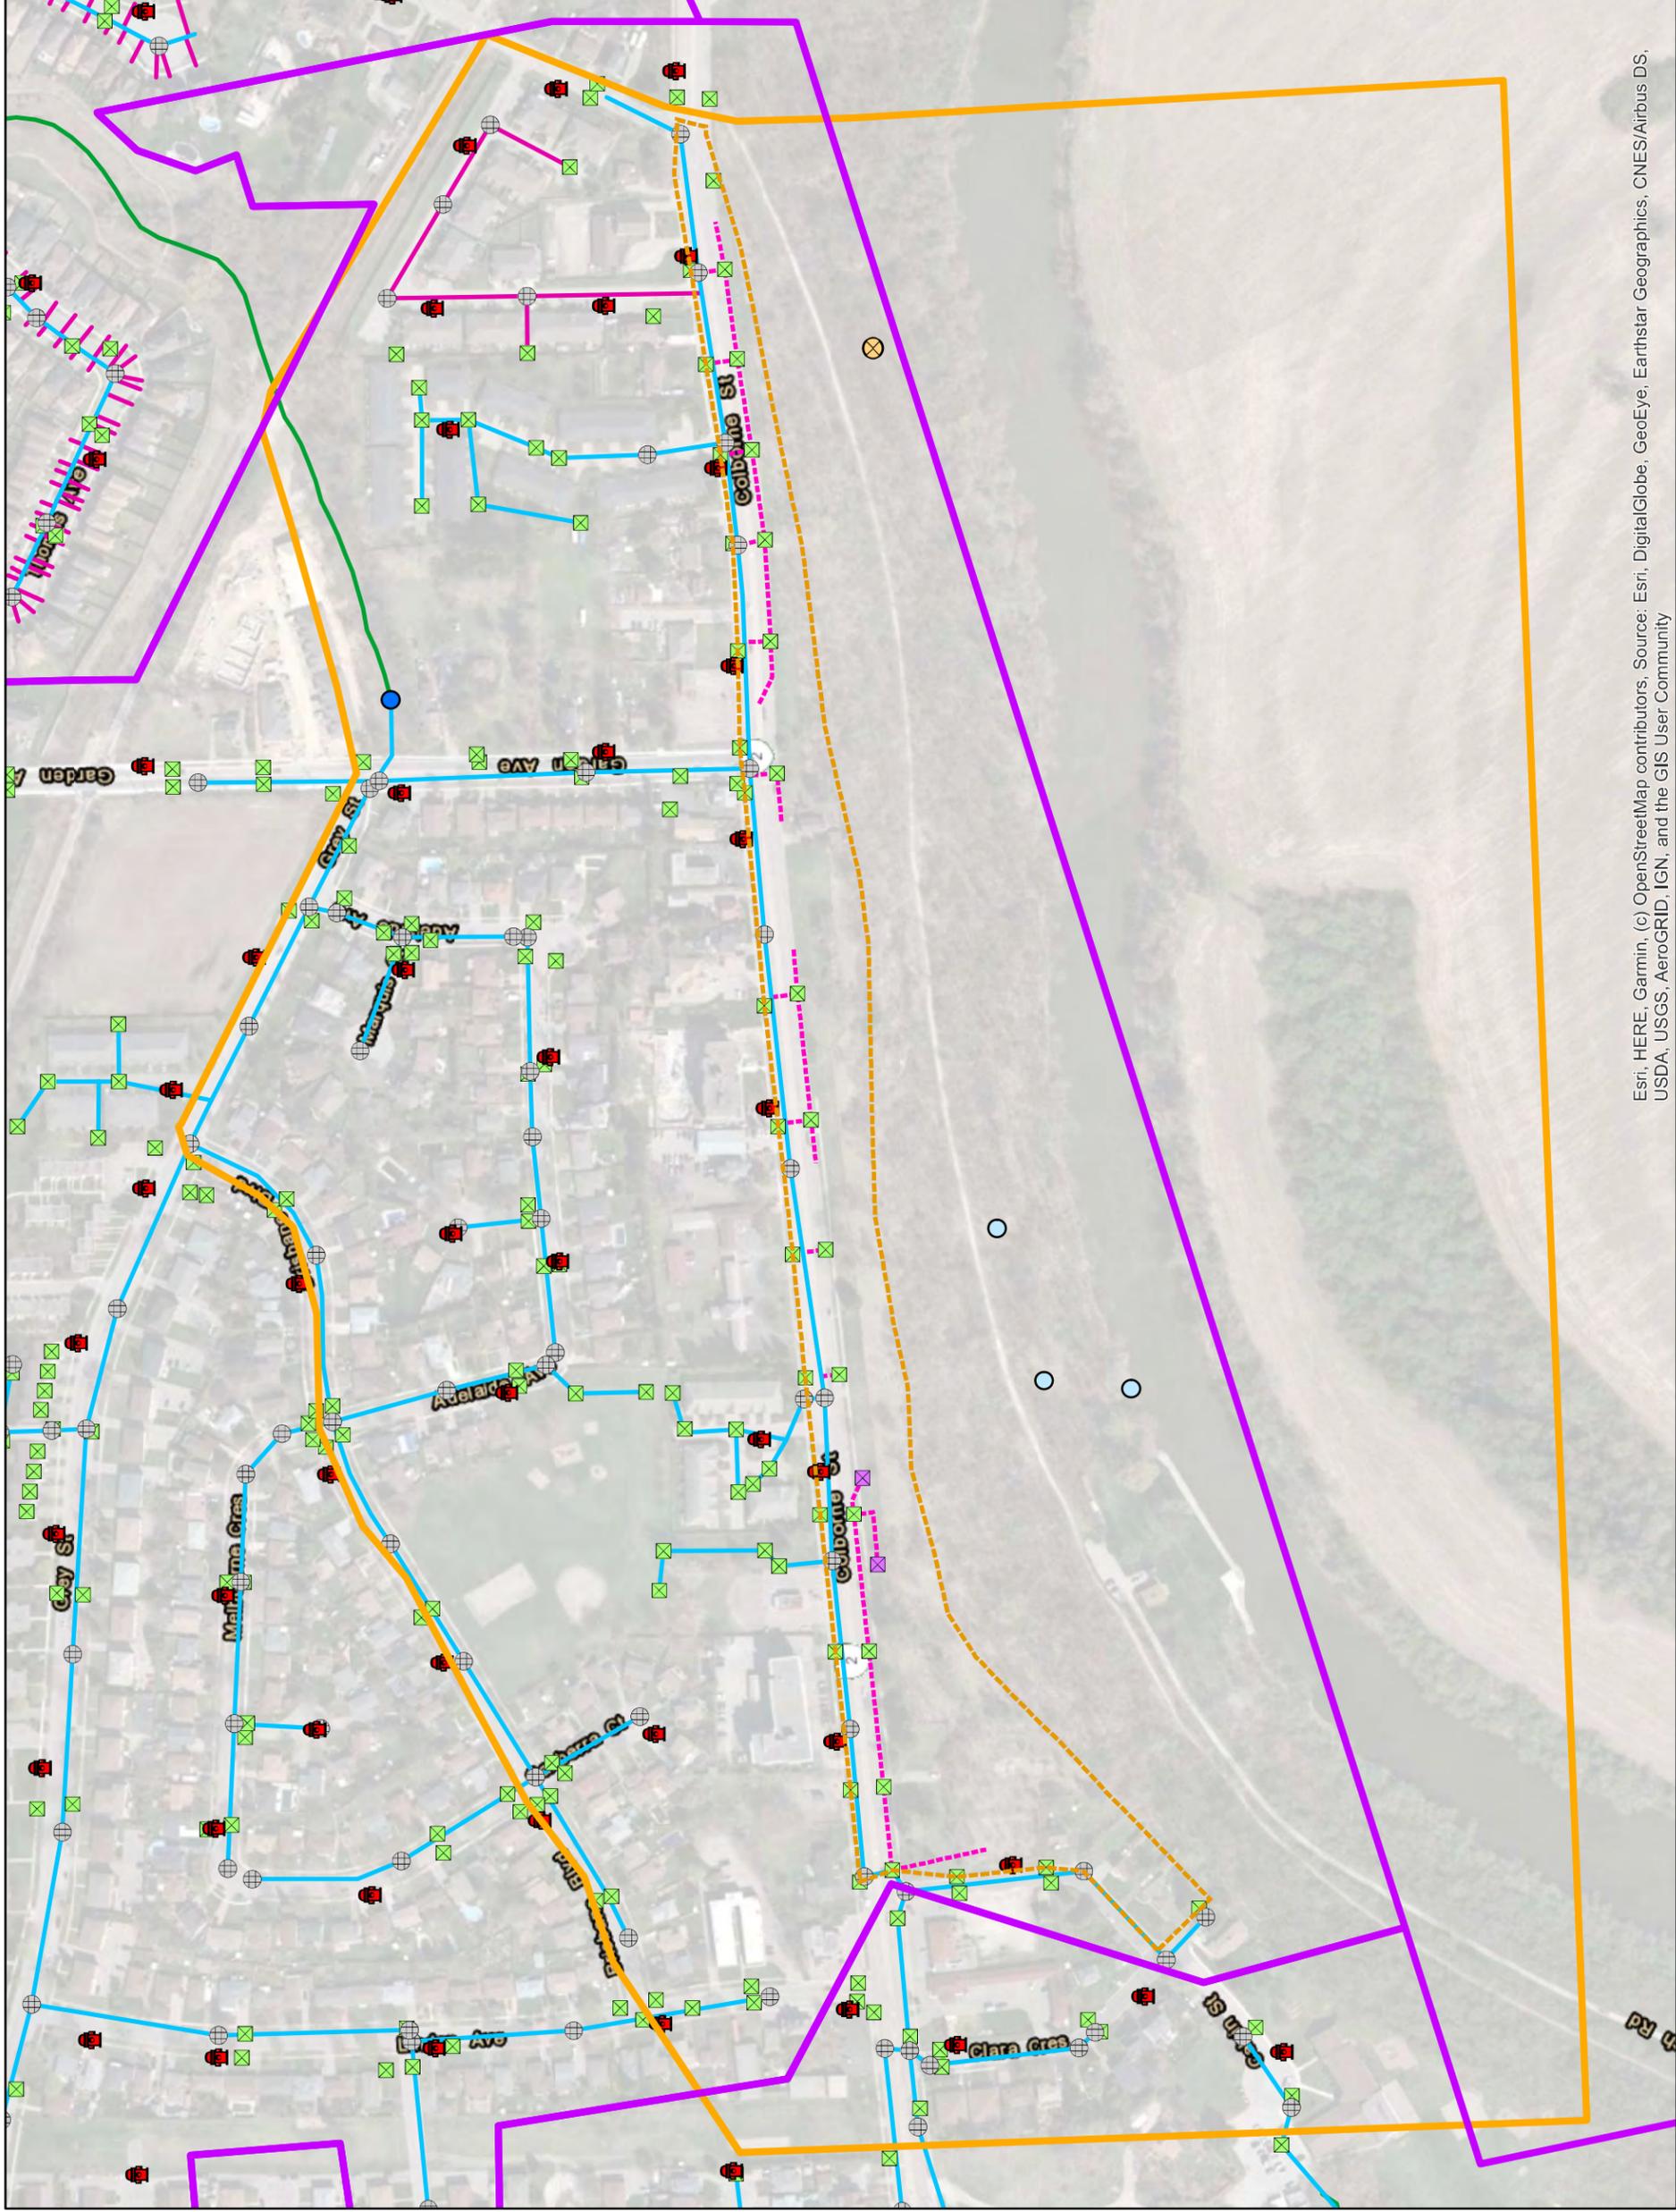
The major drainage system is defined by the MTO as the path of runoff that is followed when the minor drainage system is exceeded (i.e., for storms greater than the 2 to 10-year design of the minor system). This includes natural topography, roadside ditches, roadways, drainage swales, etc. The major flows catchment area was manually delineated for the study area to estimate the contribution area to the slope monitoring area during a major flow event using the SWOOP2015 contours available from the GRCA. The estimated major flow area is 0.58km². The major flow system is shown in **Figure 3-8**.

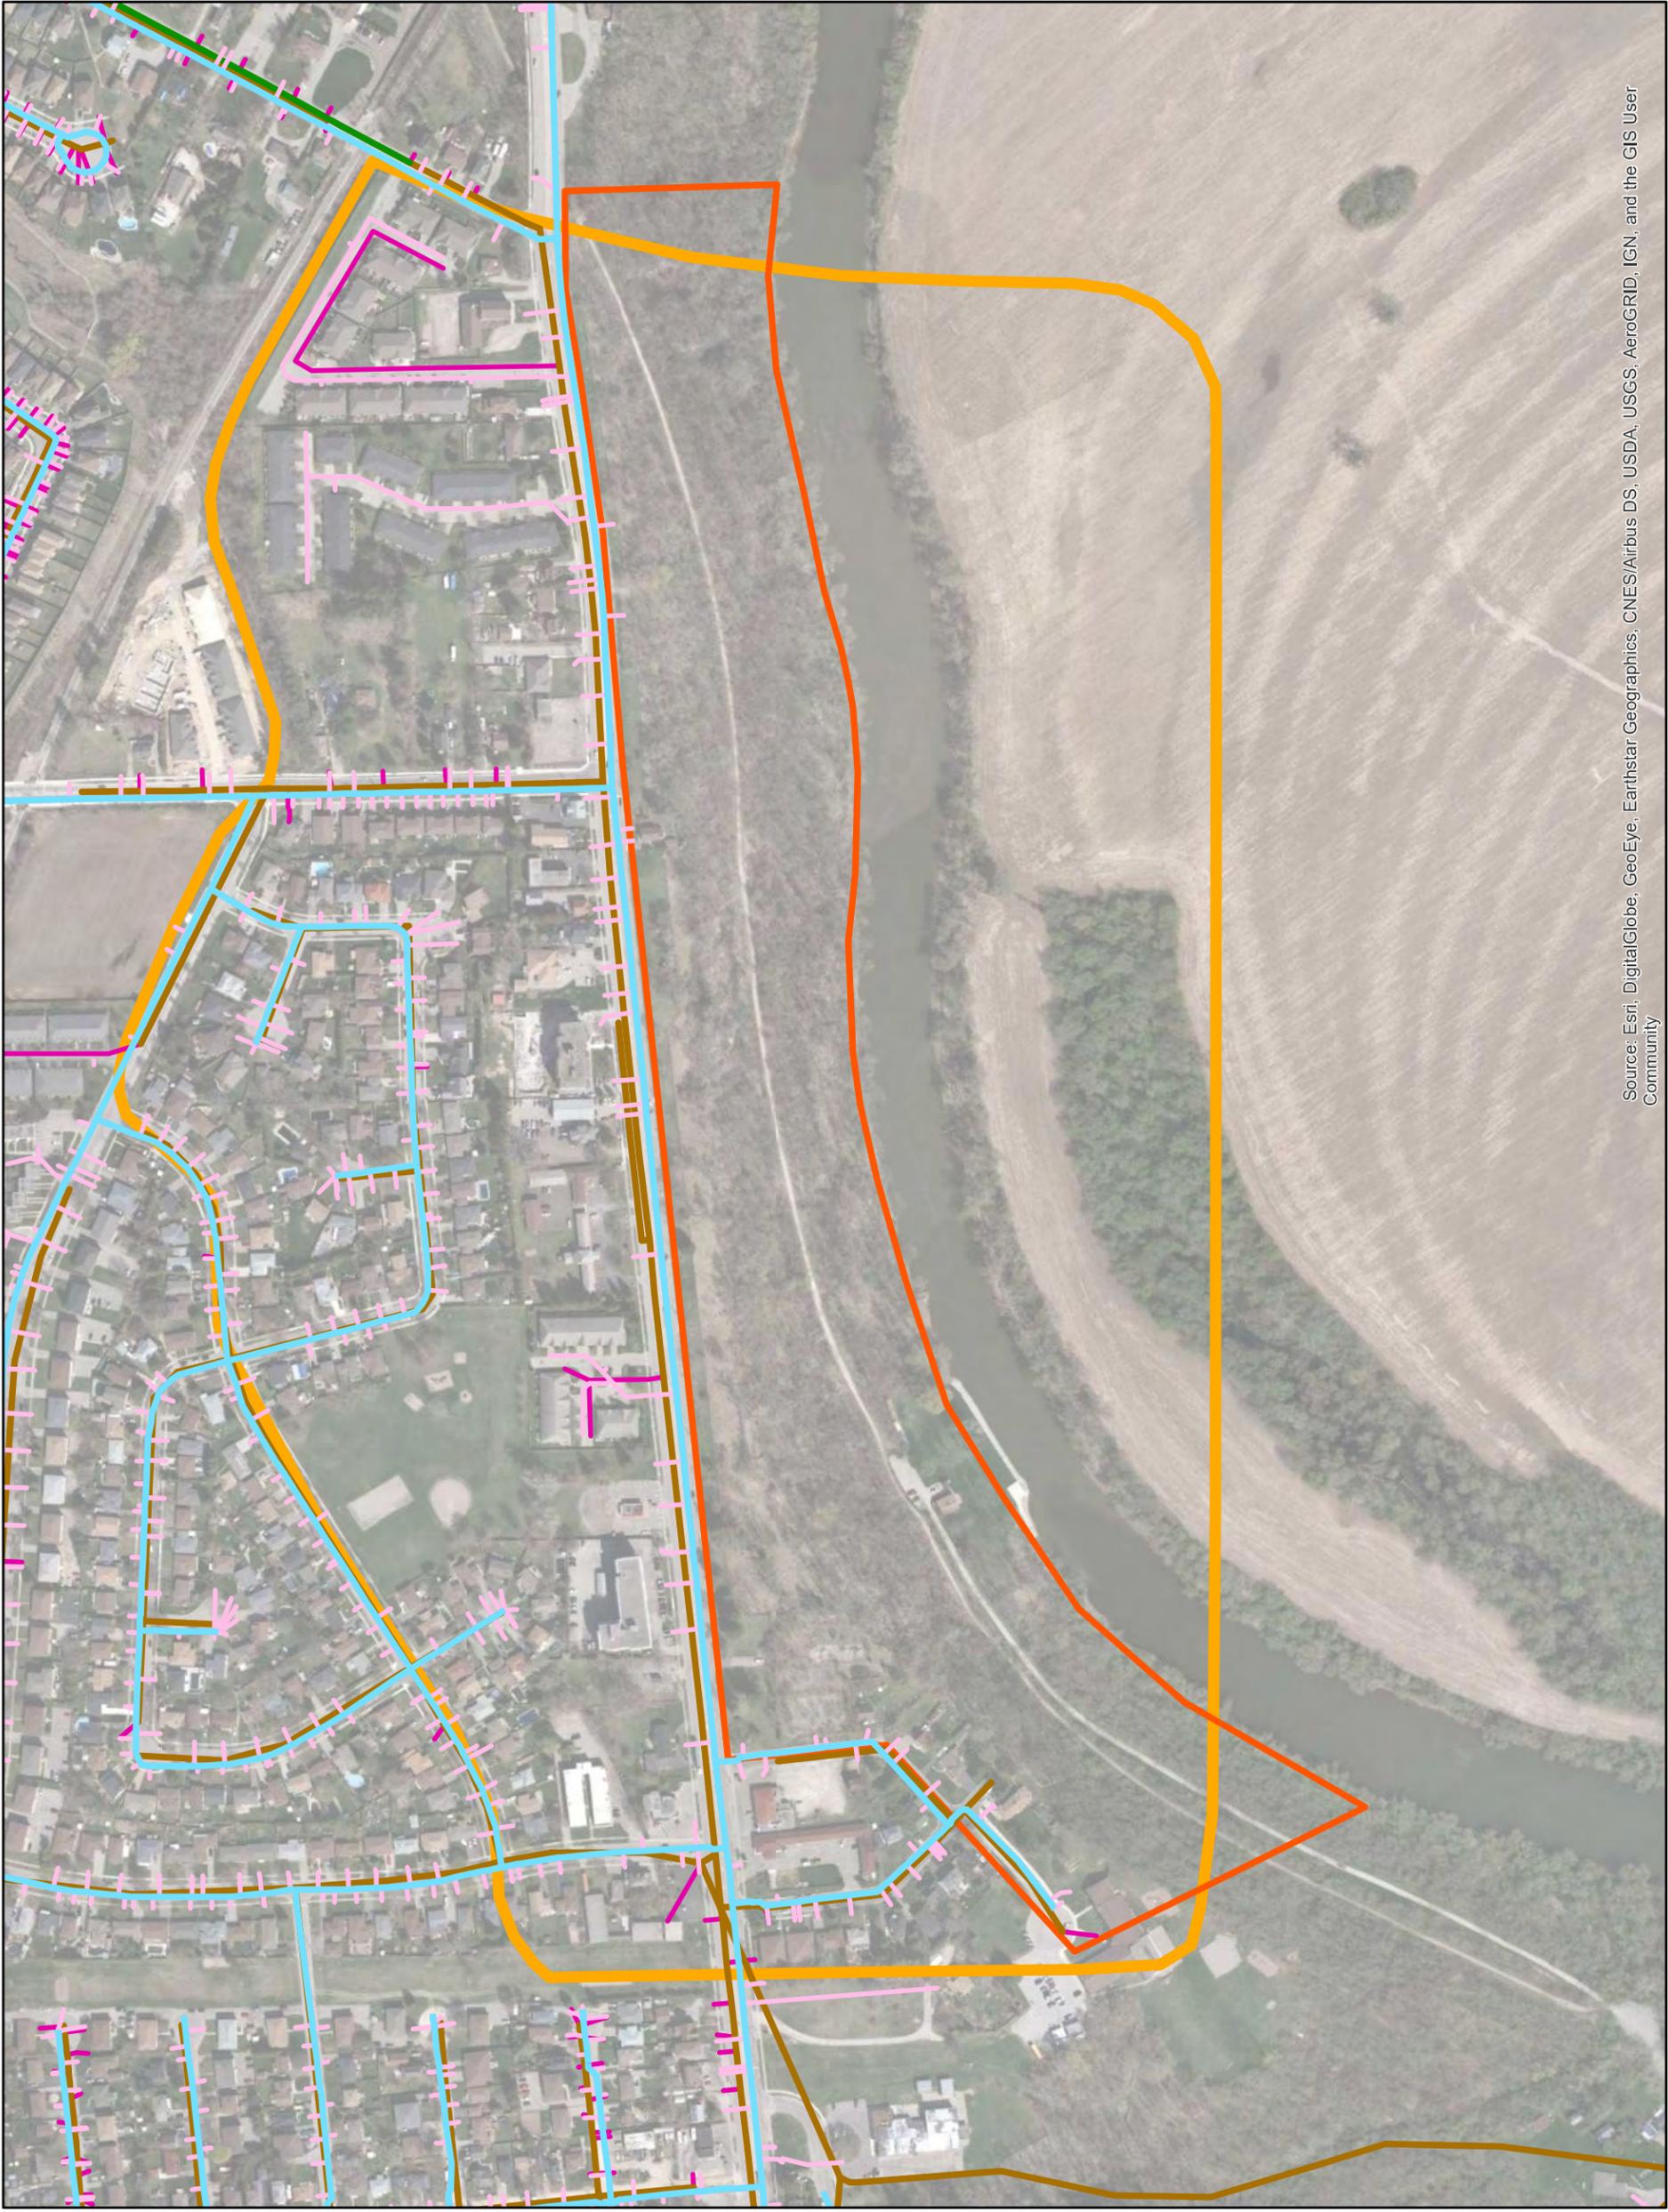
The water and sanitary municipal infrastructure data is provided visually in **Figure 3-14**. As noted above, there exist many laterals shown in this figure along Colborne Street (East) and Clara Crescent that are currently disconnected and inactive since the acquisition of private properties at those locations.

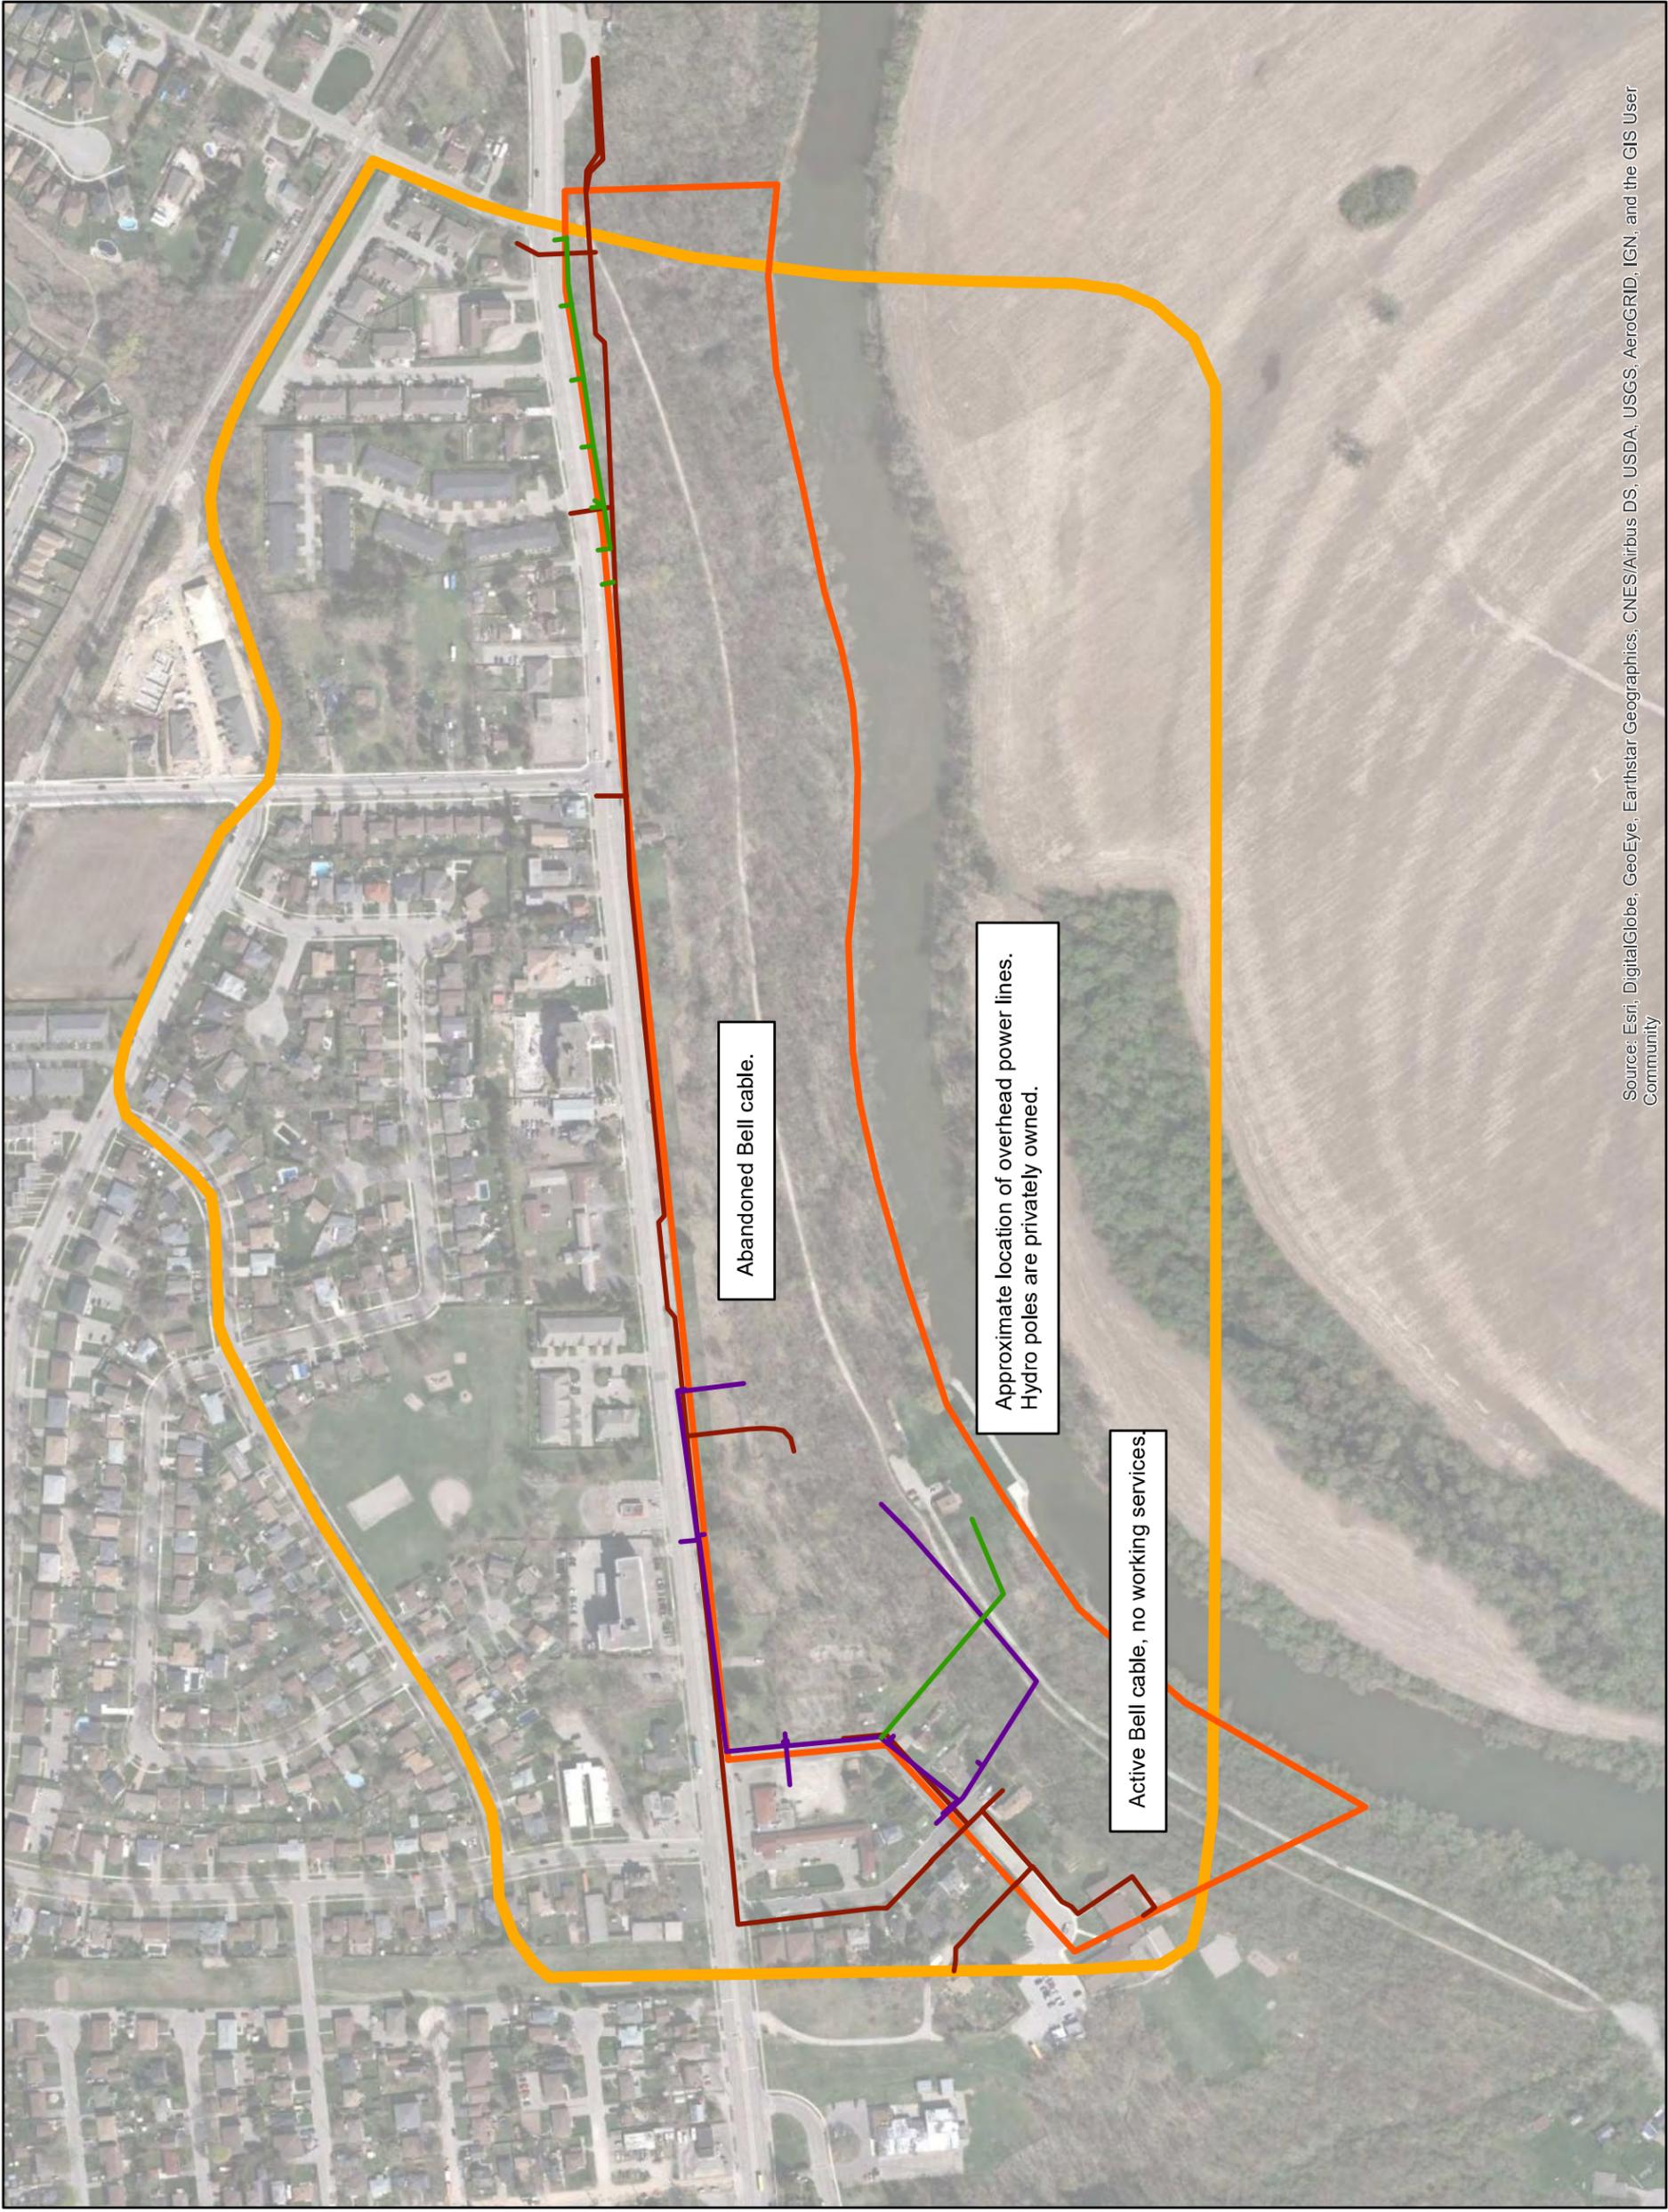
A number of existing and abandoned utilities exist within and near the slope monitoring area that have the potential to be impacted by the alternatives identified through the EA process. The utilities within and near the slope monitoring area are summarized in the sections below. The utilities located within the slope monitoring area are shown in **Figure 3-15**.
