City of Brantford

**Colborne Street East - Slope Stabilization
Municipal Class Environmental Assessment
September 2020**

Project Number: 1824

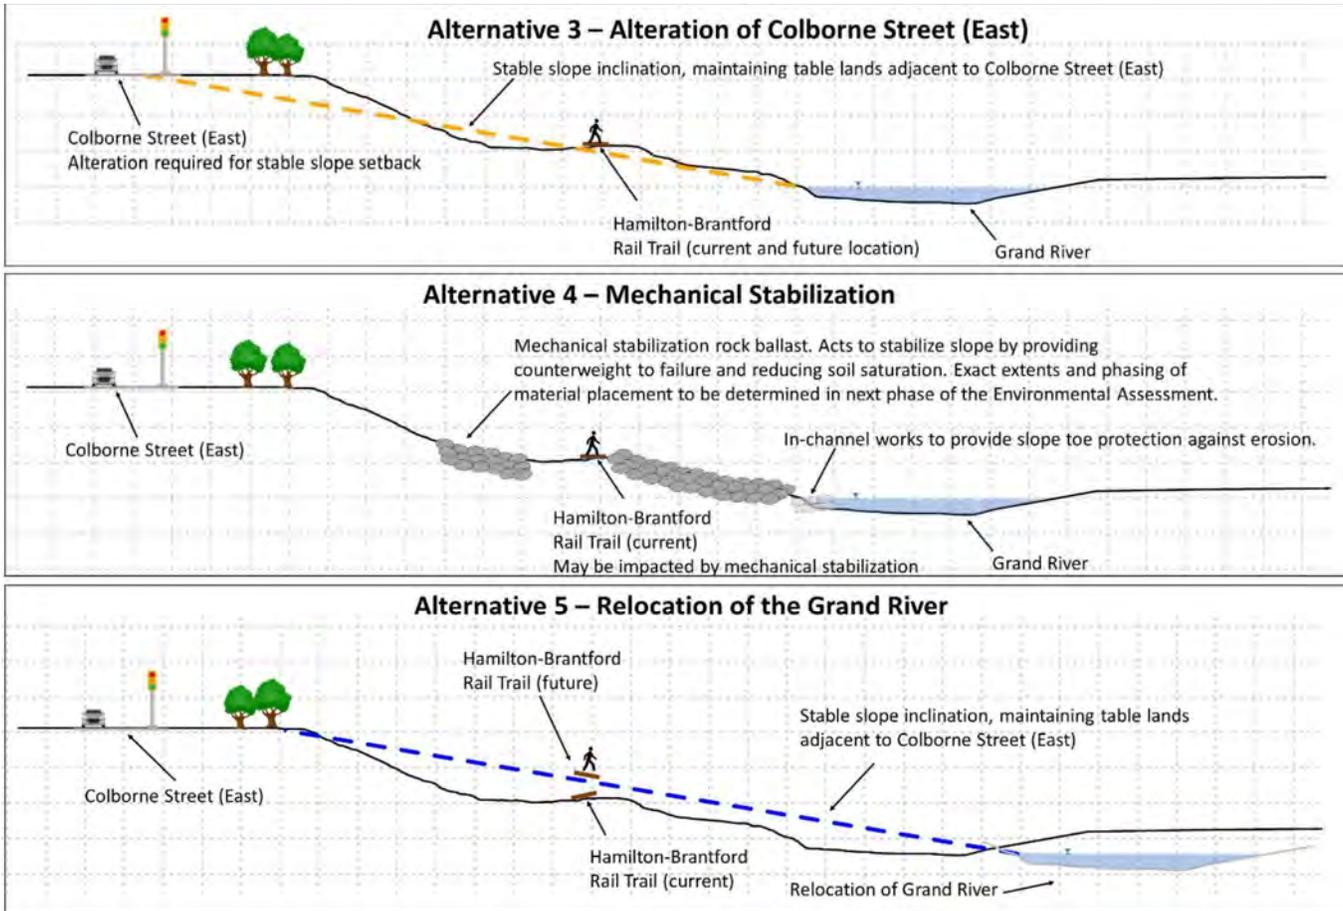
Figure 4-1. Alternative Solution Concepts in Profile for Alternative Solutions 3-5

The conceptual representations of alternative solutions for Alternatives 3-5 are presented in profile view in **Figure 4-1** and in plan view in **Figure 4-2**.

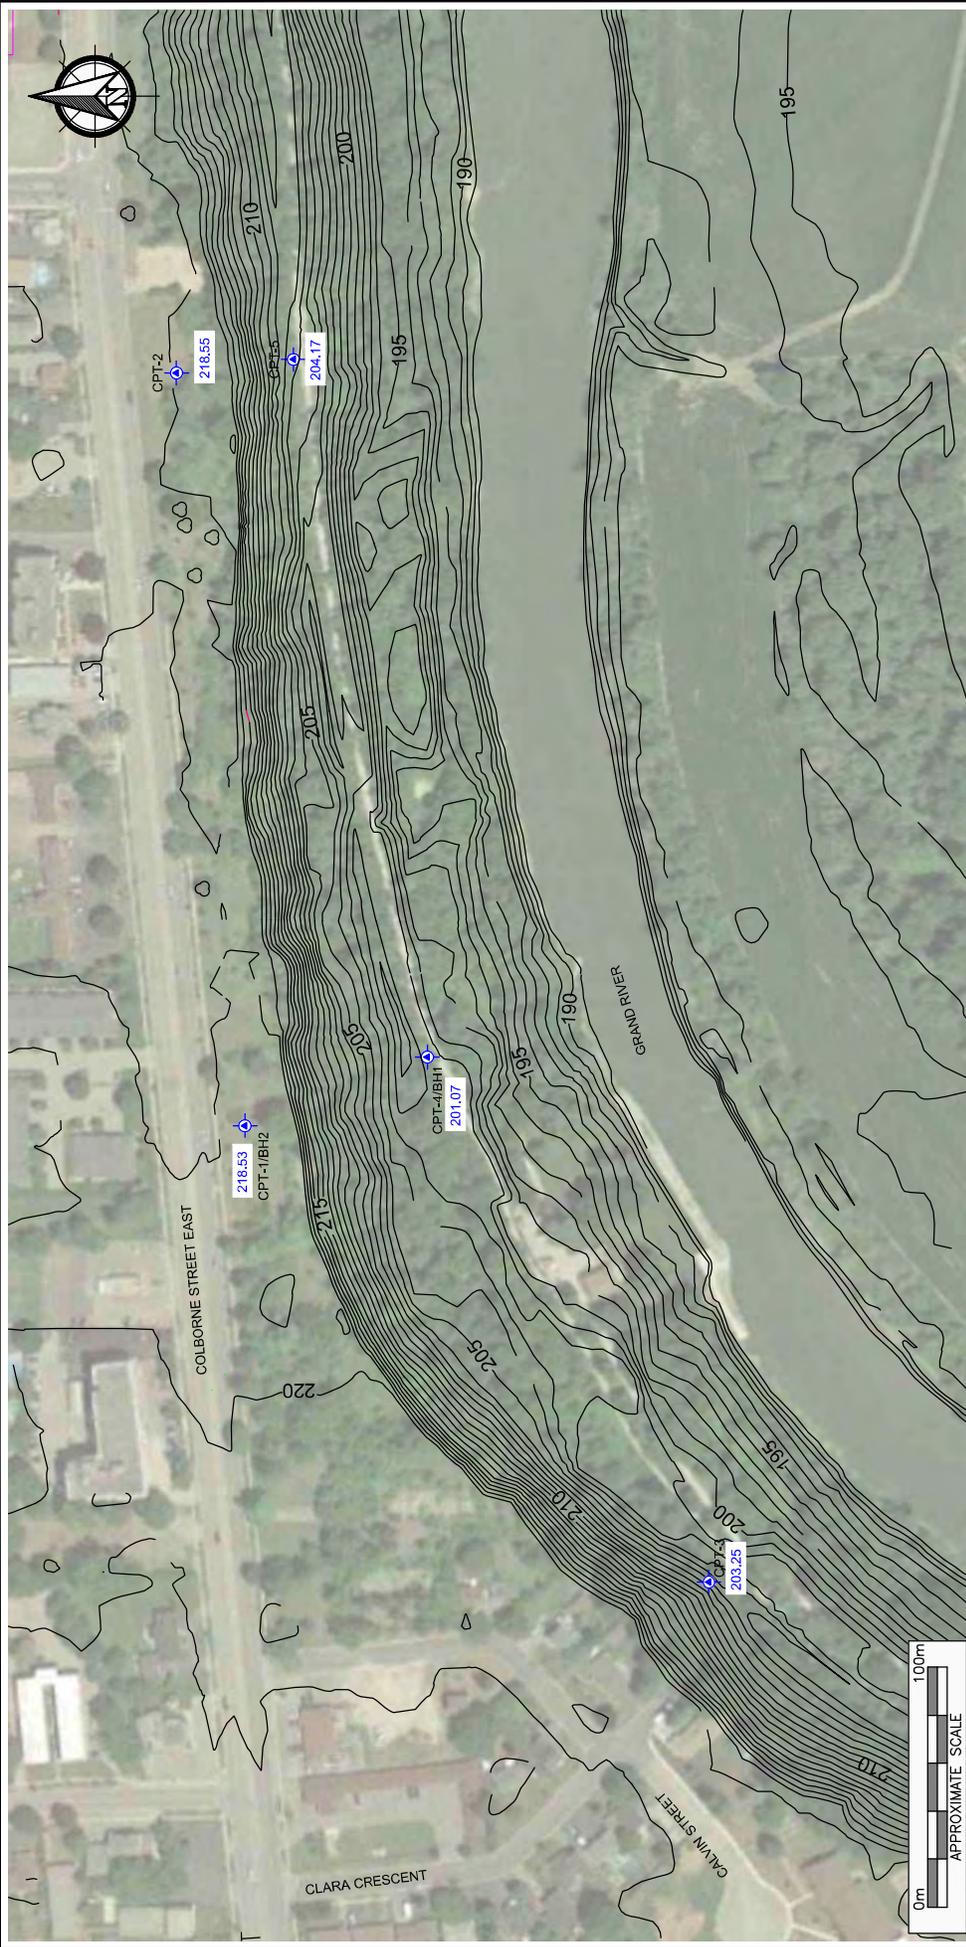
PROJECT NAME		COLBORNE SLOPE STABILIZATION	
CLIENT NAME		ECOSYSTEM RECOVERY INC.	
PROJECT LOCATION		COLBORNE STREET EAST, BRANTFORD, ONTARIO	
FIGURE NAME		BOREHOLE/CPT LOCATION PLAN	
APPROXIMATE SCALE	PROJECT NO.	DATE	FIGURE NO.
AS SHOWN	223798	DEC. 2019	2

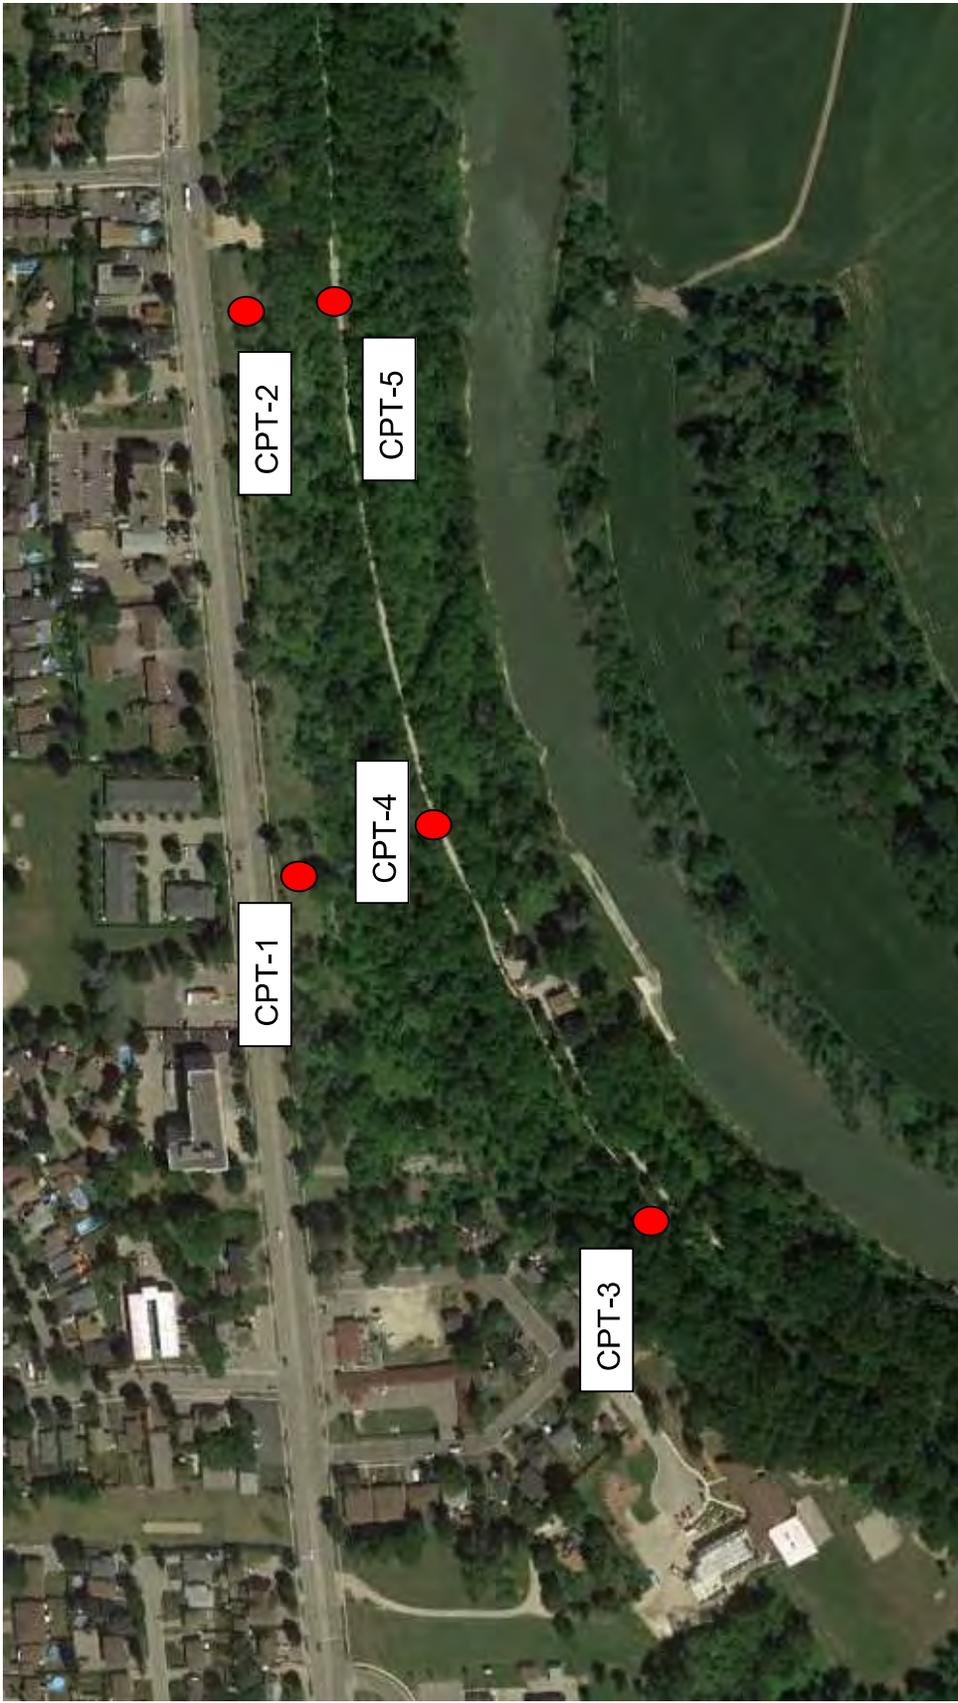
Figure No.1
CPT Location Plan

Locations are approximate.

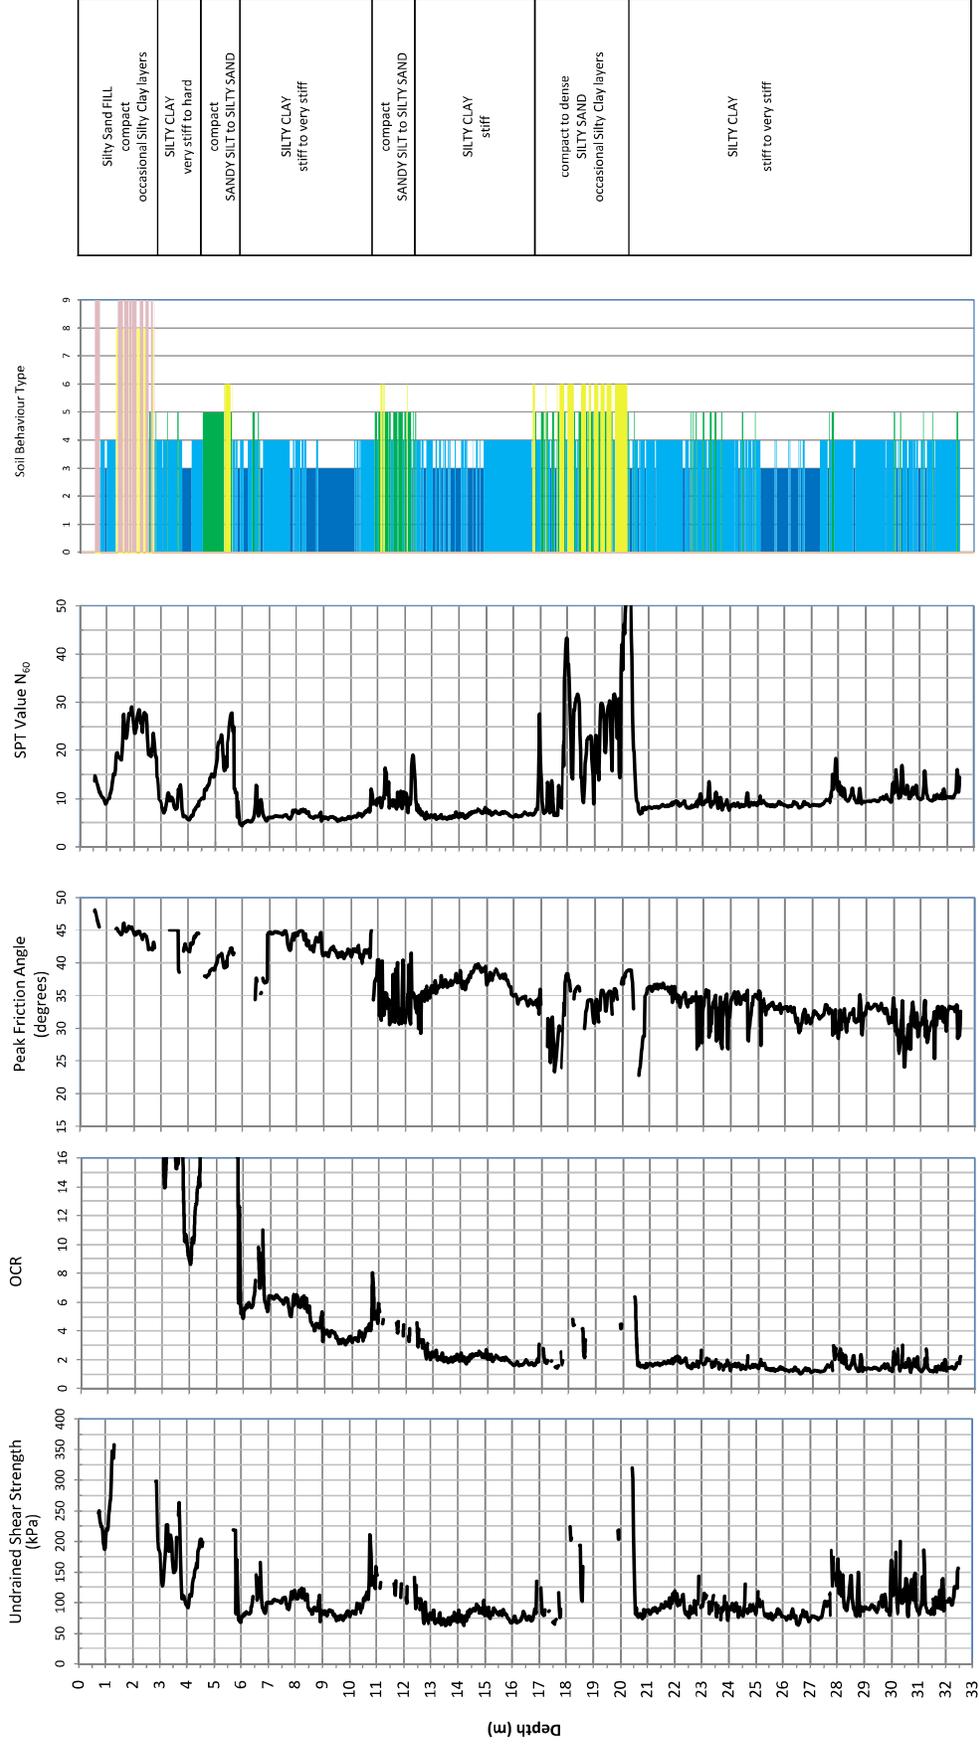
Silty Sand FILL compact occasional Silty Clay layers
SILTY CLAY very stiff to hard
compact SANDY SILT to SILTY SAND
SILTY CLAY stiff to very stiff
compact SANDY SILT to SILTY SAND
SILTY CLAY stiff
compact to dense SILTY SAND occasional Silty Clay layers
SILTY CLAY stiff to very stiff

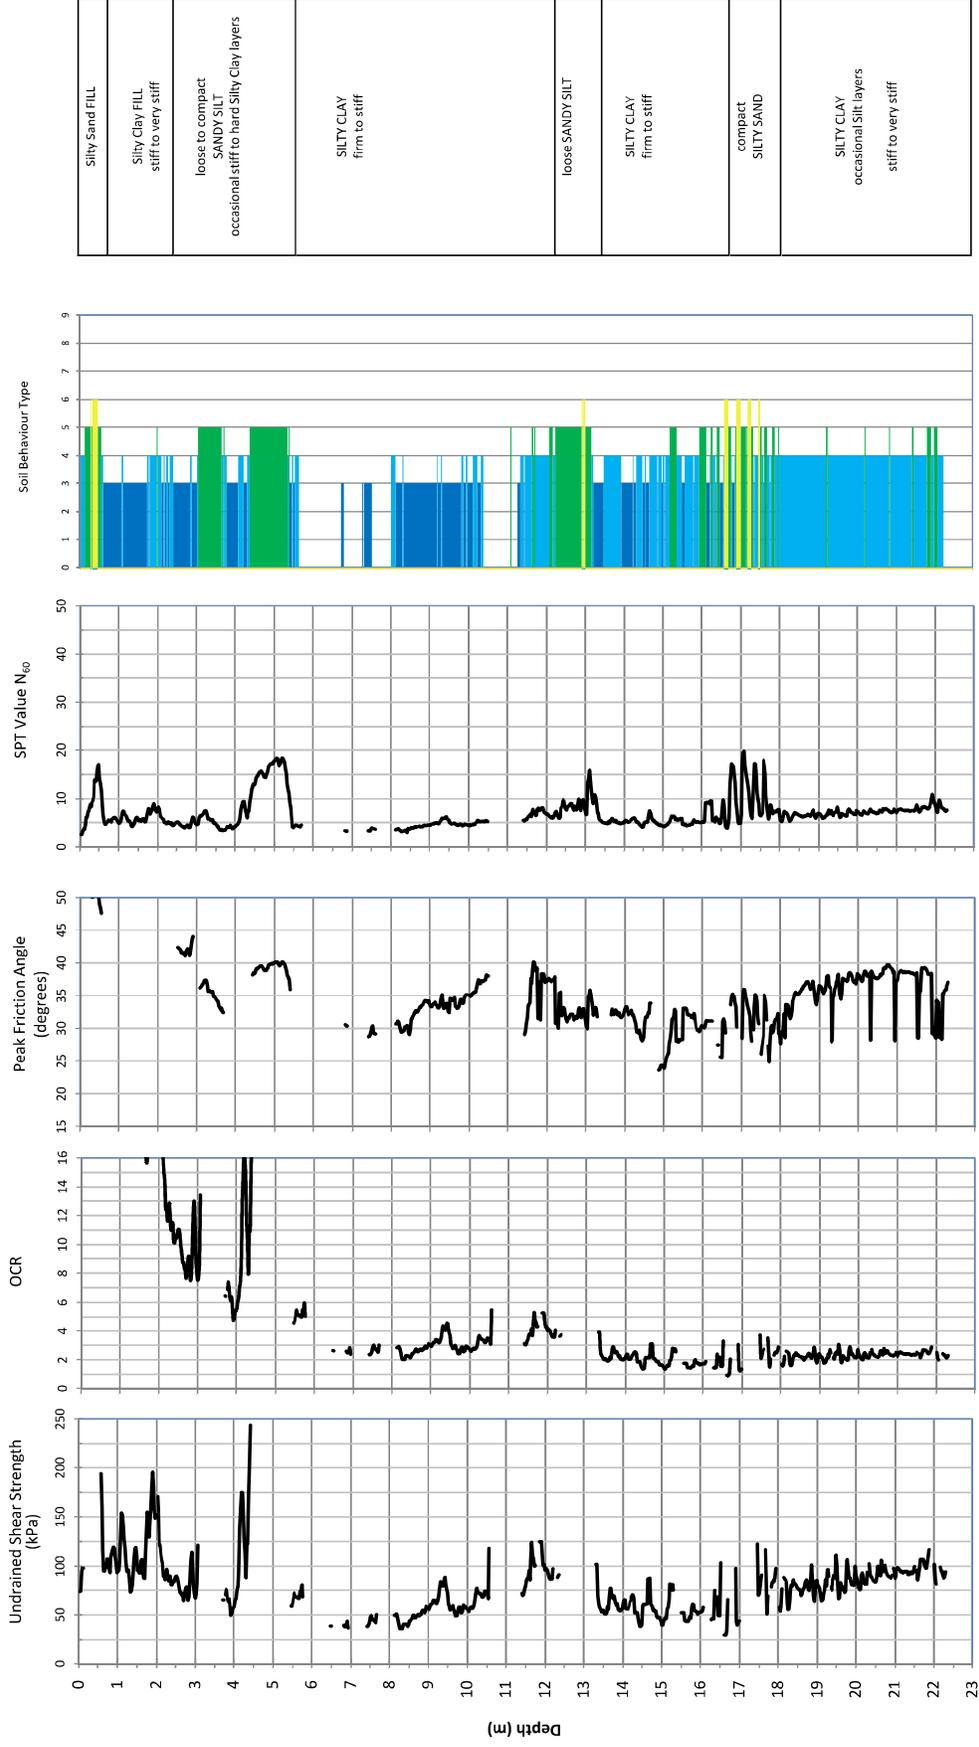
Date: July 31, 2019
 Location: Hamilton-Brantford Rail Trail, Brantford, Ontario
 Engineer: A.Drevininkas
 Cone: GEOTECH AB 10 tonne
 Tip Area: 10 cm²
 Friction Sleeve Area: 150 cm²
 Filter Location: U₂

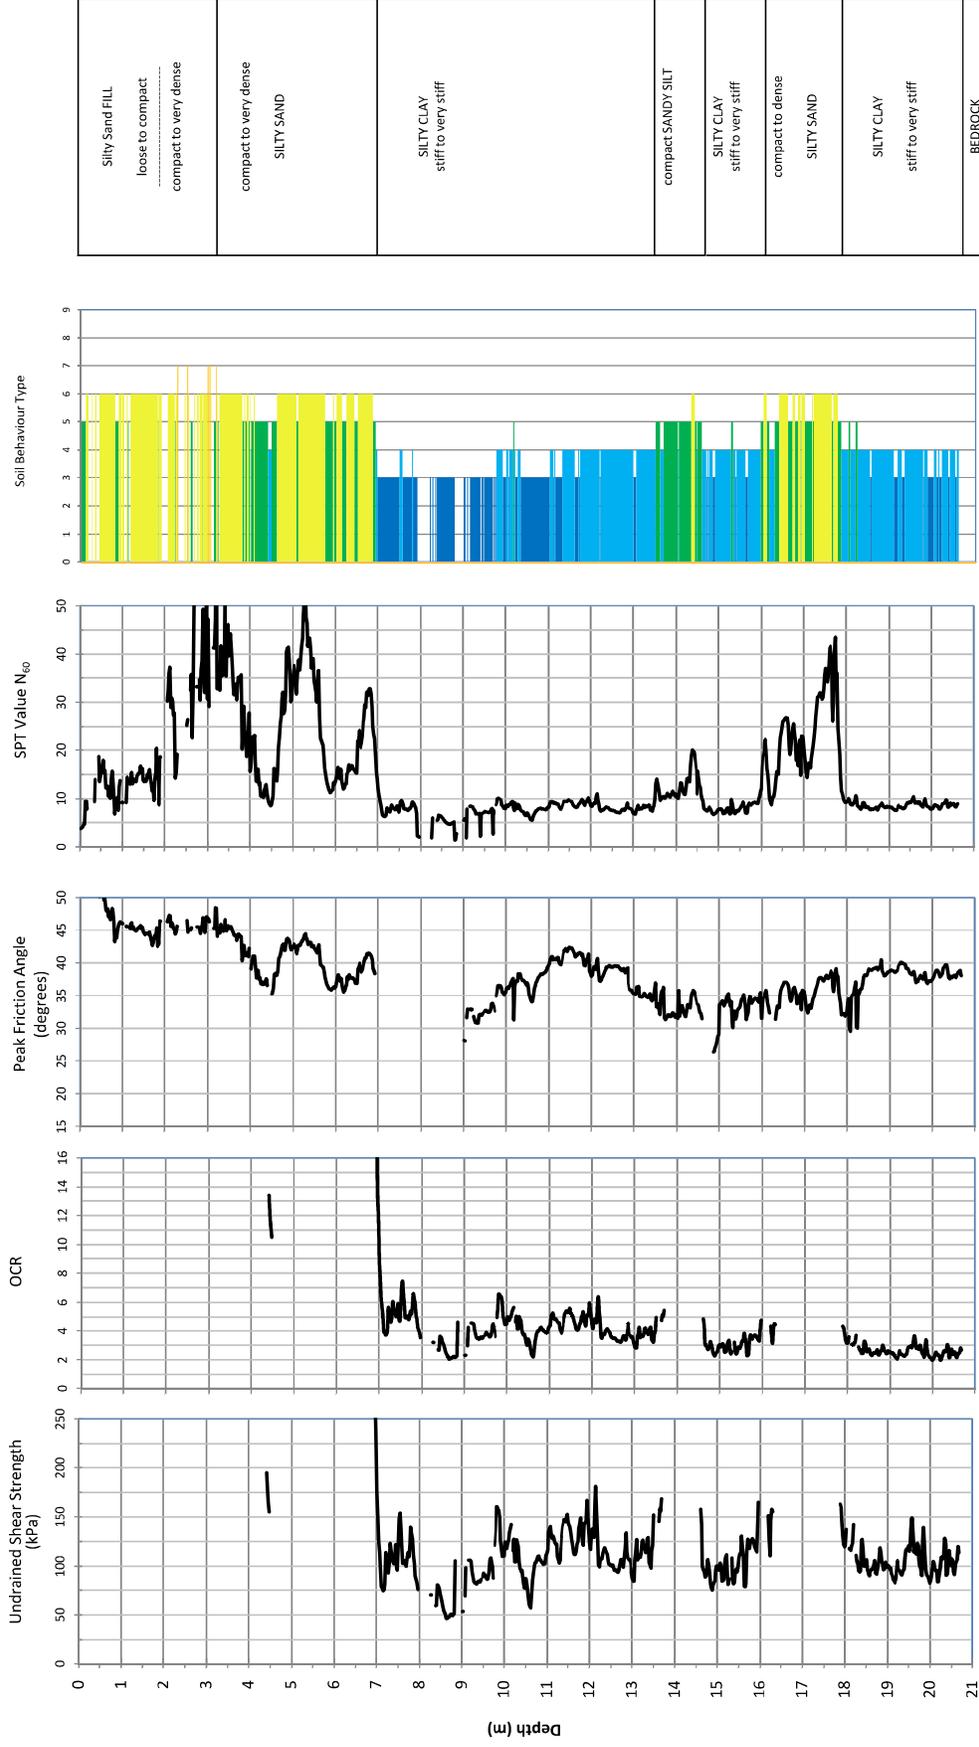
Date: August 1, 2019
 Location: Hamilton-Brantford Rail Trail, Brantford, Ontario
 Engineer: A.Drevininkas
 Cone: GEOTECH AB 10 tonne
 Tip Area: 10 cm²
 Friction Sleeve Area: 150 cm²
 Filter Location: U₂

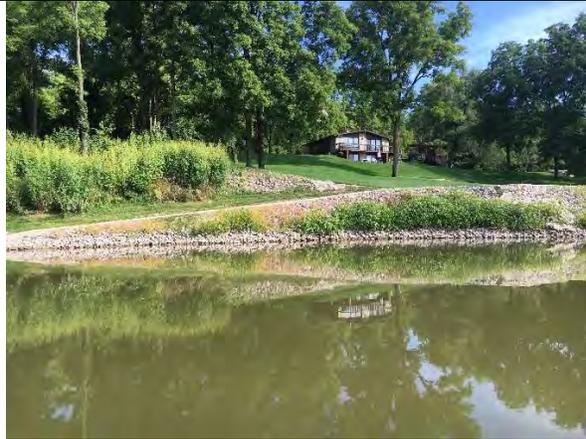
Photo of private property bank treatment along the Grand River

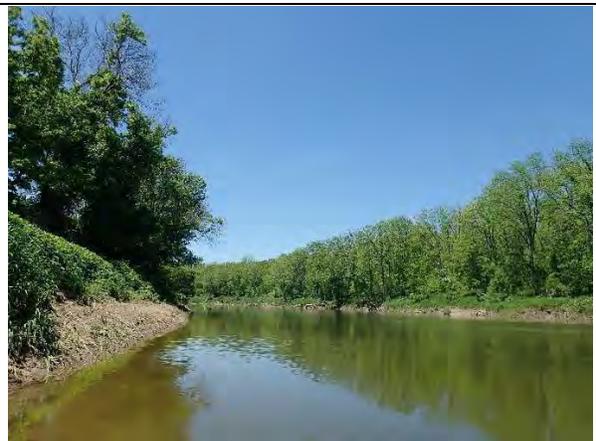
Photos of typical bank along the Grand River

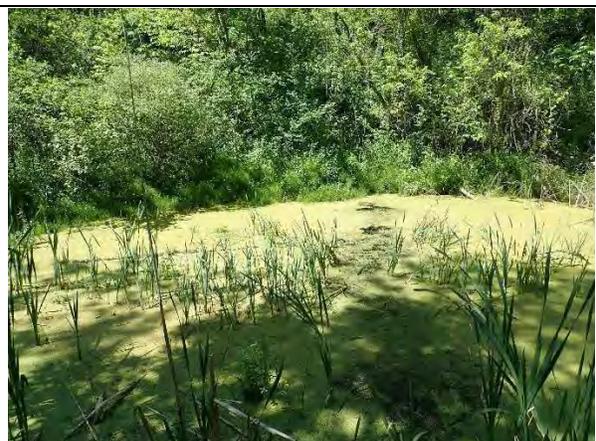
Organic shallow marsh habitat with duckweed covering water surface.

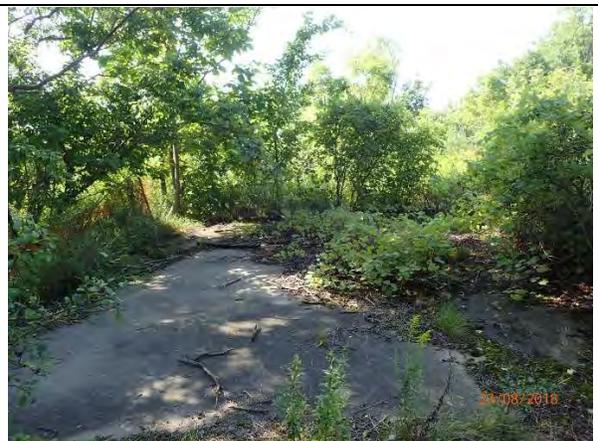
Old building foundation remnants in the mineral cultural thicket.

This thicket community is located in the western corner of the study area and is a disturbed community. An old building foundation is present within this community and the human influences are evident within the vegetation community. Ornamental tree species, pioneer successional species, and non-native species have established within this community. Vegetation found in this community includes Manitoba maple, black walnut, eastern cottonwood, northern catalpa, staghorn sumac, European buckthorn, honeysuckle species, willow species, eastern red cedar, red raspberry, blackberry, riverbank grape, trumpet creeper, goldenrod species, coltsfoot, poison ivy, common tansy, eastern red cedar, and white sweet clover, amongst others.

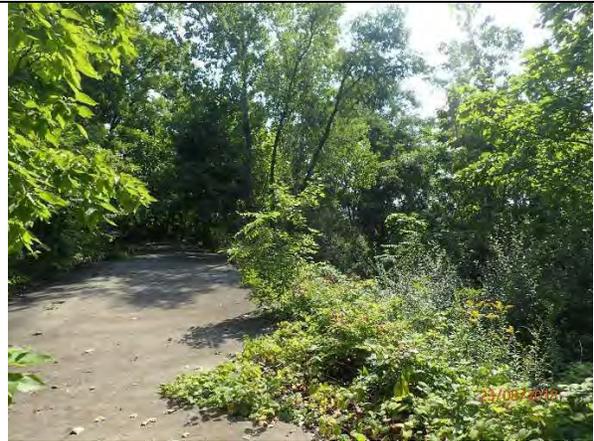
Old building foundation remnants overlooking deciduous forest (FOD7-4)

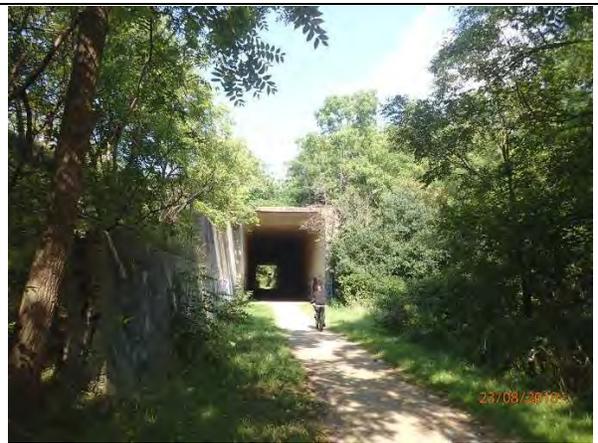
Bridge at east extent of study area

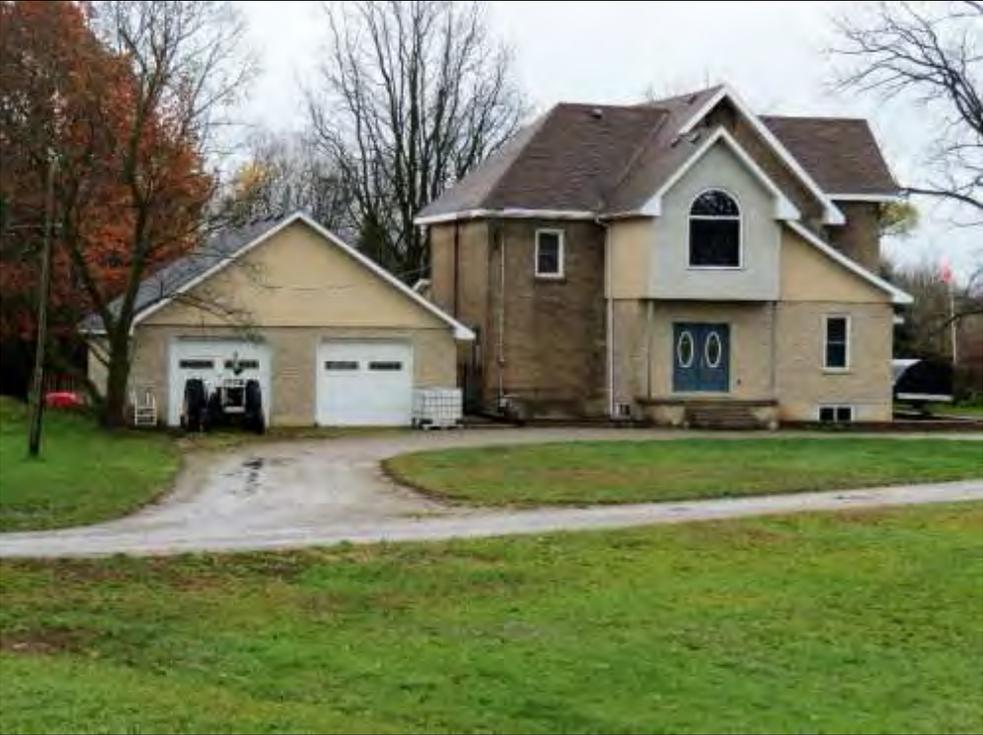
BUILT HERITAGE RESOURCE NO. 1

Description of Property	
Street Address	1059 Colborne Street
Name	n/a
Recognition	None
Location	County of Brant (Cainsville)
Type of Property	Residential
Date(s)	After 1875
Description	<ul style="list-style-type: none"> • Example of a highly modified Edwardian residence • Two-and-a-half-storey house with a hip roof and large front dormer, now has a modified roof line • Buff brick • Set back from the road • Outbuildings on the property
Photo(s)

Evaluation of Property			
Criteria	Description	✓	Value Statement(s)
<p>Design or Physical Value</p>	<p>Is a rare, unique, representative or early example of a style, type, expression, material or construction method</p>		
	<p>Displays a high degree of craftsmanship or artistic value</p>		
	<p>Displays a high degree of technical or scientific achievement</p>		
<p>Historical or Associative Value</p>	<p>Has direct associations with a theme, event, belief, person, activity, organization or institution that is significant to a community</p>		
	<p>Yields or has the potential to yield information that contributes to the understanding of a community or culture</p>		
	<p>Demonstrates or reflects the work or ideas of an architect, builder, artist, designer or theorist who is significant to a community</p>		
<p>Contextual Value</p>	<p>Is important in defining, maintaining or supporting the character of an area</p>	<p>✓</p>	<p>Important in defining the historic character of this section of Colborne Street in the former Village of Cainsville</p>

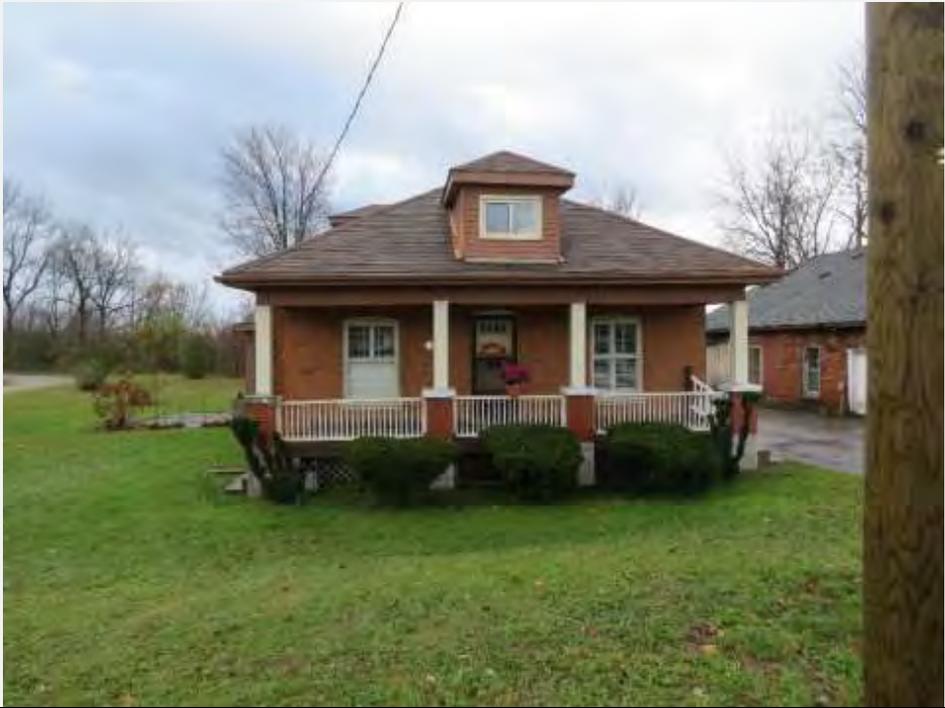
BUILT HERITAGE RESOURCE NO. 2

Description of Property	
Street Address	1057 Colborne Street
Name	n/a
Recognition	None
Location	County of Brant
Type of Property	Residential
Date(s)	After 1875
Description	<ul style="list-style-type: none"> • Example of a vernacular house • Red brick cladding • One-and-a-half-storey three-bay building • Segmentally arched window and door openings with brick voussoirs and stone sills • Hip roof with a dormer in the façade and east elevation • One-storey rear addition • Situated set back the road • Roofline extends over the porch supported by half pillars on brick and cinderblock bases • Foundation hydrostone (it is unclear if the foundation is built of or clad with hydrostone), may be field stone under segmentally arched basement window openings
Photo(s)

Evaluation of Property			
Criteria	Description	✓	Value Statement(s)
Design or Physical Value	Is a rare, unique, representative or early example of a style, type, expression, material or construction method	✓	Representative example of a vernacular residence.
	Displays a high degree of craftsmanship or artistic value

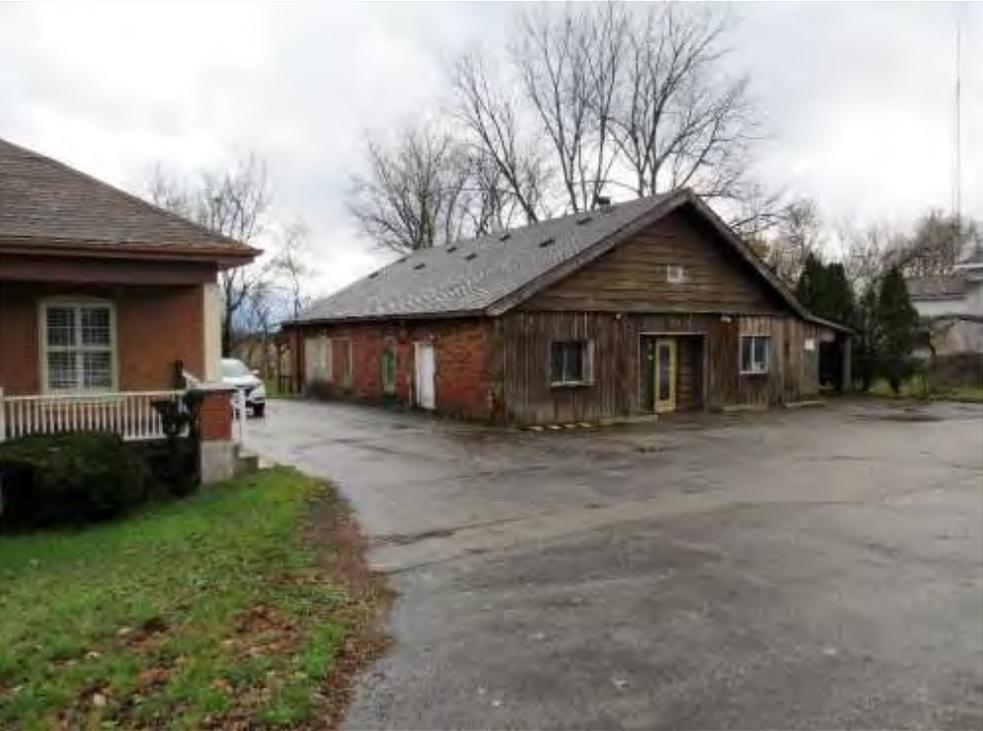
BUILT HERITAGE RESOURCE NO. 3

Description of Property	
Street Address	1053 Colborne Street
Name	n/a
Recognition	None
Location	County of Brant
Type of Property	Residential
Date(s)	After 1875
Description	<ul style="list-style-type: none"> • Vernacular building with three-bay façade • Possible outbuilding associated with 1057 Colborne Street as both structures share the same property parcel • Red brick cladding • Low pitch front gable roof • Clear distinction in types of brick cladding, indicating the rear portion of the building was added later and with wood siding on the façade • Foundation appears to be the same hydrostone (again, unclear if it is clad in or built with hydrostone) as used in the neighbouring 1057 Colborne Street residence
Photo(s)

Evaluation of Property			
Criteria	Description	✓	Value Statement(s)
Design or Physical Value	Is a rare, unique, representative or early example of a style, type, expression, material or construction method	✓	Representative example of a brick clad outbuilding associated with the neighbouring residence.
	Displays a high degree of craftsmanship or artistic value		
	Displays a high degree of technical or scientific achievement		
Historical or Associative	Has direct associations with a theme, event, belief, person, activity, organization or

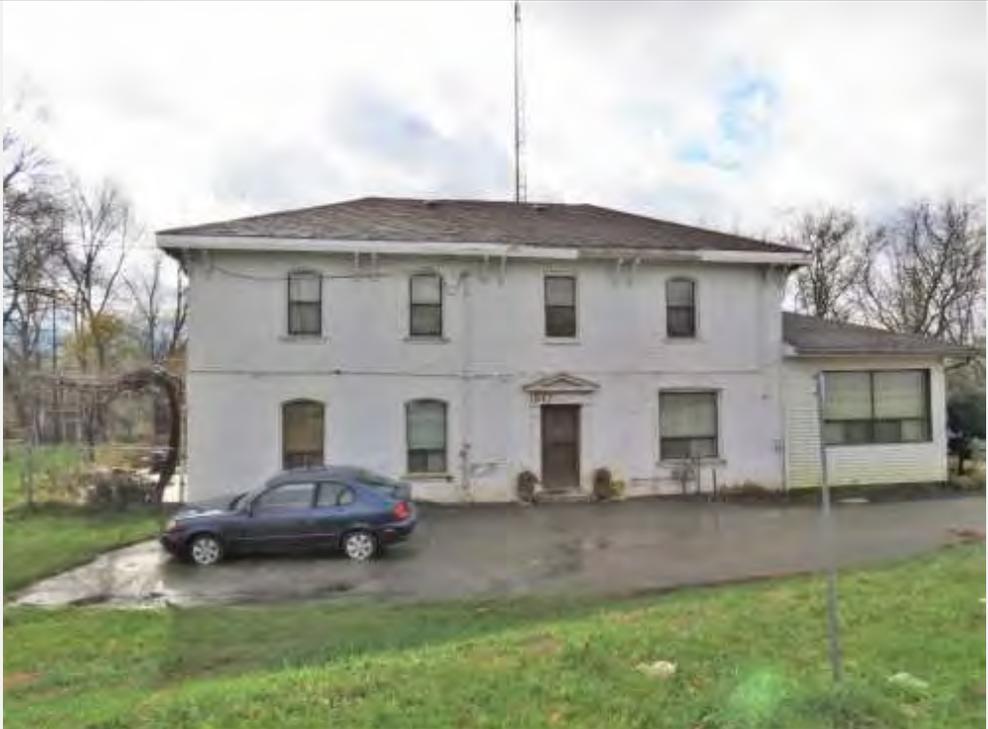
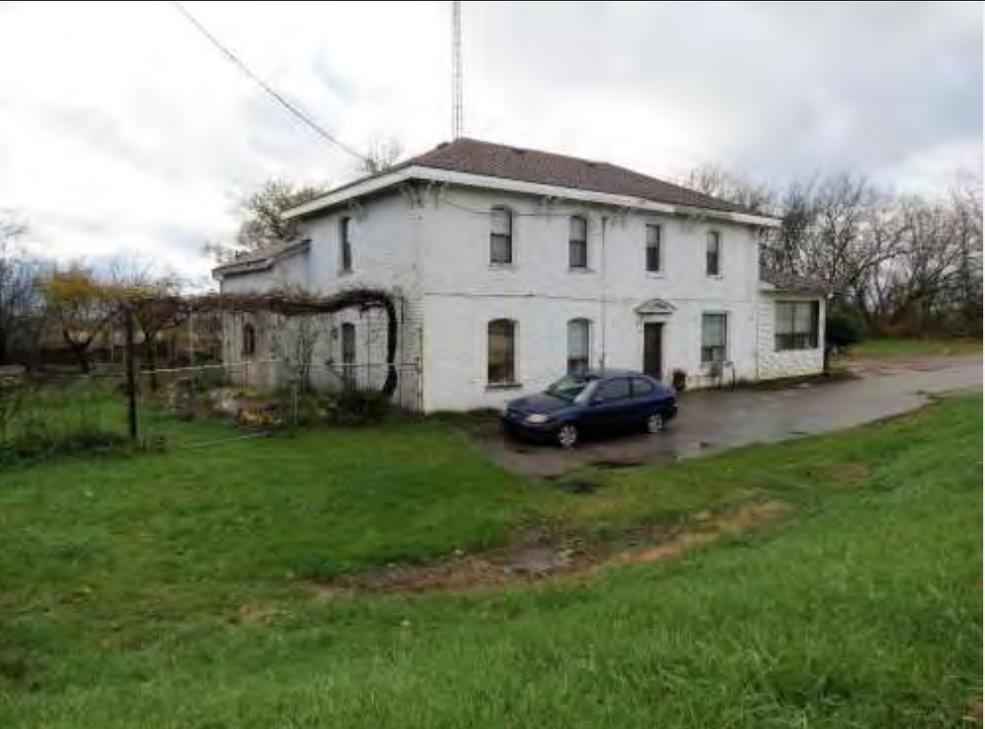
BUILT HERITAGE RESOURCE NO. 4

Description of Property	
Street Address	1047 Colborne Street
Name	n/a
Recognition	None
Location	County of Brant (Cainsville)
Type of Property	Residential
Date(s)	Circa 1872 (CWI n.d.a:7)
Description	<ul style="list-style-type: none"> • Representative example of an Edwardian building • Initially a hotel/tavern • Buff brick (now painted), hip roof with paired decorative brackets • Originally frame, bricked circa 1882 (CWI n.d.a:7) • Brick obtained from Langford, ON (east of Cainsville) (CWI n.d.a:7) • Balanced four-bay façade • Adorned wooden entryway surround with gable pediment and engaged pilasters with geometric decoration • Segmentally arched window openings with wood sills and brick voussoirs, rectangular door opening with rectangular window opening above • Rear one story portion that may have been the summer kitchen • Setback from the road
Photo(s)

Evaluation of Property			
Criteria	Description	✓	Value Statement(s)
Design or Physical Value	Is a rare, unique, representative or early example of a style, type, expression, material or construction method	✓	Representative example of an Edwardian style building.
	Displays a high degree of craftsmanship or artistic value		
	Displays a high degree of technical or scientific achievement		
Historical or	Has direct associations with a theme, event, belief, person, activity, organization or

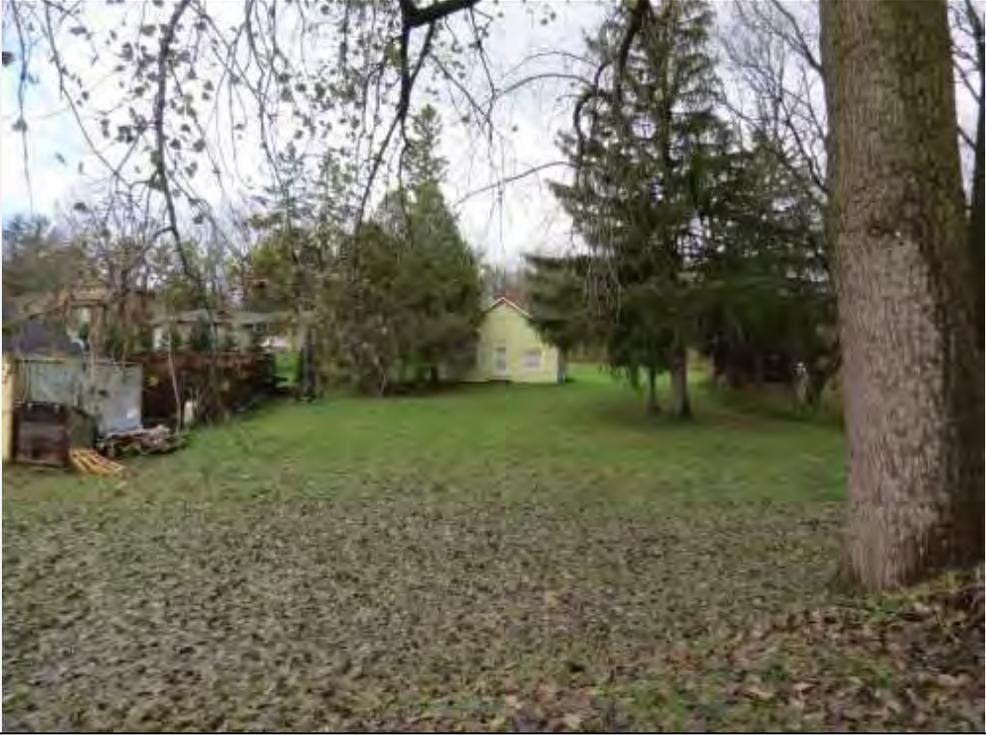
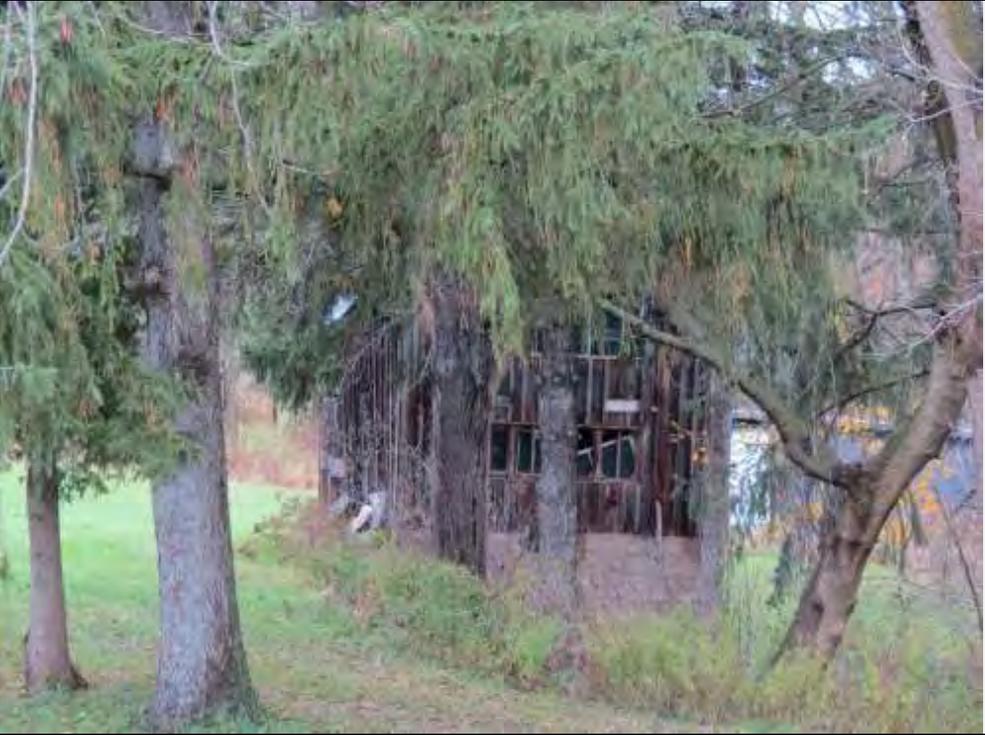
BUILT HERITAGE RESOURCE NO. 5

Description of Property	
Street Address	Beach Road House and Mill (just east of 11 Beach Road)
Name	n/a
Recognition	None
Location	City of Brantford
Type of Property	Residential
Date(s)	Unknown
Description	<ul style="list-style-type: none">• Representative example of a vernacular residence• Front gable roof with rectangular plan• Three bay façade, one storey• Set back a significant distance from the road on a heavily treed• Adjacent mill structure located on the same property to the east of the house<ul style="list-style-type: none">○ Wood cladding○ Two storeys○ Rectangular plan○ Stone foundation that is built down to the ravine○ Obscured by trees
Photo(s)

Evaluation of Property			
Criteria	Description	✓	Value Statement(s)
Design or Physical Value	Is a rare, unique, representative or early example of a style, type, expression, material or construction method	✓	Representative example of a one-storey vernacular residence and two-storey vernacular mill structure.
	Displays a high degree of craftsmanship or artistic value	✓	
	Displays a high degree of technical or scientific achievement		
Historical or Associative Value	Has direct associations with a theme, event, belief, person, activity, organization or institution that is significant to a community		
	Yields or has the potential to yield information that contributes to the understanding of a community or culture		
	Demonstrates or reflects the work or ideas of an architect, builder, artist, designer or theorist who is significant to a community		
Contextual Value	Is important in defining, maintaining or supporting the character of an area

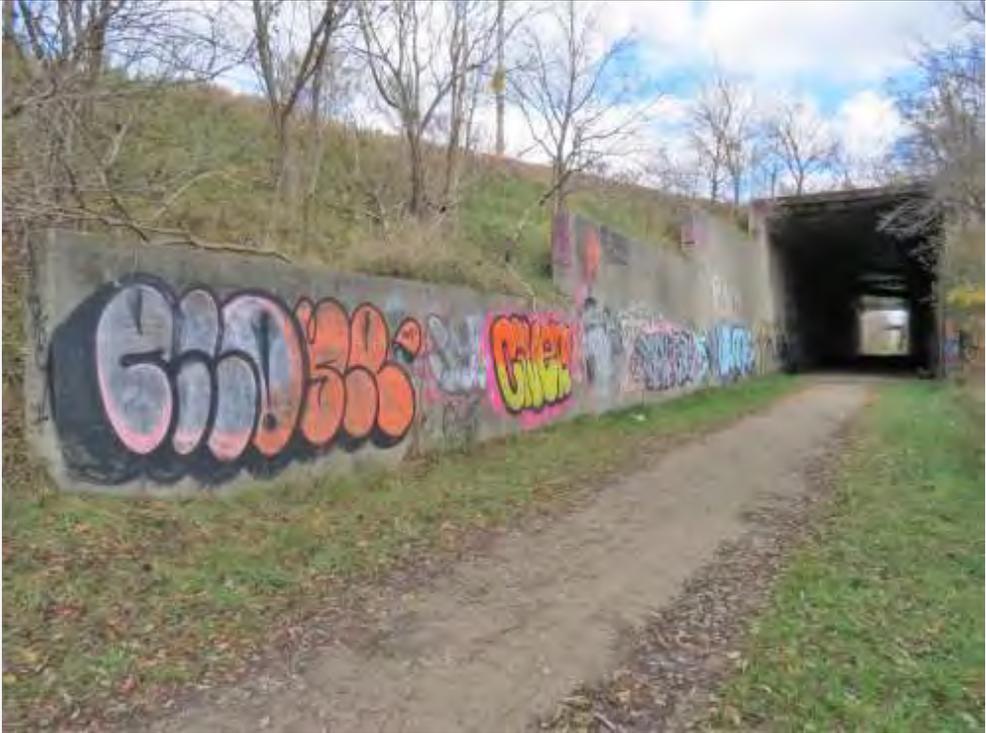
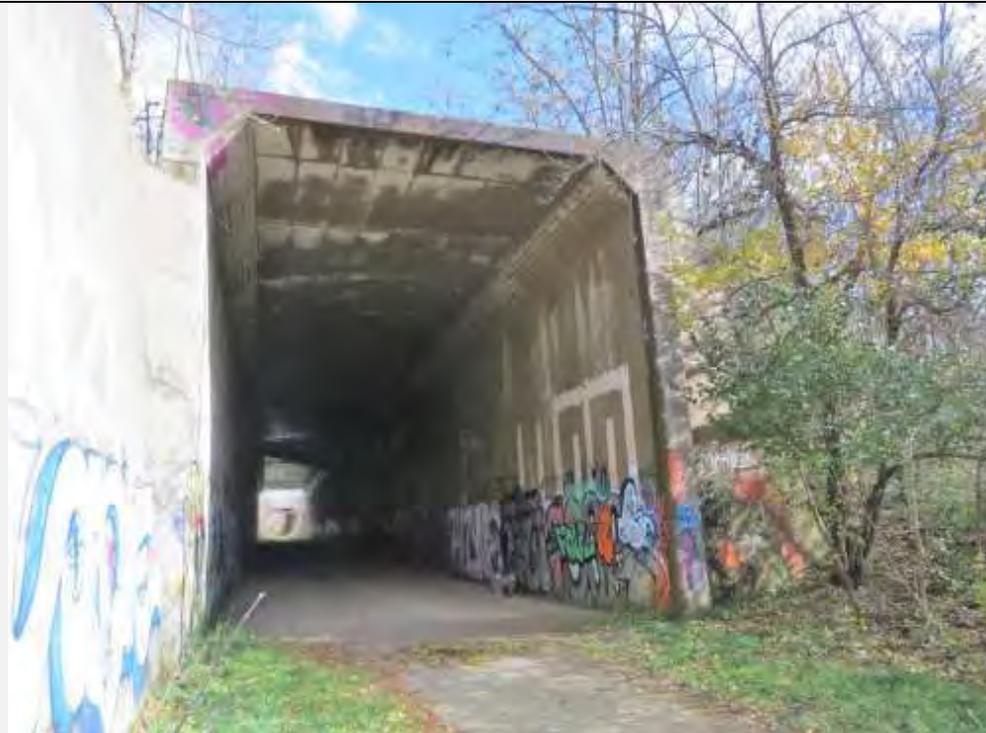
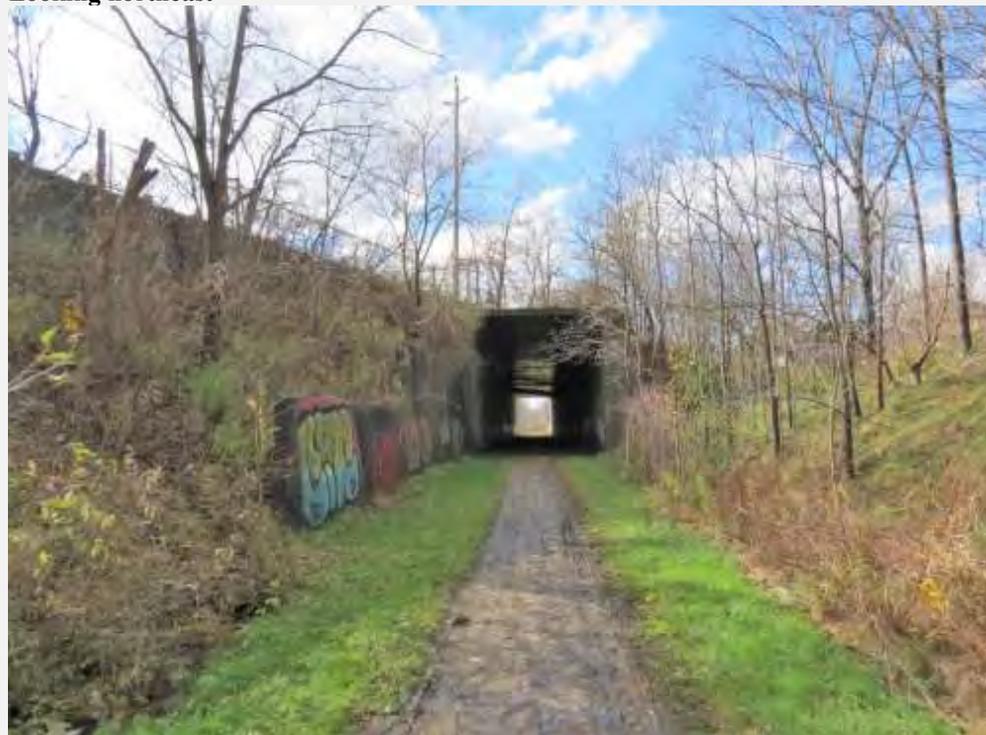
BUILT HERITAGE RESOURCE NO. 6

Description of Property	
Street Address	Colborne Street
Name	Colborne Street Pedestrian Underpass
Recognition	None
Location	Underpass at the TransCanada Trail under Colborne Street at Johnson Road
Type of Property	Underpass tunnel
Date(s)	1957
Description	<ul style="list-style-type: none"> • Built in 1957 in anticipation of the construction of the Hamilton to Brantford section of Hwy 403 to accommodate and allow for more traffic as a result of the planned interchange • Was constructed to allow for the rail traffic to continue under the Colborne Street ROW • Current concrete structure was constructed in the location of the former wooden bridge
Photo(s)

Evaluation of Property			
Criteria	Description	✓	Value Statement(s)
Design or Physical Value	Is a rare, unique, representative or early example of a style, type, expression, material or construction method		
	Displays a high degree of craftsmanship or artistic value		
	Displays a high degree of technical or scientific achievement		
Historical or Associative Value	Has direct associations with a theme, event, belief, person, activity, organization or institution that is significant to a community		
	Yields or has the potential to yield information that contributes to the understanding of a community or culture		
	Demonstrates or reflects the work or ideas of an architect, builder, artist, designer or theorist who is significant to a community		
Contextual	Is important in defining, maintaining or

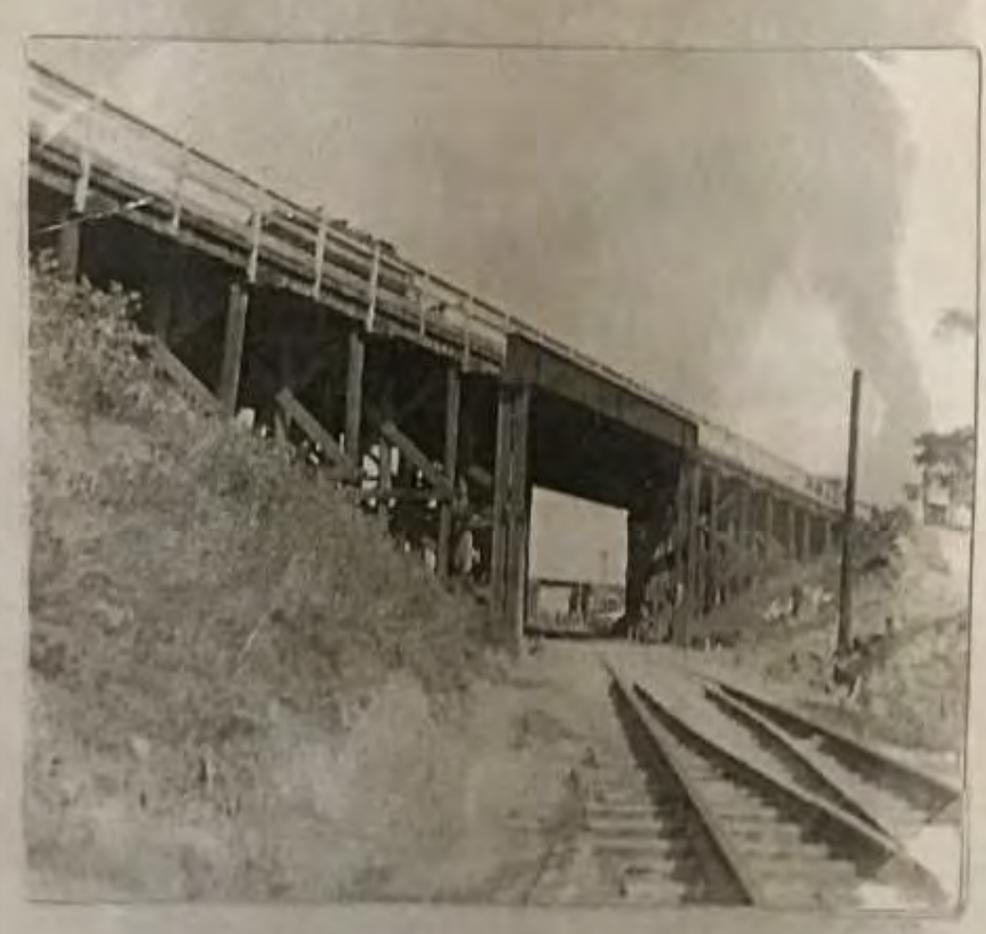
<p>Former Colborne St. bridge before 1957 improvement (1956)</p>
<p>Date of Historic Photo(s)</p>	<p>1956; 1957 (CWI n.d.a:171, 173)</p>
