City of Brantford

**Colborne Street East - Slope Stabilization
Municipal Class Environmental Assessment
September 2020**

Project Number: 1824

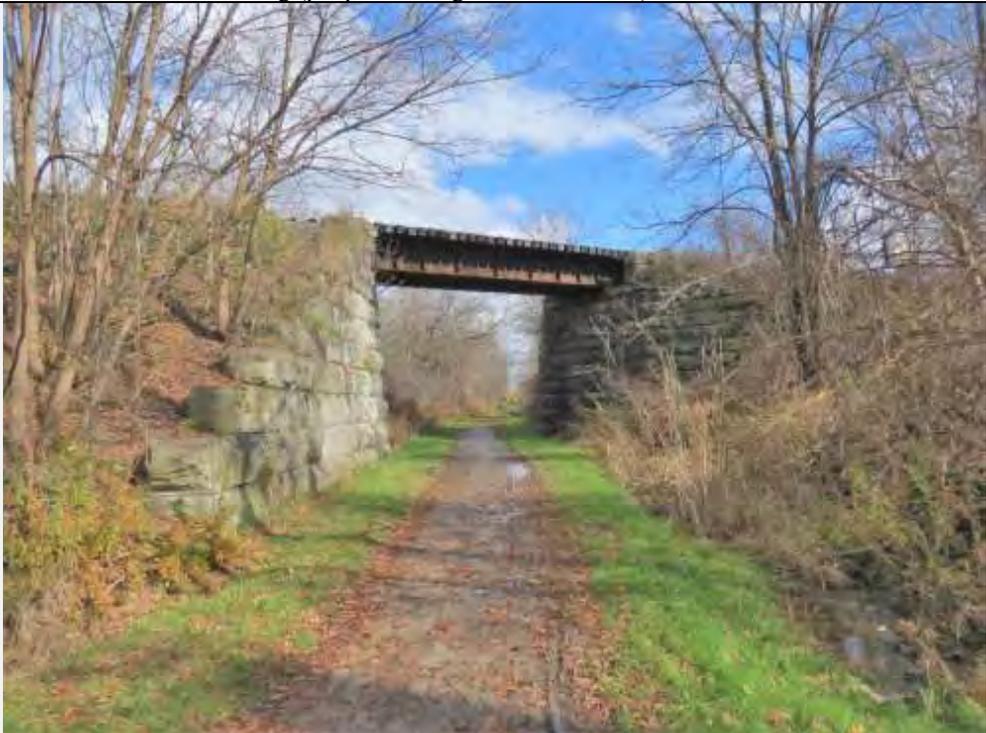
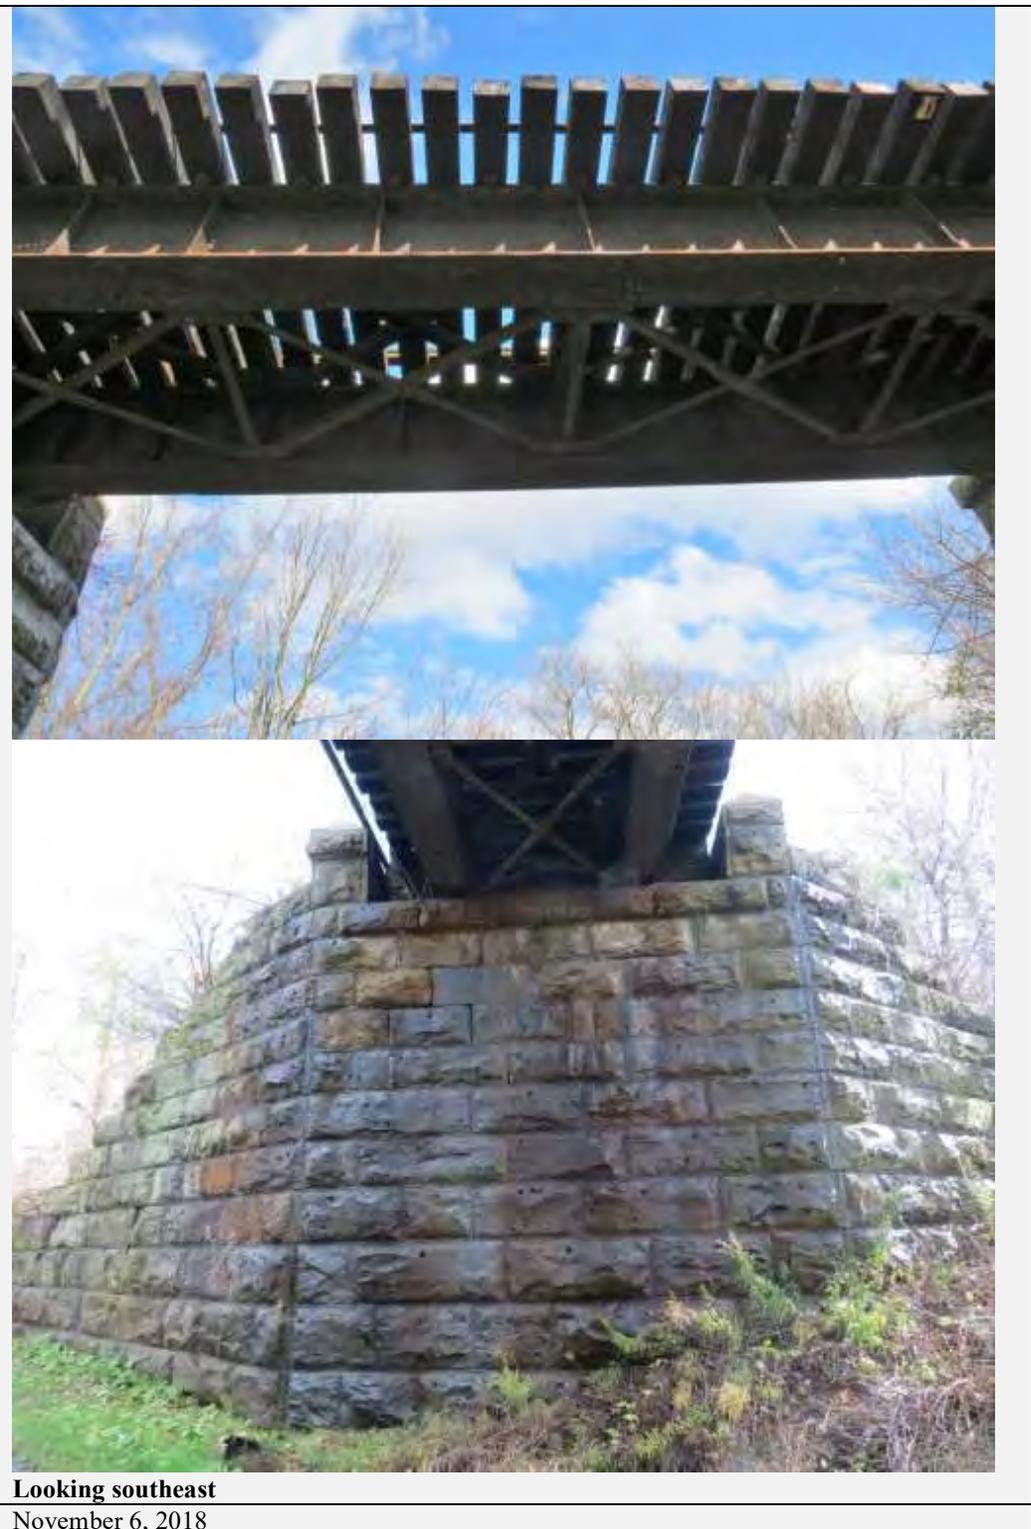
BUILT HERITAGE RESOURCE NO. 7

Description of Property	
Street Address	Colborne Street Rail Bridge
Name	n/a
Recognition	None
Location	Railway bridge over the TransCanada Trail
Type of Property	Bridge
Date(s)	Circa 1908 (Mills 2010)
Description	<ul style="list-style-type: none"> • Early example of a rail bridge with square cut rough cast limestone abutments • Decorative capstones at railway level on either side of the track on both abutments • Rail bridge for the former Brantford and Hamilton Electric Railway, now the Buffalo and Lake Huron Railway which allowed the passage of below rail traffic of the former Toronto, Hamilton & Buffalo Railway • Former location of a plaque commemorating the early black Canadian settlement at Bunnell's Landing (plaque missing since circa 2015)
Photo(s)

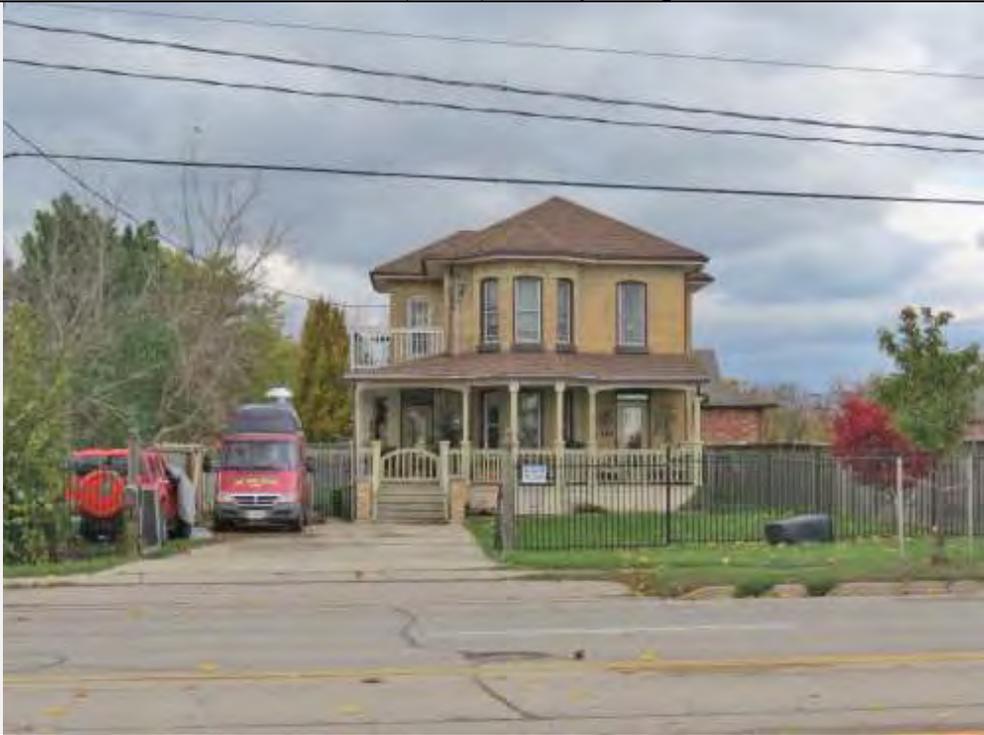
BUILT HERITAGE RESOURCE NO. 9

Description of Property	
Street Address	1036 Colborne Street
Name	n/a
Recognition	City of Brantford Heritage Inventory
Location	City of Brantford
Type of Property	Residential
Date(s)	1900 (City of Brantford Heritage Inventory); 1889 (CWI n.d.b.:33)
Description	<ul style="list-style-type: none"> • Good example of a residence constructed in the Queen Anne Style • Two-storey rectangular plan with a hip roof • Two-storey bay window on the façade flanked by entryways with a shed roof covered porch • Buff brick • Segmentally arched window openings with brick voussoirs • Rectangular first storey entryway door openings with large rectangular transom windows • Hip roofed projections from each side elevation • One-storey rear addition • Functioned as the Methodist (United) Church parsonage until 1956
Photo(s)

Evaluation of Property			
Criteria	Description	✓	Value Statement(s)
<p>Design or Physical Value</p>	<p>Is a rare, unique, representative or early example of a style, type, expression, material or construction method</p>	<p>✓</p>	<p>Representative example of a Queen Anne style residence.</p>
	<p>Displays a high degree of craftsmanship or artistic value</p>		
	<p>Displays a high degree of technical or scientific achievement</p>		
<p>Historical or Associative Value</p>	<p>Has direct associations with a theme, event, belief, person, activity, organization or institution that is significant to a community</p>		
	<p>Yields or has the potential to yield information that contributes to the understanding of a community or culture</p>		
	<p>Demonstrates or reflects the work or ideas of an architect, builder, artist, designer or theorist who is significant to a community</p>		
<p>Contextual Value</p>	<p>Is important in defining, maintaining or supporting the character of an area</p>	<p>✓</p>	<p>Important in defining the historic character of this section of Colborne Street in the former Village of Cainsville.</p>

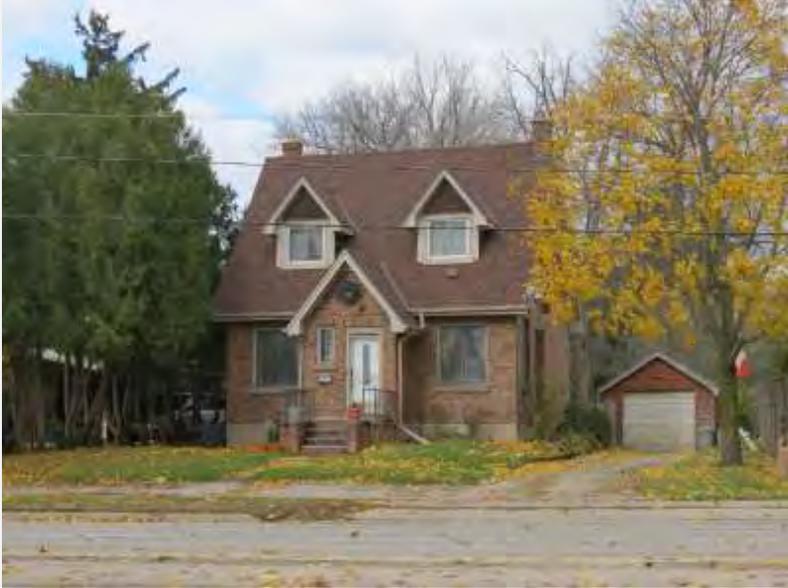
BUILT HERITAGE RESOURCE NO. 10

Description of Property	
Street Address	1024 Colborne Street
Name	n/a
Recognition	None
Location	City of Brantford
Type of Property	Residential
Date(s)	Unknown
Description	<ul style="list-style-type: none"> • Example of a vernacular house with Tudor Revival elements • Tri-colour brick cladding • One-and-a-half-storey three-bay building • Rectangular plan • Side gable roof with two symmetrically placed gable dormers • Rectangular window and door openings with brick voussoirs • Two brick chimneys at each gable end
Photo(s)

Evaluation of Property			
Criteria	Description	✓	Value Statement(s)
Design or Physical Value	Is a rare, unique, representative or early example of a style, type, expression, material or construction method	✓	Representative example of a Tudor Revival style house
	Displays a high degree of craftsmanship or artistic value		
	Displays a high degree of technical or scientific achievement		
Historical or Associative Value	Has direct associations with a theme, event, belief, person, activity, organization or institution that is significant to a community		
	Yields or has the potential to yield information that contributes to the understanding of a community or

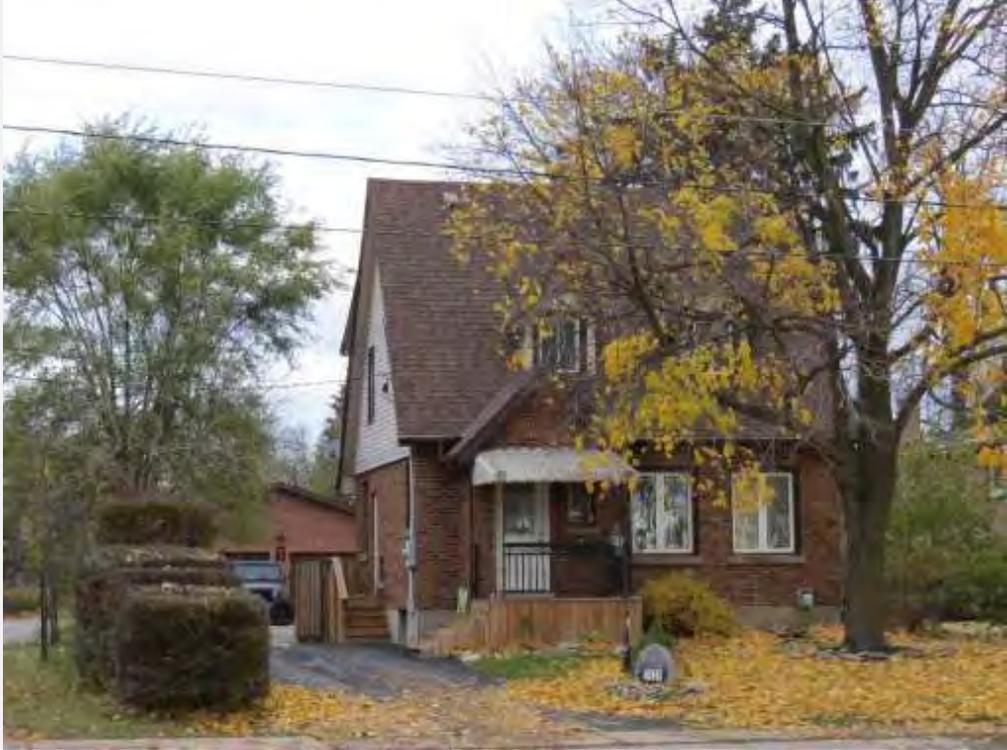
BUILT HERITAGE RESOURCE NO. 11

Description of Property	
Street Address	1020 Colborne Street
Name	n/a
Recognition	None
Location	City of Brantford
Type of Property	Residential
Date(s)	Unknown
Description	<ul style="list-style-type: none"> • Example of a Tudor Revival style house • Tri-colour brick cladding • One-and-a-half-storey three-bay building • Rectangular plan • Side gable roof with two symmetrically placed gable dormers • Rectangular window and door openings with brick voussoirs • Offset gable projection entryway
Photo(s)

Evaluation of Property			
Criteria	Description	✓	Value Statement(s)
Design or Physical Value	Is a rare, unique, representative or early example of a style, type, expression, material or construction method	✓	Representative example of a Tudor Revival style house.
	Displays a high degree of craftsmanship or artistic value		
	Displays a high degree of technical or scientific achievement		
Historical or Associative	Has direct associations with a theme, event, belief, person, activity,

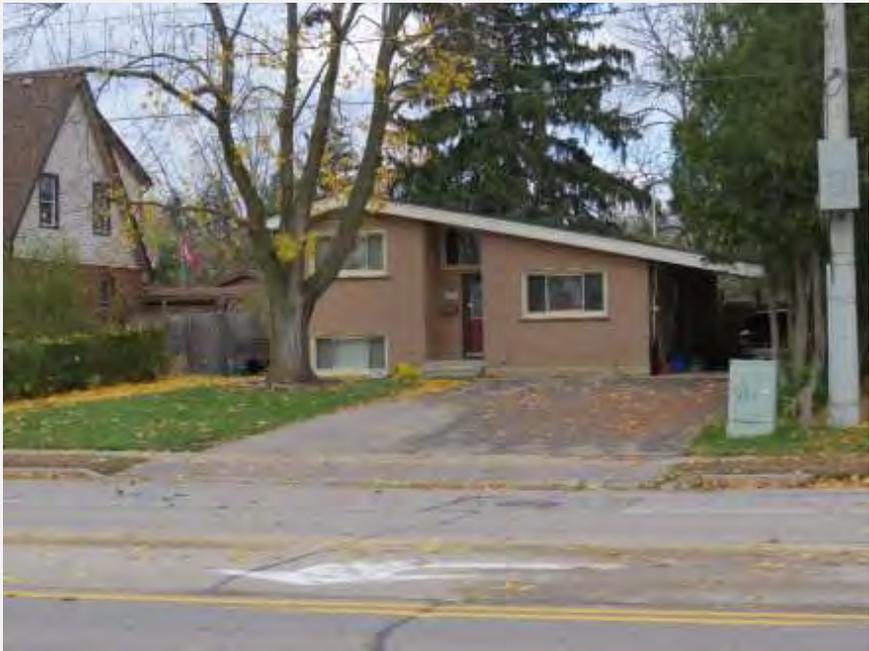
BUILT HERITAGE RESOURCE NO. 12

Description of Property	
Street Address	1022 Colborne Street
Name	n/a
Recognition	None
Location	City of Brantford
Type of Property	Residential
Date(s)	Unknown
Description	<ul style="list-style-type: none"> • Example of a Mid-Century Modern style house • Beige brick cladding • One-and-a-half-storey • Rectangular plan • Car port • Asymmetrical front gable roof • Rectangular window and door openings • Large irregular window above entryway
Photo(s)

Evaluation of Property			
Criteria	Description	✓	Value Statement(s)
Design Physical Value	Is a rare, unique, representative or early example of a style, type, expression, material or construction method	✓	Representative example of a Mid-Century Modern style house.
	Displays a high degree of craftsmanship or artistic value		
	Displays a high degree of technical or scientific achievement		
Historical Associative Value	Has direct associations with a theme, event, belief, person, activity, organization or institution that is significant to a community

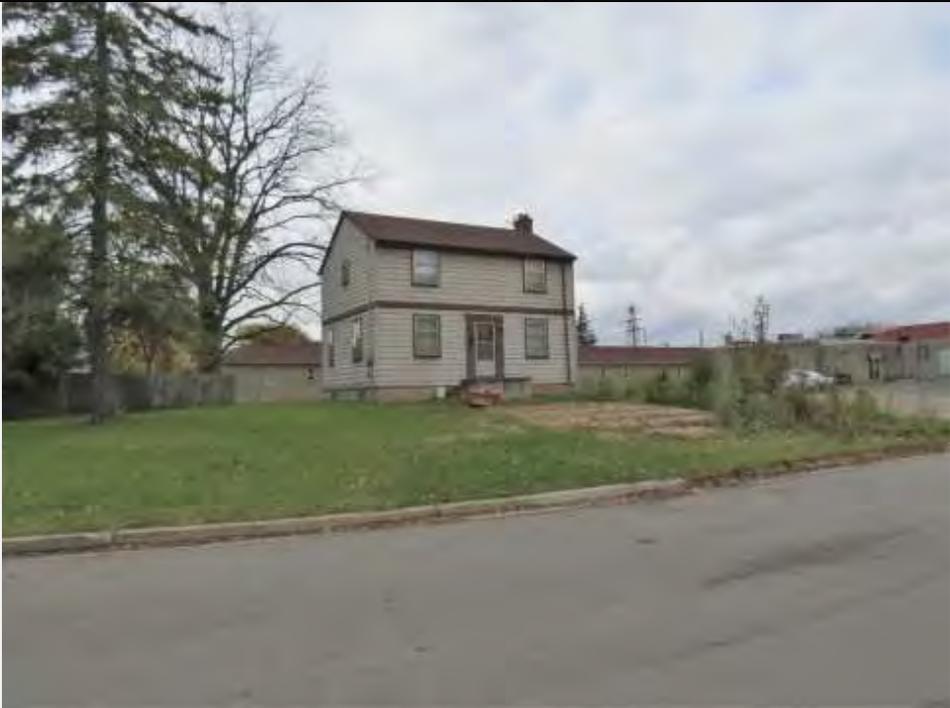
BUILT HERITAGE RESOURCE NO. 13

Description of Property	
Street Address	29 Clara Crescent
Name	n/a
Recognition	None
Location	City of Brantford
Type of Property	Residential
Date(s)	Unknown
Description	<ul style="list-style-type: none"> • Two-storey vernacular house • Rectangular plan • Symmetrical façade • Side gable roof • Centrally placed entryway • Rectangular window openings • Set back from the road on a rise in topography
Photo(s)

Evaluation of Property			
Criteria	Description	✓	Value Statement(s)
Design or Physical Value	Is a rare, unique, representative or early example of a style, type, expression, material or construction method	✓	Representative example of a two-storey vernacular house with a rectangular plan.
	Displays a high degree of craftsmanship or artistic value		
	Displays a high degree of technical or scientific achievement		
Historical or Associative Value	Has direct associations with a theme, event, belief, person, activity, organization or institution that is

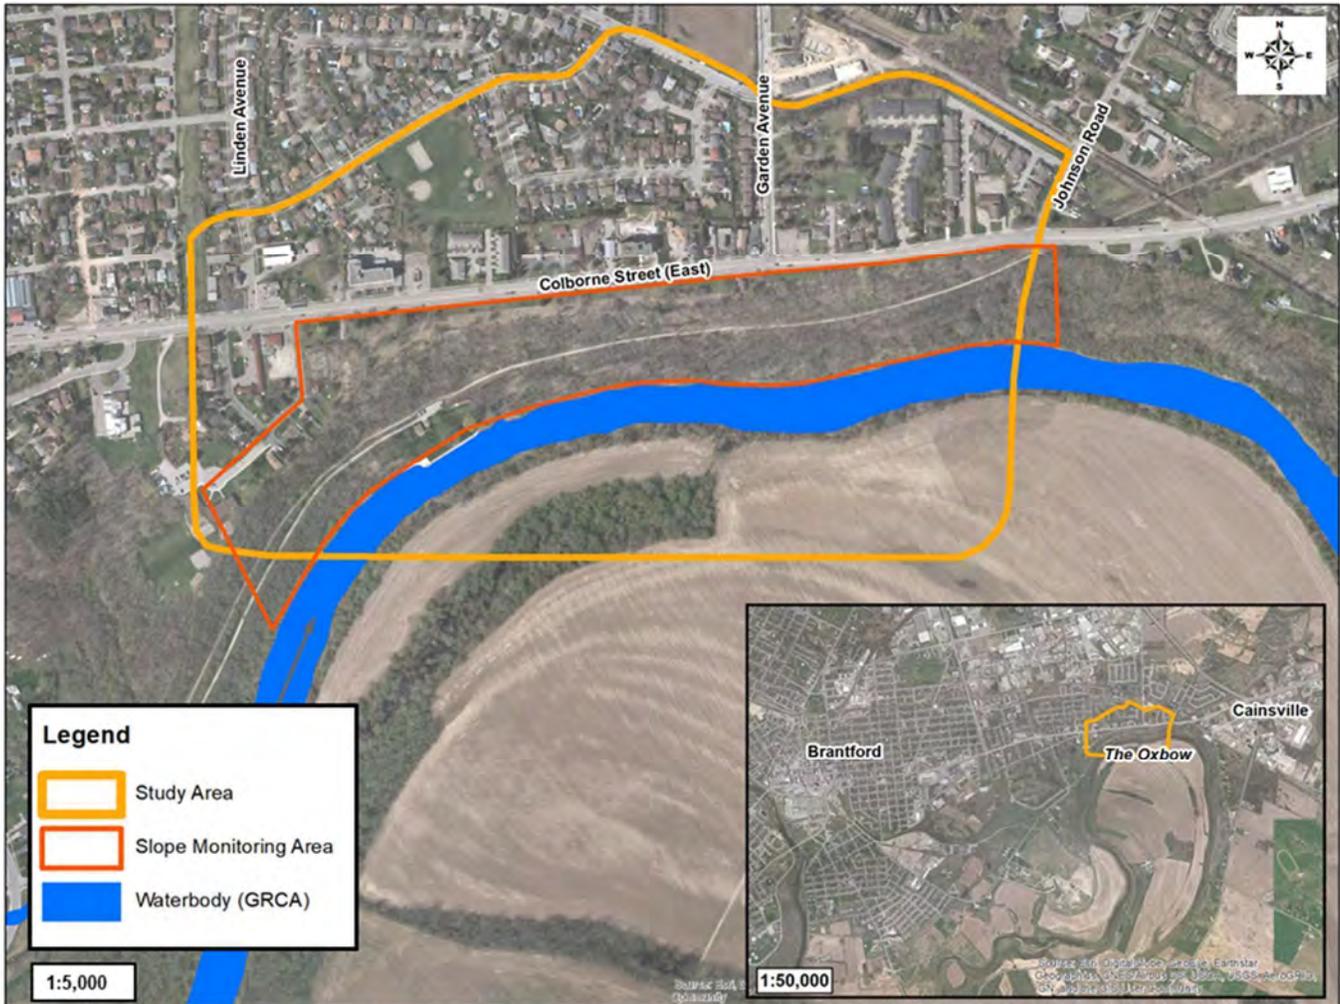
Figure 1. Project Location and Study Area

The overall study area is shown in **Figure 1**; any potential rehabilitation work would likely be limited to the area shown as the ‘Slope Monitoring Area’, depending on the alternative solution selected through the EA process.

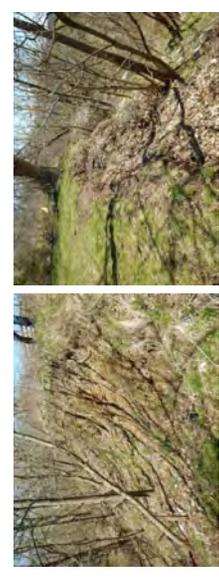
Slope monitoring in 2016, unstable slope evidence (left) and slumping near property line (right)

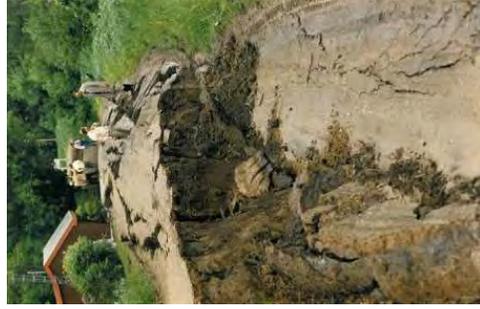
Beach Road after 1986 landslide

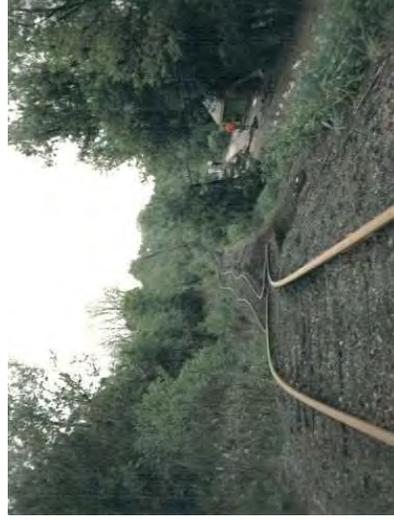
Railway along Beach Road after 1986 landslide

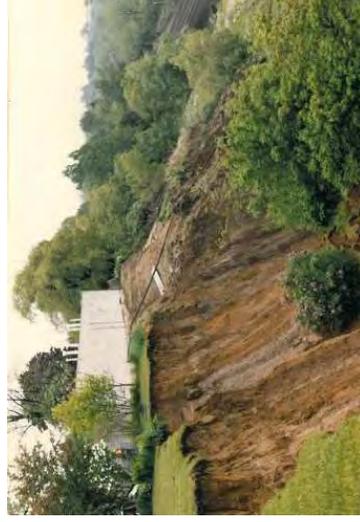
929 Colborne Street (East) after 1986 landslide

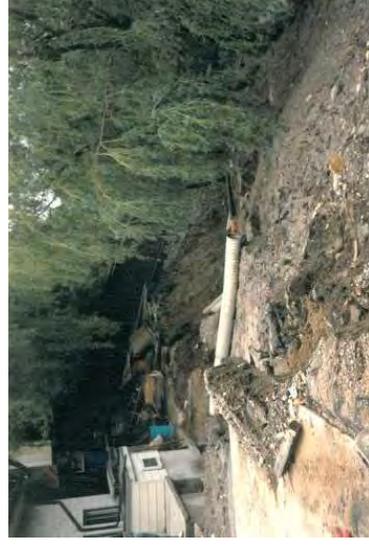
951 Colborne Street (East) after 1986 landslide

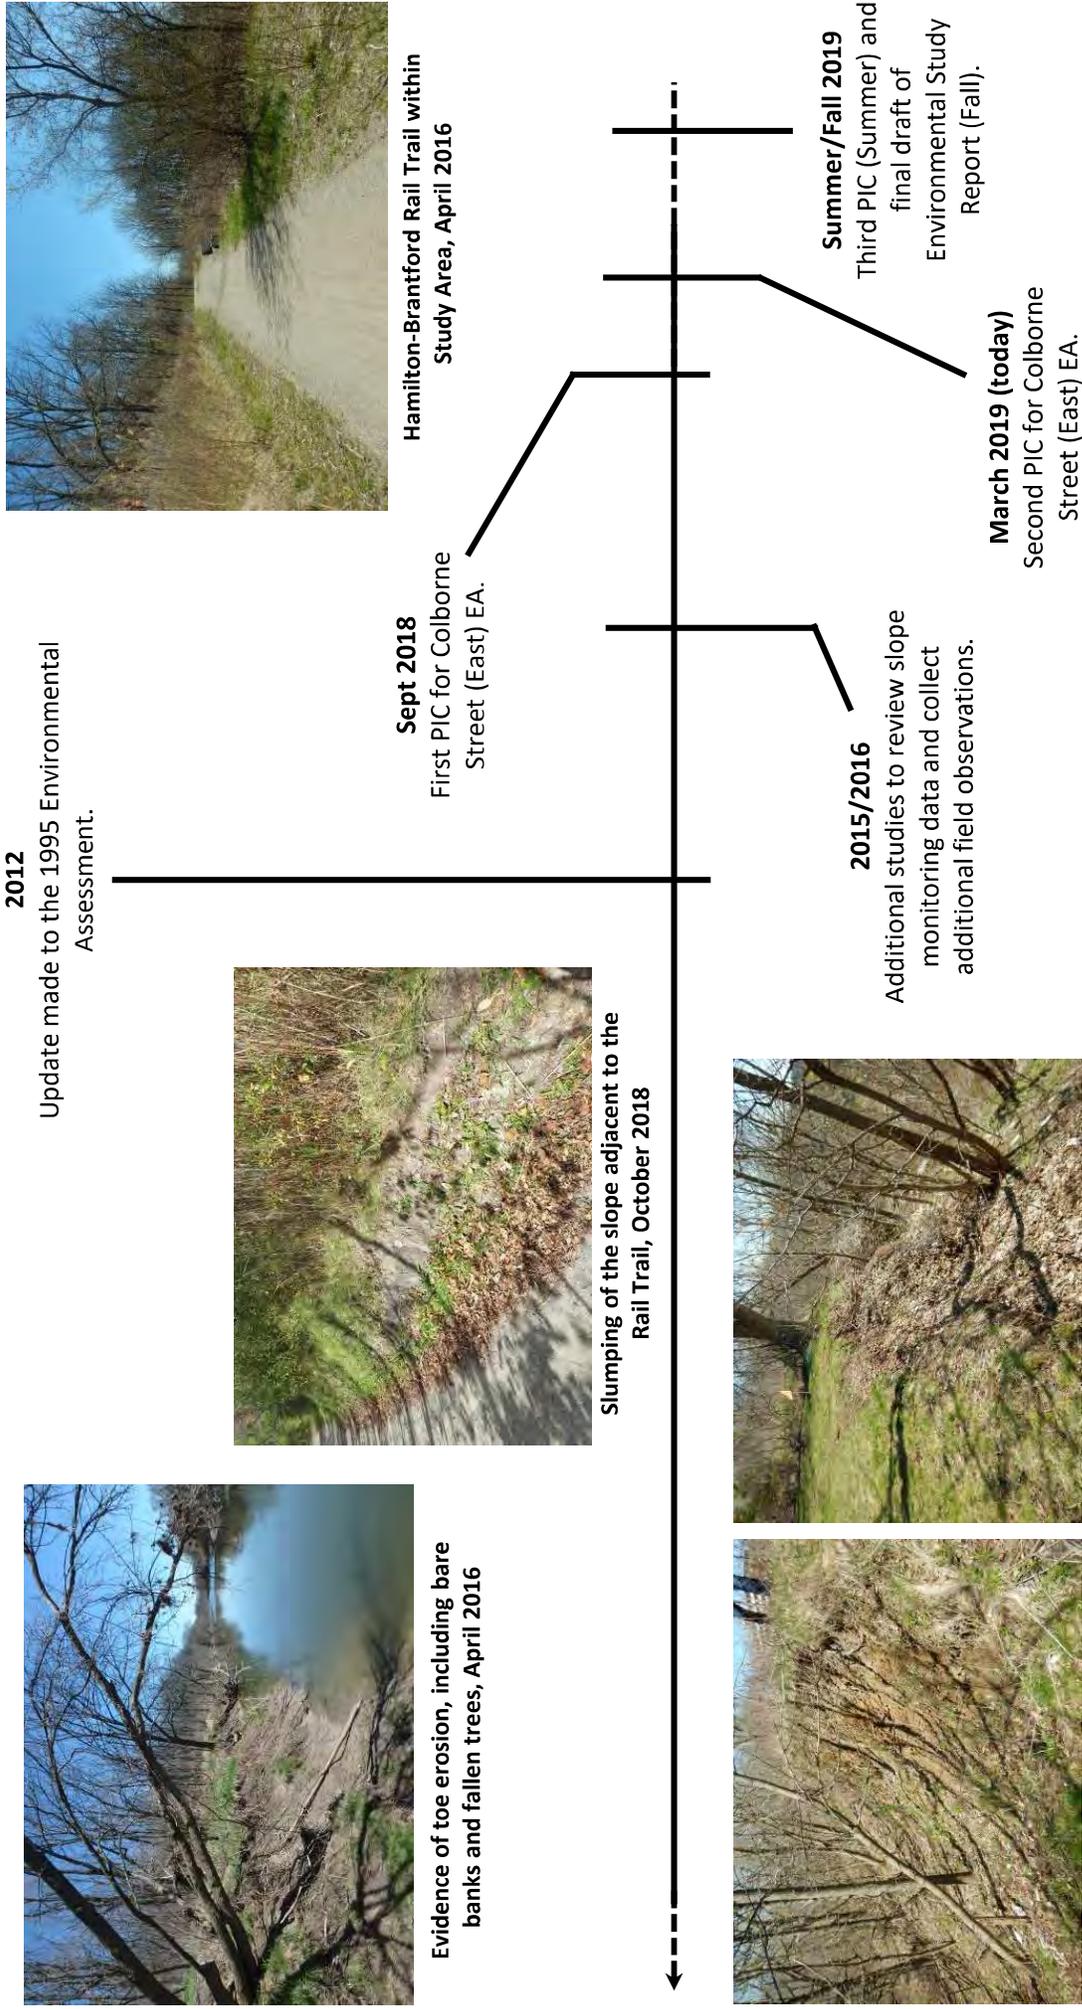
Evidence of toe erosion, including bare banks and fallen trees, April 2016

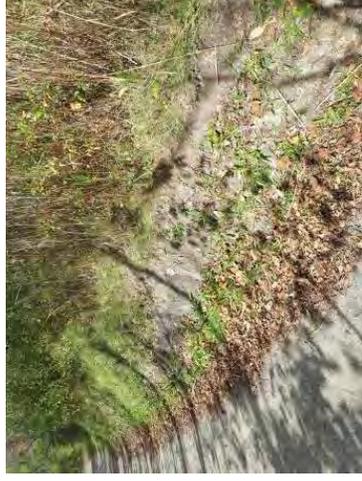
Slumping of the slope adjacent to the Rail Trail, October 2018

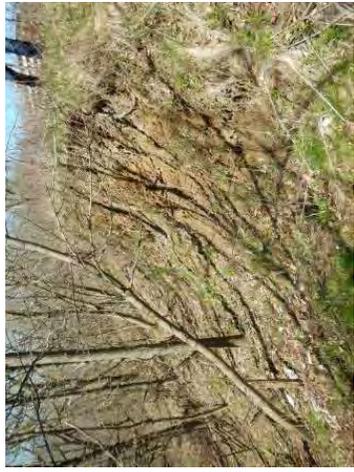
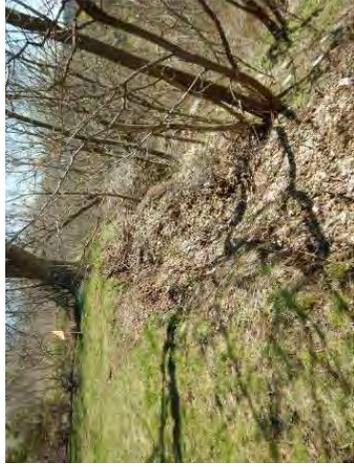
Slope monitoring in 2016, unstable slope evidence (left) and slumping near property line (right)

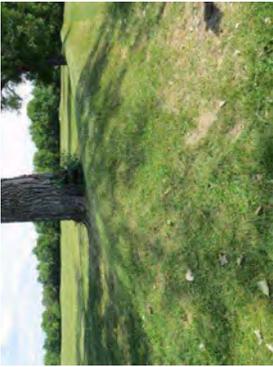
<p>Berm</p>

<p>Berm to manage and redirect overland flows. Could be used at the top of slope to minimize runoff onto the slope.</p>	<p>Flexible Piping</p>

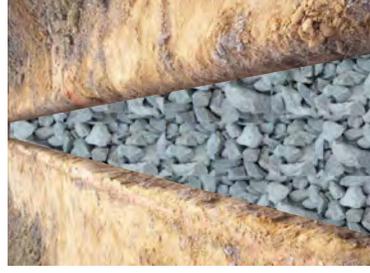
<p>Series of rock drainage features on the lower slope to reduce soil moisture. Would be required to support mechanical stabilization.</p>
<p>Trail Culverts</p>

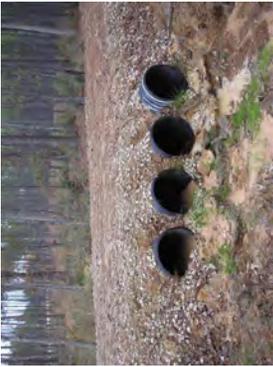
<p>Culverts installed at locations along the trail to drain pooled water along the trail. Would reduce soil moisture on the slope.</p>	<p>Interceptor Trench</p>

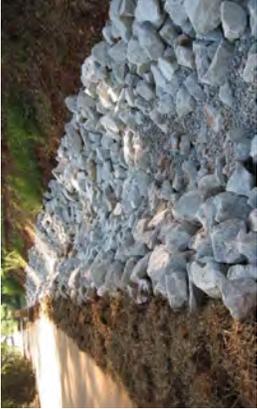
<p>Interceptor Trench to collect and drain near-surface water at the top of slope and at the trail.</p>
