City of Brantford

Three Grand River Crossings Schedule 'C' Municipal Class Environmental Assessment

Environmental Study Report

GMBP File: 119104 January 2023

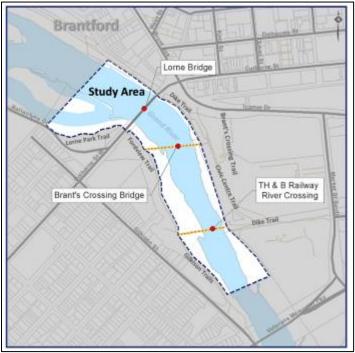
Figure 1-1: Study Area

The study encompasses an area along the Grand River approximately 175 metres wide, starting 200 metres north of Lorne Bridge to 200 metres south of the TH&B Crossing Bridge. Refer to **Figure 1-1** for a location plan of the Study Area.

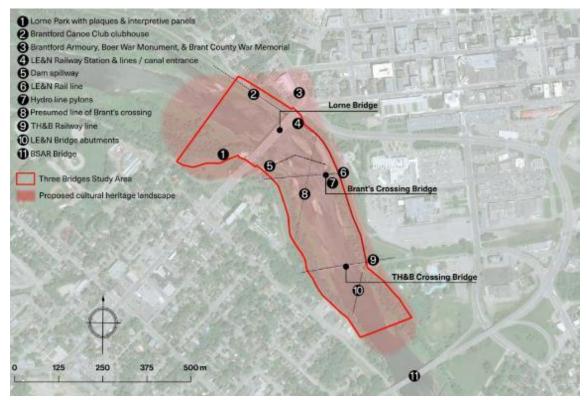
Figure 5-1: Proposed Brantford Crossings cultural heritage landscape

Figure 5-1 below shows the proposed boundaries of the potential cultural heritage landscape, referred to as "Brantford Crossings", in relation to the study area of this Environmental Assessment.

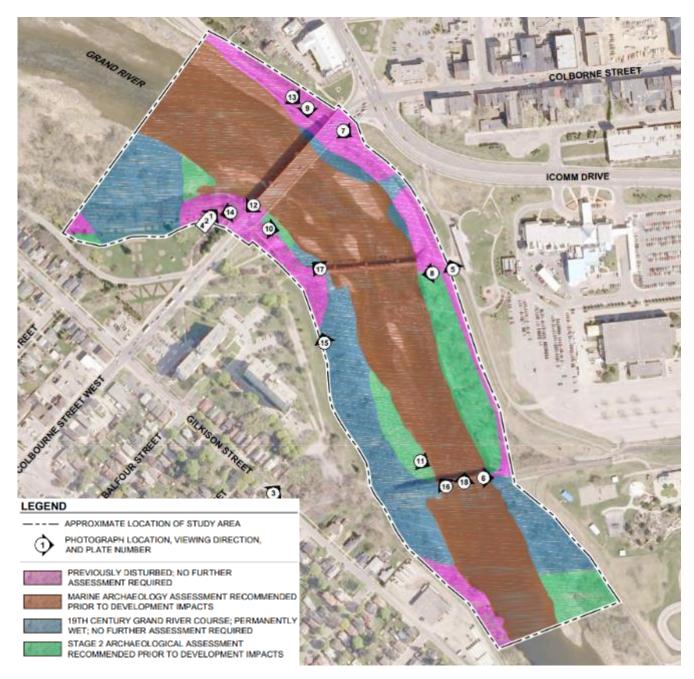
Figure 5-2: Results of Property Inspection (Source: Golder Associated Ltd., Stage 1 Archeological Assessment, Map 18)

- The remainder of the Study Area does not possess archaeological potential due to disturbance from previous construction or did not exist due to permanently wet conditions until the late 19th century. These areas do not require further assessment. Refer to the blue and pink shaded area as shown in **Figure 5-2** below.

Recommendations from the Stage 1 Archaeological Assessment report include the requirement for a Stage 2 Archaeological Assessment for any part of the Study Area exhibiting archaeological potential that could be impacted by the selected preferred solution.

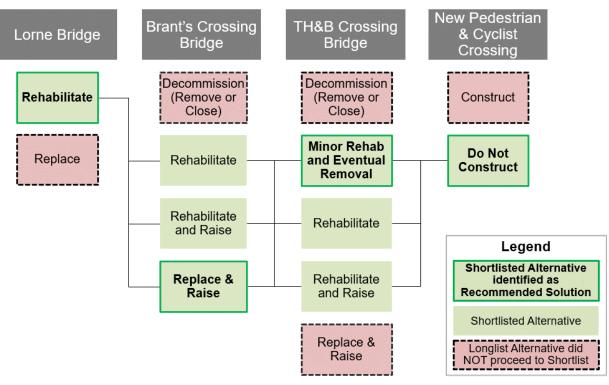
Figure 6-1: Summary of Shortlisted Individual Crossing Alternatives

Refer to **Figure 6-1** below for a summary of an overview of individual crossing alternatives, including which alternatives were shortlisted to be evaluated as part of the Overall Crossing Strategy.

The shortlisted alternatives were combined into a list of Overall Crossing Strategies for the Study Area. Each Overall Crossing Strategy consists of an alternative solution for the Lorne Bridge, Brant's Crossing Bridge and TH&B Crossing Bridge. Prior to the evaluation of the Overall Crossing Strategies, each strategy was screened to determine if it was feasible.

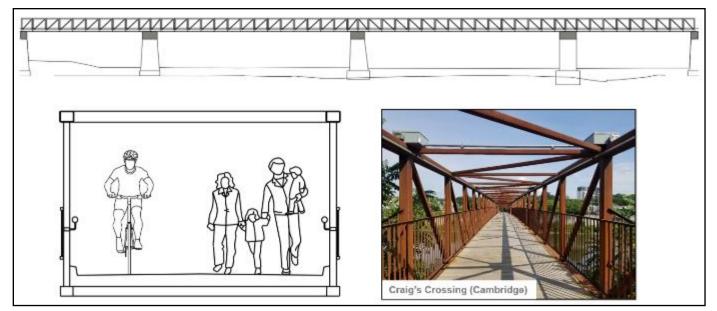
Figure 8-1: Representation of Through Truss Spans for all Spans

Through trusses for all four spans would have a similar appearance to the version of the structure that was present prior to 1913, which consisted of three through truss spans. Refer to **Figure 8-1** for an elevation view representation of a through truss for all four spans, as well as a section of a typical through truss, and a photograph of Craig's Crossing Bridge in Cambridge which is an example of a through truss. With pony trusses at the end spans the new superstructure would have a similar profile to the existing superstructure, with shorter end spans and taller spans in the middle. Pony truss spans also provide the opportunity to view above the sides of the trusses, similar to the existing girder spans. Refer to **Figure 8-2** for an elevation view representation of pony truss spans at the end spans, as well as a section of a typical pony truss, and a photograph of the Homer Watson Boulevard Bridge in Waterloo, which is an example of a pony truss.

The recommended solution for the Brant's Crossing Bridge accounts for replacing the existing steel superstructure and rehabilitating the concrete substructure. To mitigate the negative impact of removing the heritage superstructure, the existing through truss spans will be replaced with new prefabricated through trusses. The existing girder spans adjacent to the embankments could also be replaced with a through truss, or a pony truss. The main difference between through trusses and pony trusses is that a through truss has steel components overhead, where as a pony truss does not.
