Prepared for:
City of Brantford

North Brantford and Tutela Heights Subwatershed Study Update

Phase 1 Update Report

Prepared by:
Aquafor Beech Ltd.

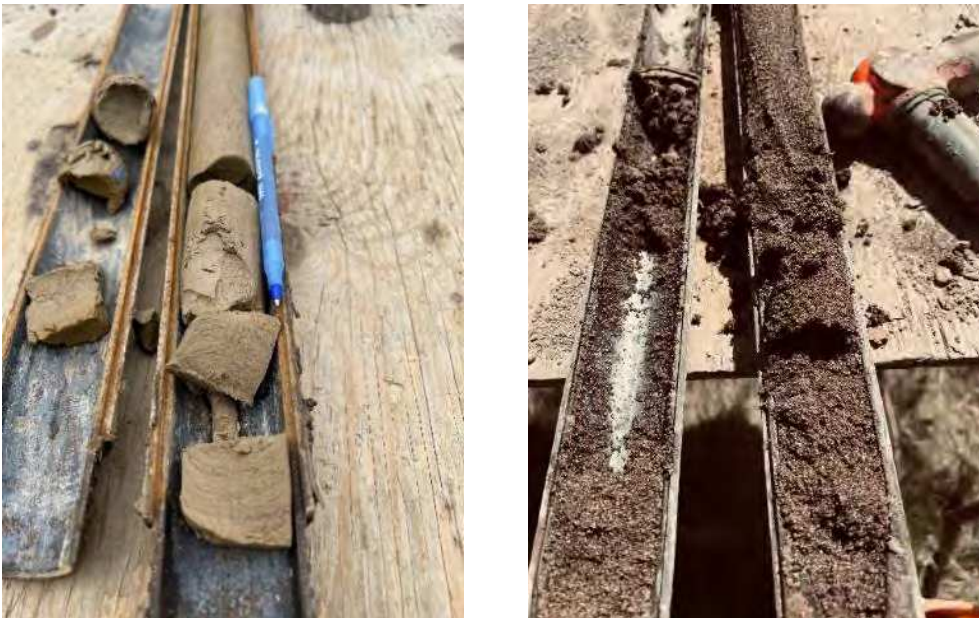
Figure 3.20: Fractures in silt/silt clay matrix filled with fine sand at MW-1 (left) and coarse sand encountered at MW2-D (right).

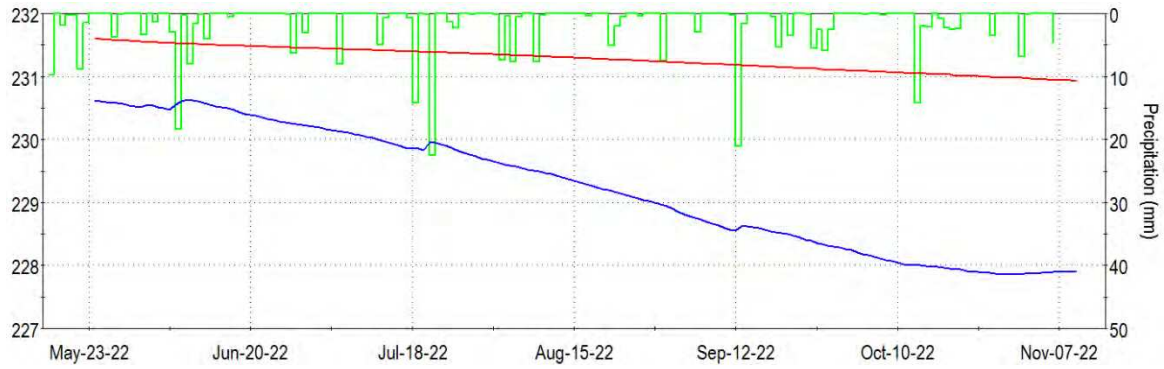
Figure 3.21: Observed groundwater levels at MW1-S (blue) and MW1-D (red) along with CASPAR rainfall data (green) for the same period.

Figure 3.21 presents the observed groundwater groundwater levels at MW1-S and MW1-D, located in the western part of North Brantford for May to November 2022. Earthfx also obtained and processed the Canadian Surface Prediction Archive (CaSPAr) rainfall data for the same period. The Canada Precipitation Analysis data set (CaPA_fine) contains hourly precipitation data interpolated to a 2.5 km grid. The data were summed to create a daily coverage that starts on March 3, 2018. The data set is extremely useful because there are few remaining operational Environment Canada rainfall gauges in proximity to the study area. The CaSPAr data are presented with an inverted scale on the secondary y-axis of the hydrograph. The hydrograph shows that groundwater levels are higher at depth within the formation and that the shallow well responds, although in a subdued manner, to larger rainfall events while the deeper well does not. Both wells show the prolonged decline (recession) in water levels during the summer and a small recovery in the fall.

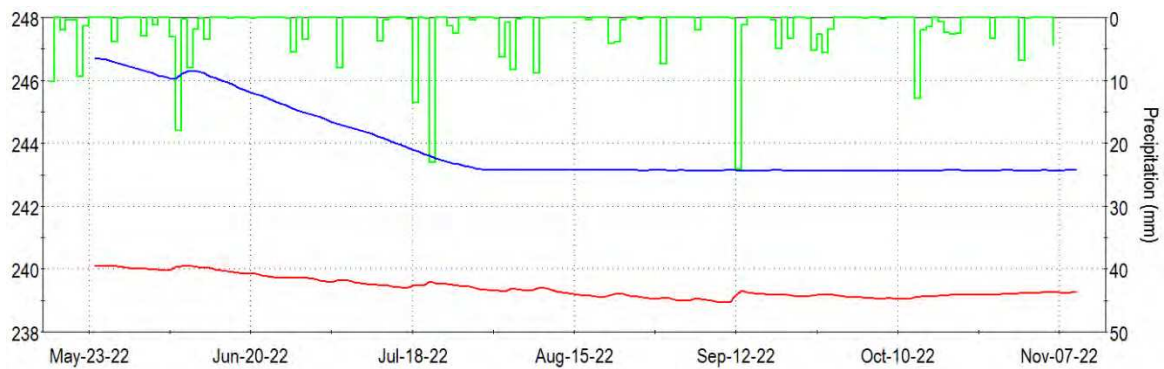
Figure 3.22: Observed groundwater levels at MW2-S (blue) and MW2-D (red).

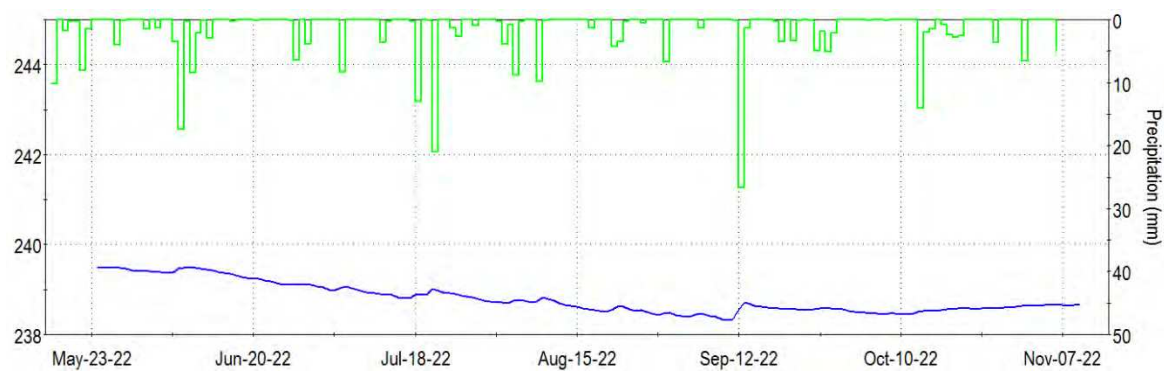
Figure 3.23: Observed groundwater levels at MW3-S.

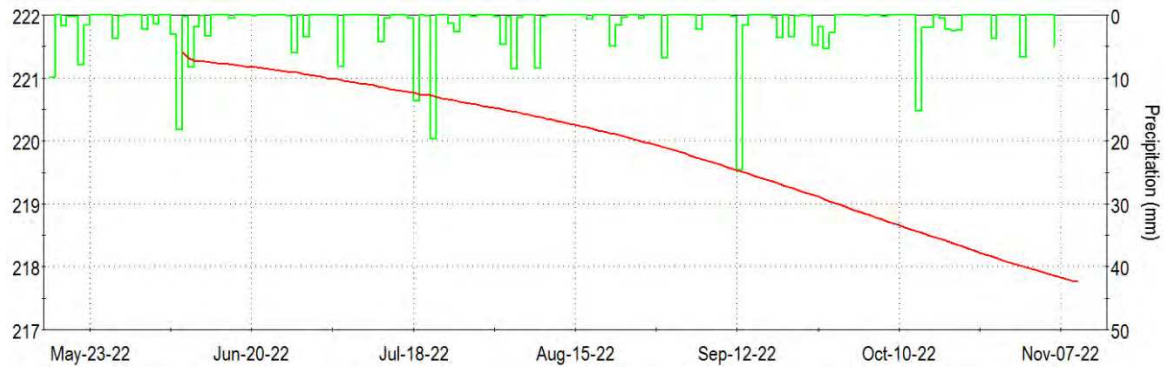
Figure 3.24: Observed groundwater levels at MW5-D.

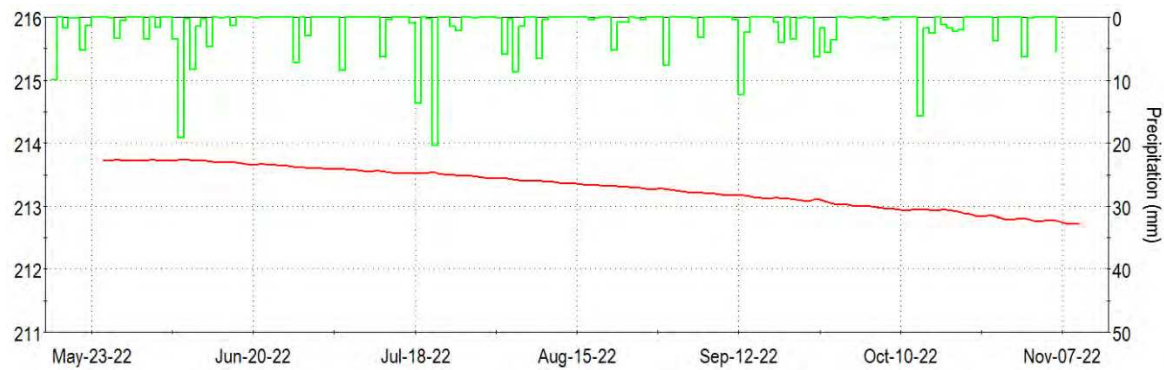
Figure 3.25: Observed groundwater levels at MW6-D.

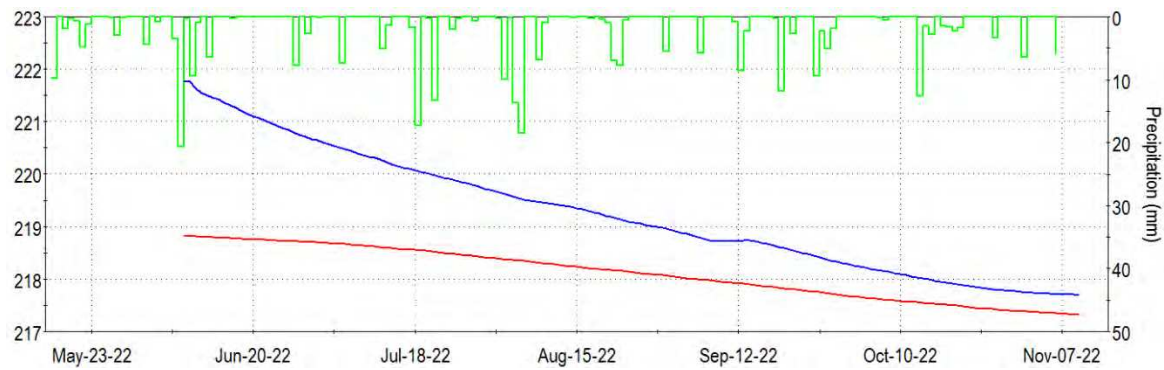
Figure 3.26: Observed groundwater levels at MW4-S (blue) and MW4-D (red).

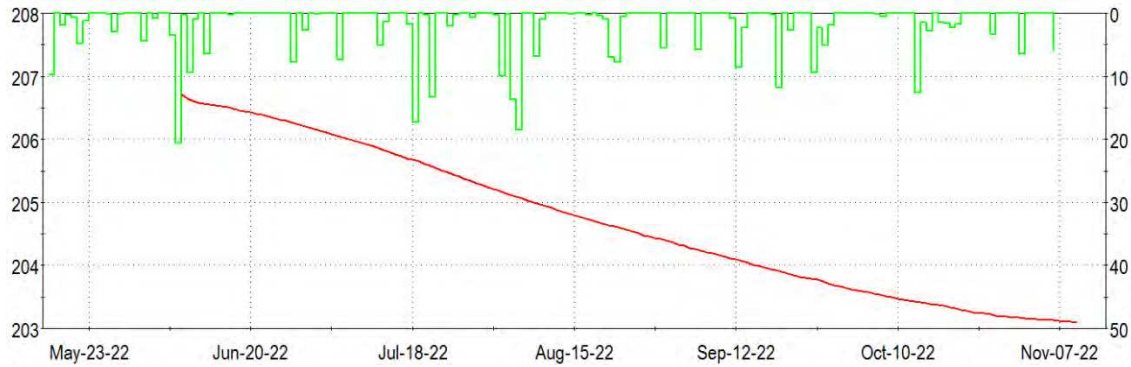
Figure 3.27: Observed groundwater levels at MW7-D.

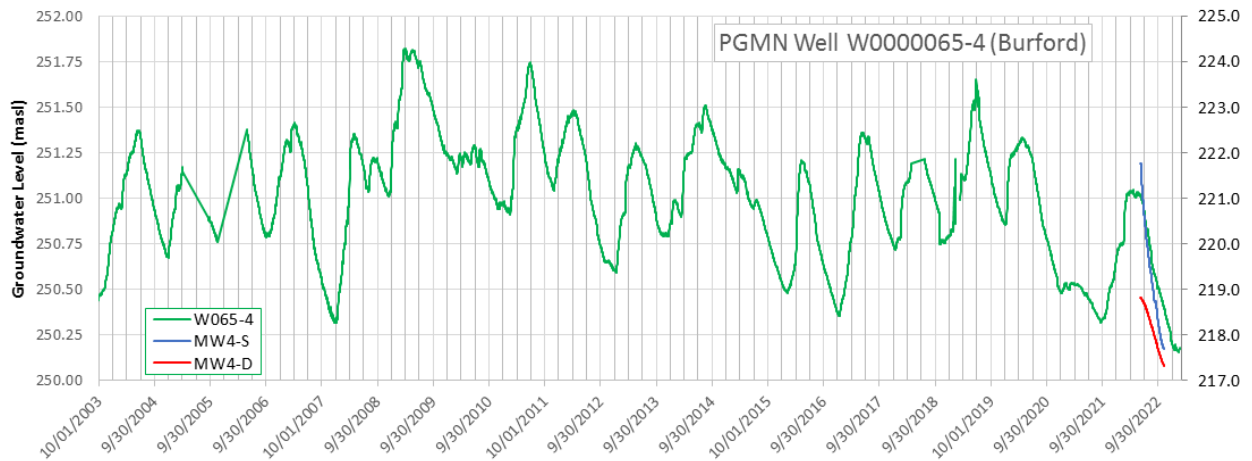
Figure 3.28: Long-term hydrograph for PGMN Well W0000065-4 in the Burford area and wells MW-4S and MW4-D (on the secondary y-axis).

Figure 3.28 shows a long-term (20-yr) hydrograph for PGMN W0000065-4 located in Burford. Water levels at MW4-S and MW4-D are plotted on the secondary y-axis for reference. As can be seen, the hydrograph shows that the PGMN well hit a 20-year low water level in February 2023 and did not show a typical fall recovery. This significant regional scale drought has likely affected all of the new wells, making interpretations of groundwater conditions very difficult at this time.

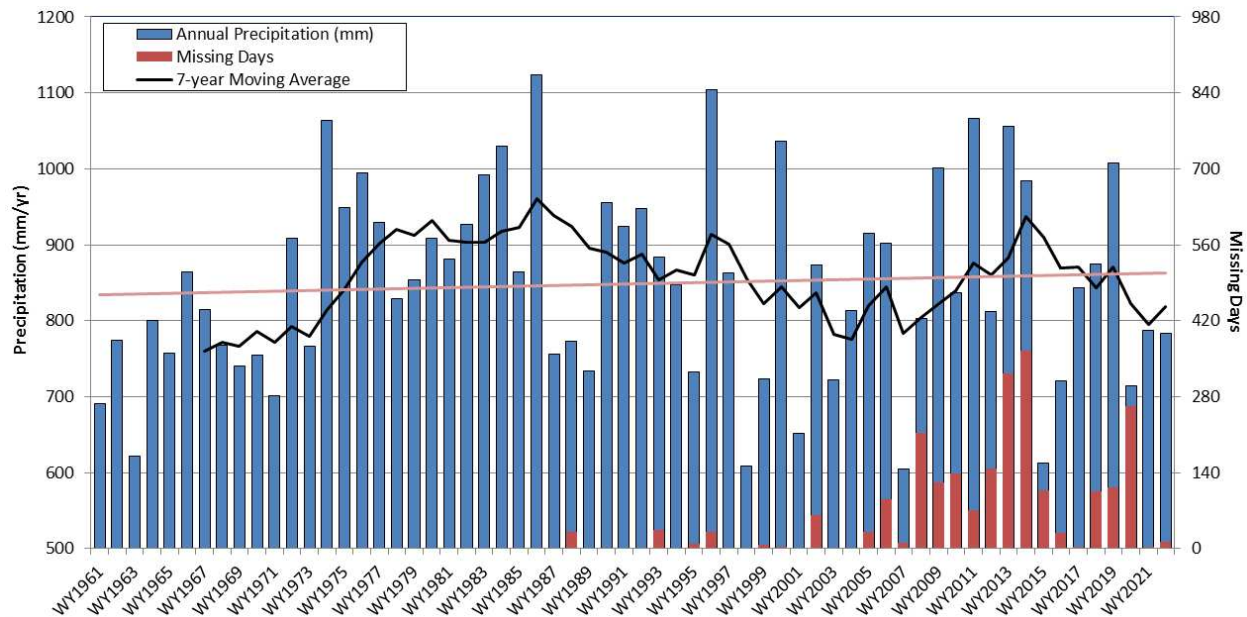
Figure 3.55: Annual average precipitation in the study area (Brantford stations, WY1961 – WY2022) and number of missing days per year.

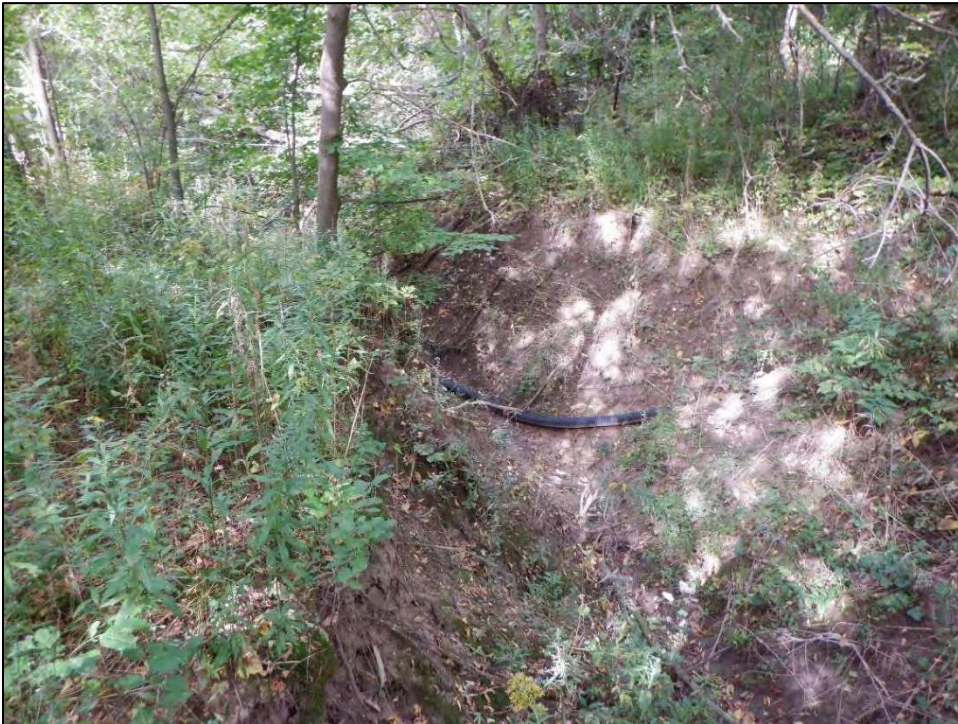
Figure 3.81: Channel Incision at Reach JC-H Tributary

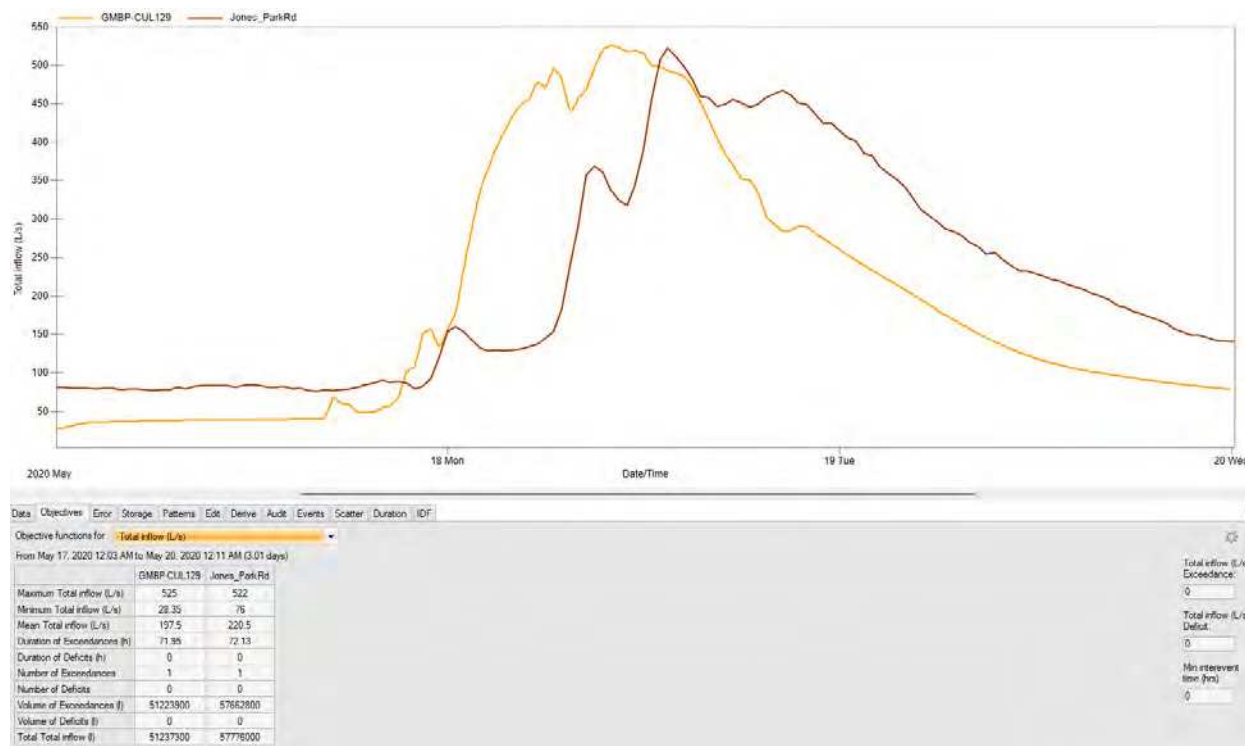
Figure 3.85: May 17, 2020 Calibration Result with Flow Record on Jones Creek at Park Road

The results of calibration for the Jones Creek at Park Road are shown in **Figure 3.85** and **Figure 3.86**.

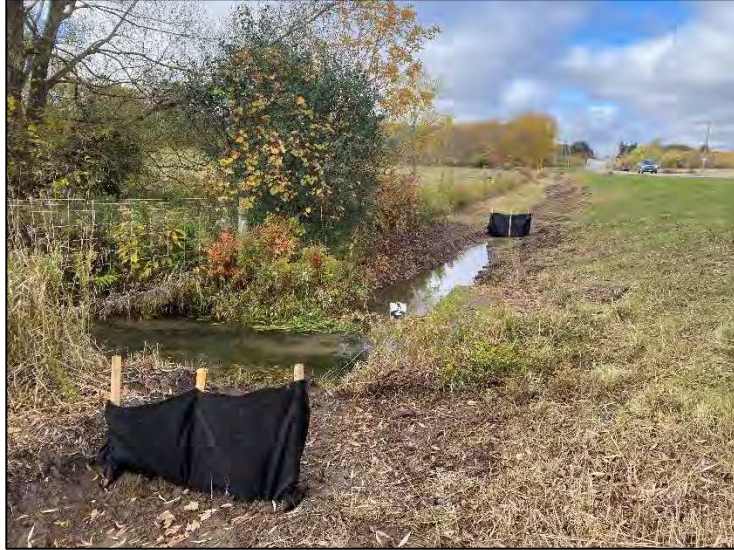
Figure 3.104: Ditching and Sediment Fencing Adjacent to Watercourse

the encroaching agriculture on either bank and a lack of established canopy cover, this watercourse appeared to provide high quality, coldwater habitat to a variety of fish species. Ongoing ditch clearance and grading was observed adjacent to Governors Road E, extending into the watercourse during a site visit on October 19, 2022 (**Figure 3.104**).

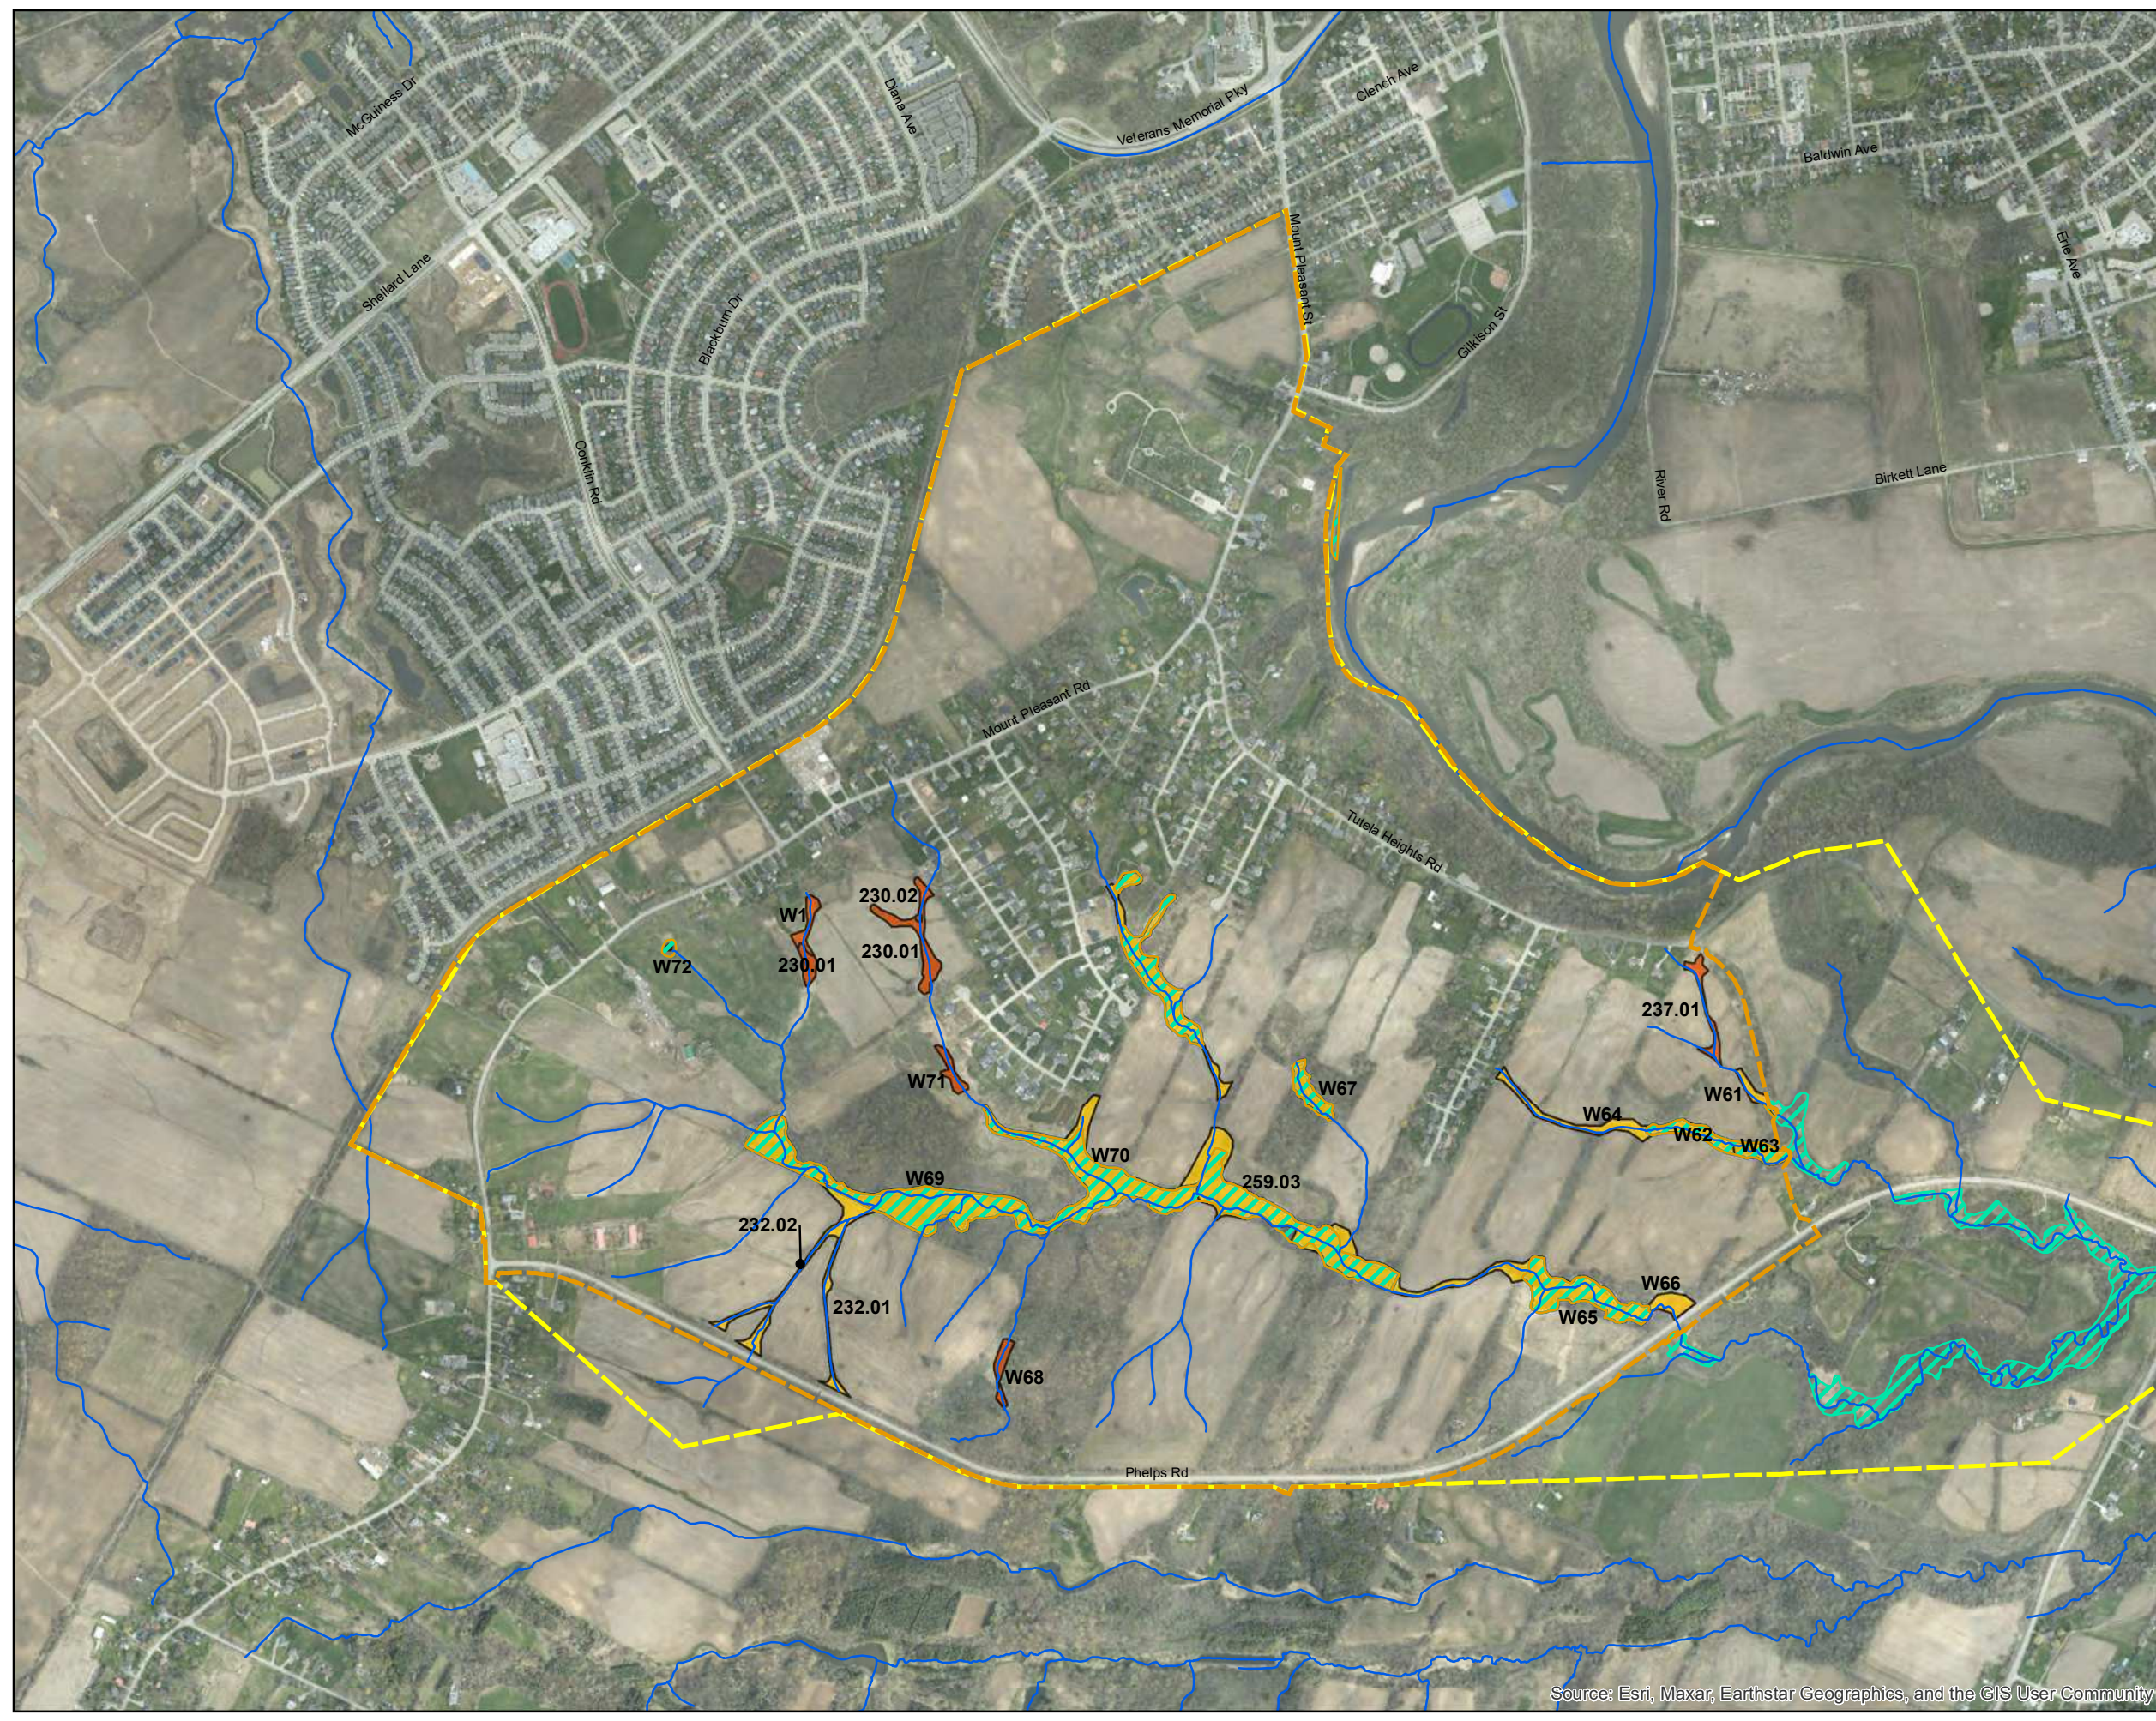
Figure 3.107
Provincially Significant Wetland Complex Considerations

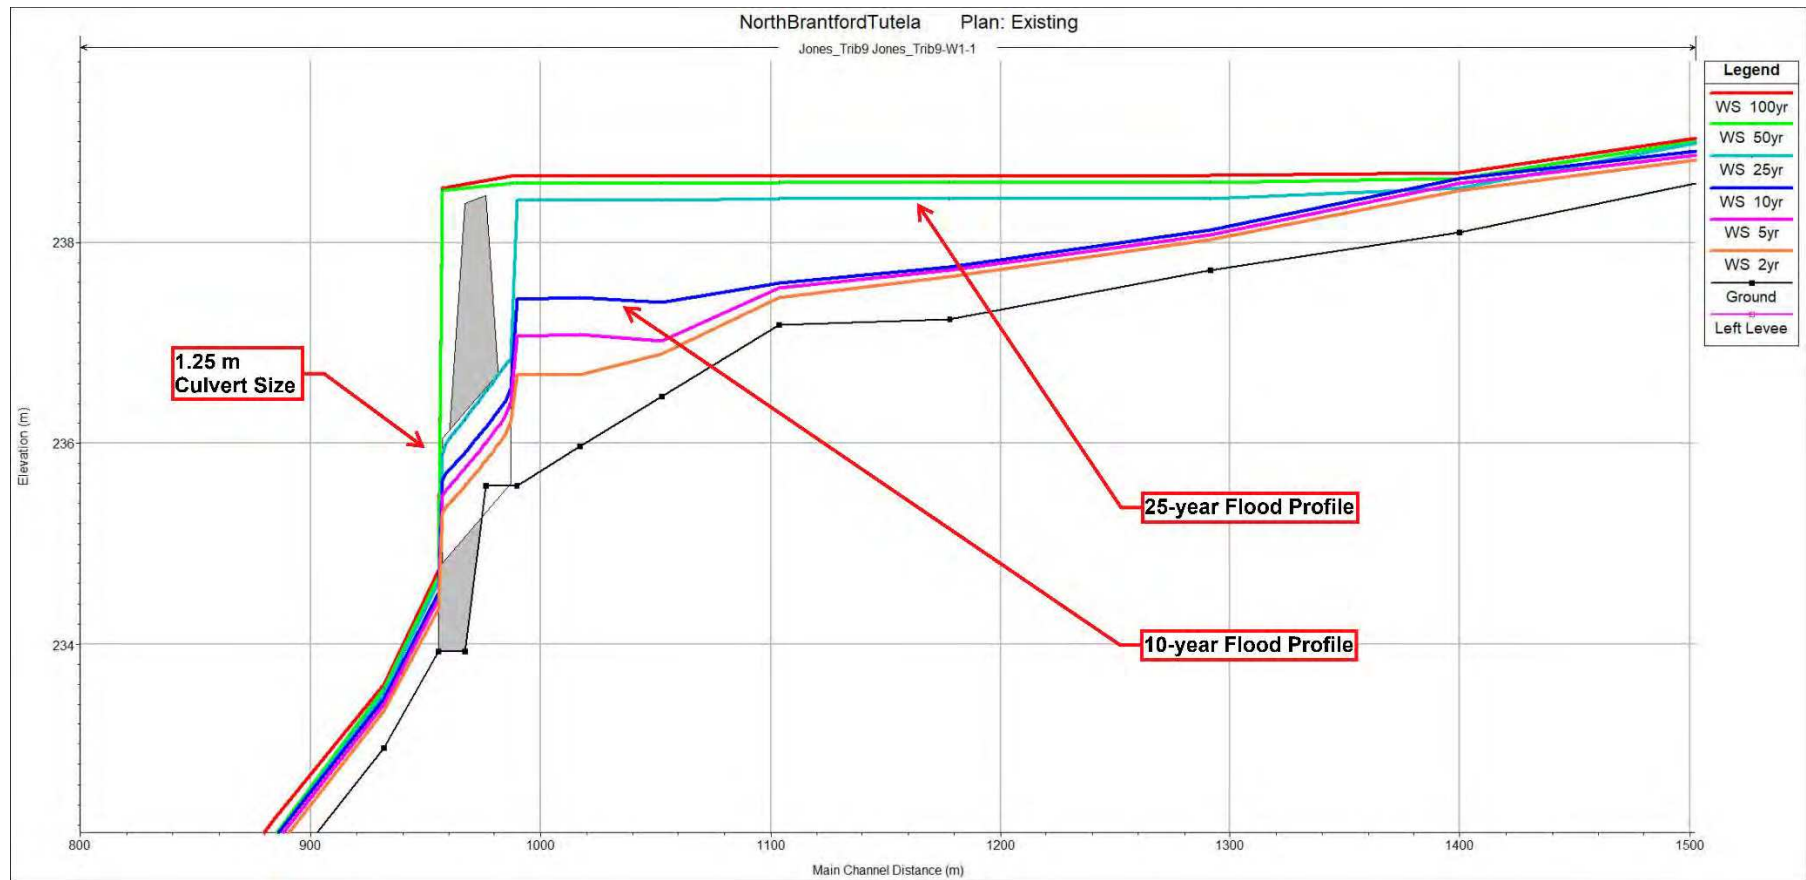
Figure 4.3: Profile for Reach UJT2-6-H0L (Jones Trib9 W1-1) for all flow events.
