Smoke Test Report

March 13, 2020

Re: 2019 Brantford Storm Sewer Smoke Testing
(Support Information for North East Flood Remediation Study)

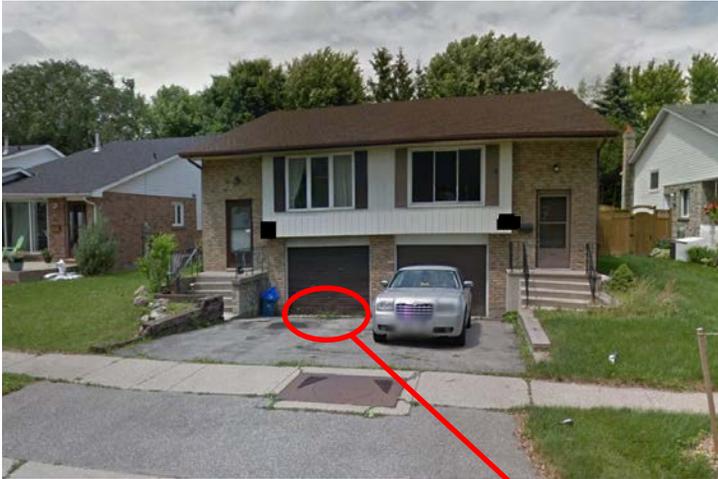
Driveway Drain Connected to Storm System

Defect Description: Reverse grade driveway drain is directly connected to the storm sewer as evidenced by visible smoke at the surface drain in the driveway during smoke testing of the storm sewer system.

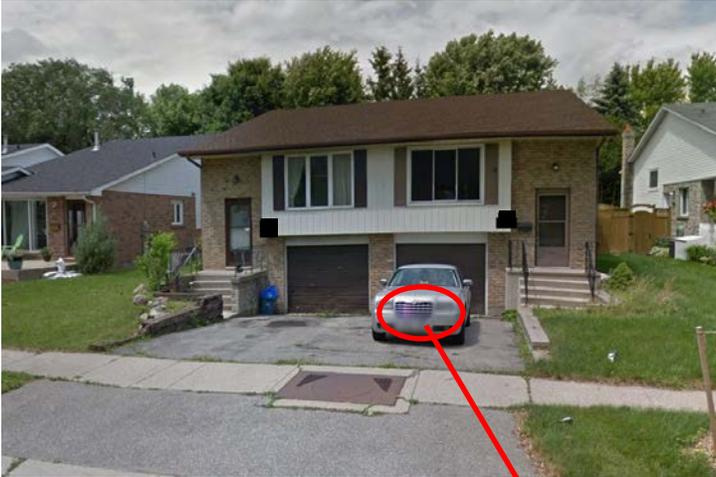
Defect Description: Reverse grade driveway drain is directly connected to the storm sewer as evidenced by visible smoke at the surface drain in the driveway during smoke testing of the storm sewer system.

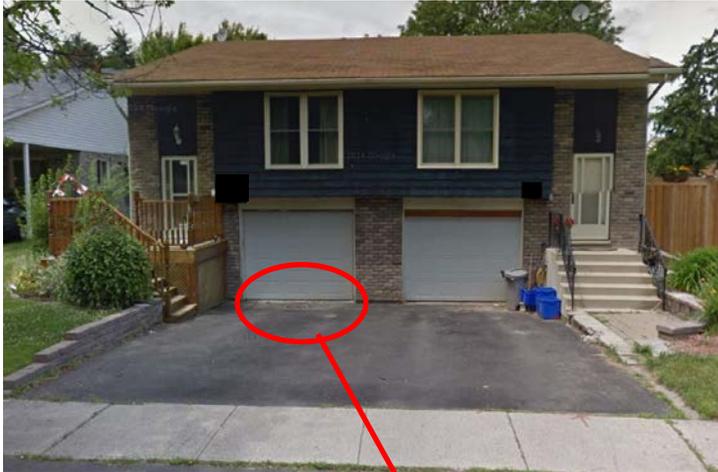
Driveway Drain Connected to Storm System

Defect Description: Reverse grade driveway drain is directly connected to the storm sewer as evidenced by visible smoke at the surface drain in the driveway during smoke testing of the storm sewer system.

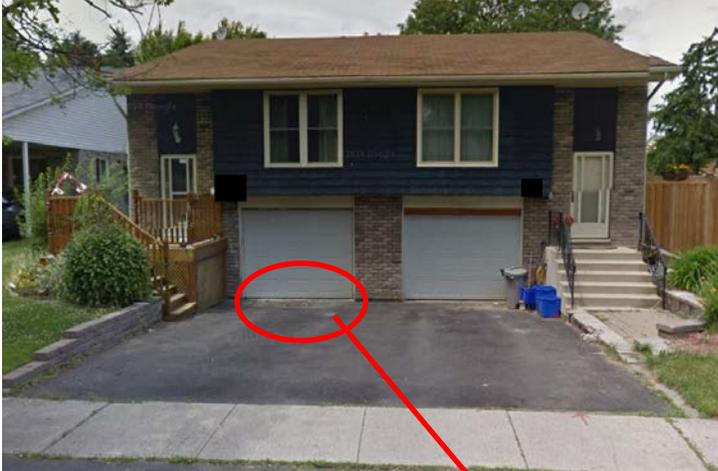
Driveway Drain Connected to Storm System

Defect Description: Reverse grade driveway drain is directly connected to the storm sewer as evidenced by visible smoke at the surface drain in the driveway during smoke testing of the storm sewer system.

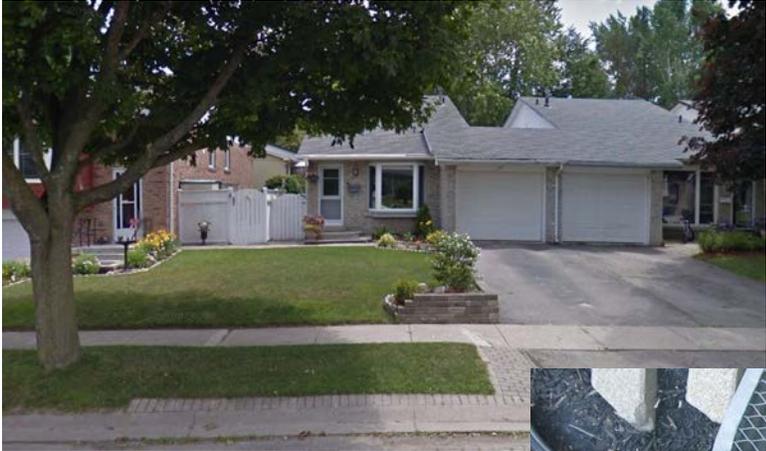
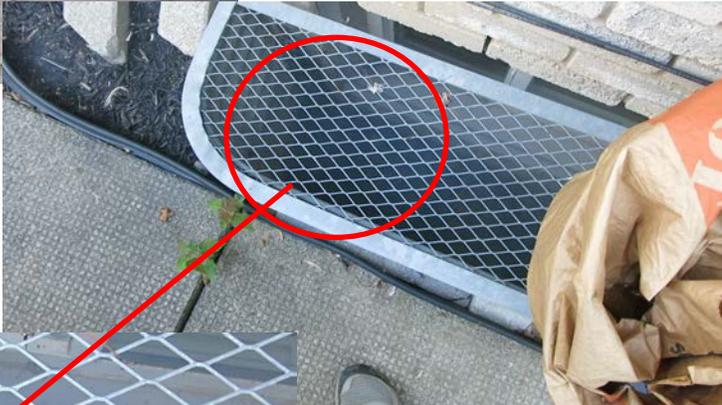
Window Well with connection to the Storm System

Defect Description: Window well connection to the storm sewer was observed. This is evidence of weeping tile (foundation drain) connection to the storm sewer. Ensure positive drainage (grading) away from the house.

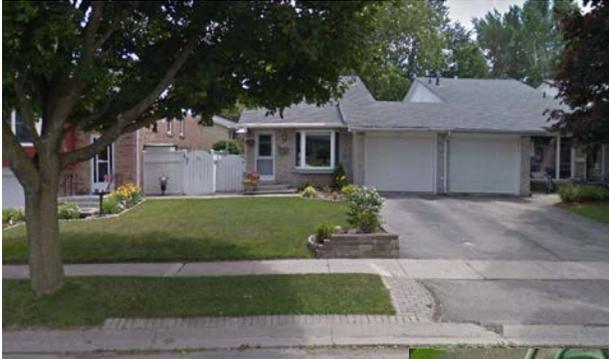
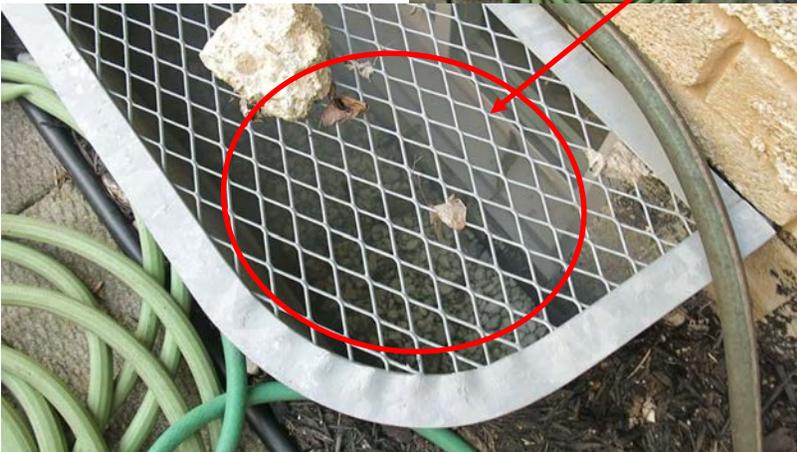
Window Well with connection to the Storm System

Defect Description: Window well connection to the storm sewer was observed. This is evidence of weeping tile (foundation drain) connection to the storm sewer. Ensure positive drainage (grading) away from the house.

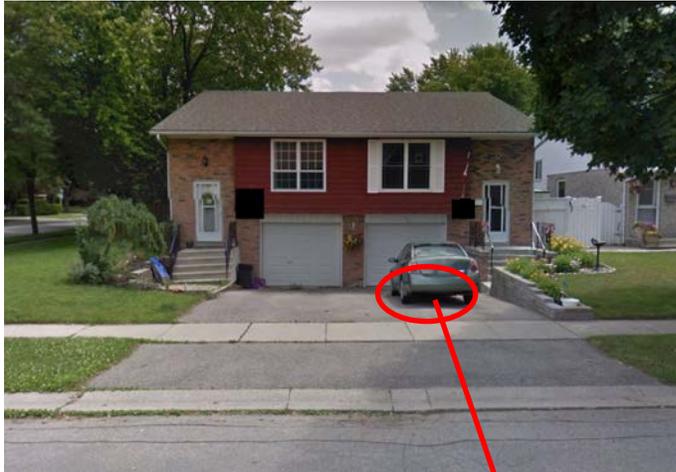
Driveway Drain Connected to Storm System

Defect Description: Reverse grade driveway drain is directly connected to the storm sewer as evidenced by visible smoke at the surface drain in the driveway during smoke testing of the storm sewer system.

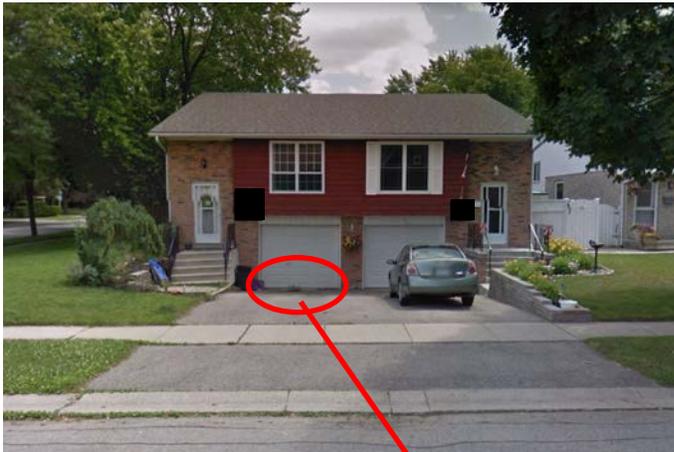
Defect Description: Reverse grade driveway drain is directly connected to the storm sewer as evidenced by visible smoke at the surface drain in the driveway during smoke testing of the storm sewer system.

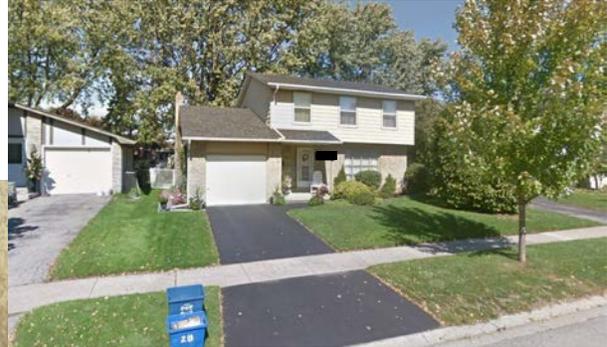
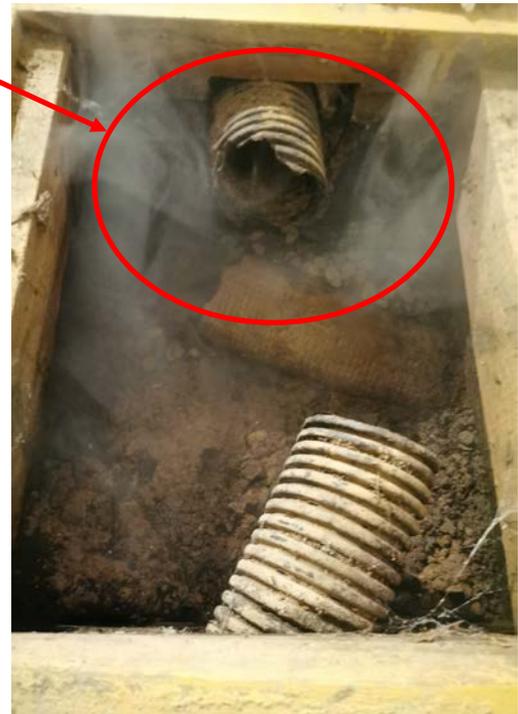
Sump Pit Connected to Storm System via Lateral

Defect Description: A sump pit in the basement is connected to the storm sewer via the weeping tiles and storm lateral. This smoked during our storm testing filling the basement with smoke. A definite connection to the storm sewer through this source.

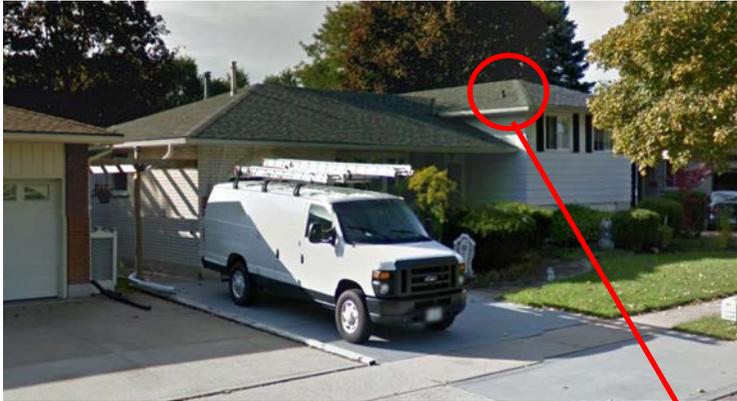
Plumbing Vent Stack with connection to Storm Sewer

Defect Description: Smoke was seen from the plumbing vent during storm smoke testing indicating a connection with the storm sewer system. Sanitary sewer smoke testing or dye testing is recommended to confirm connection of the plumbing to the storm sewer prior to any corrective action.

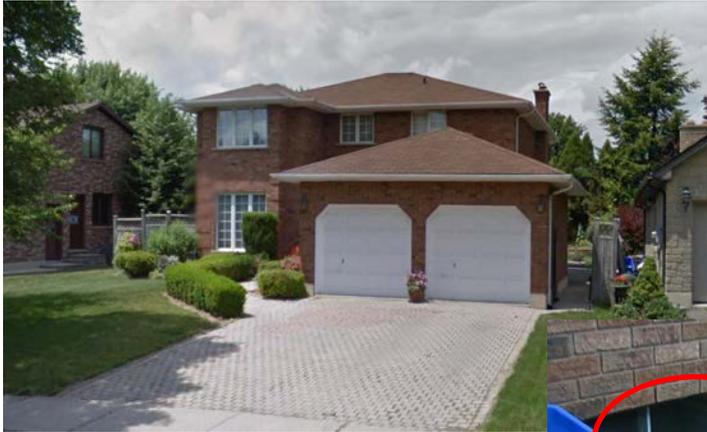
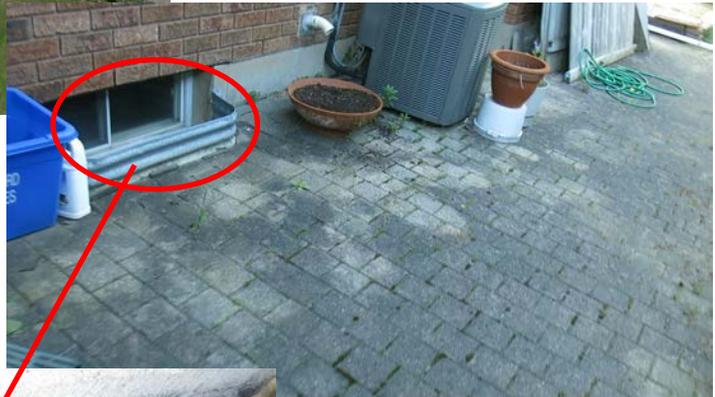
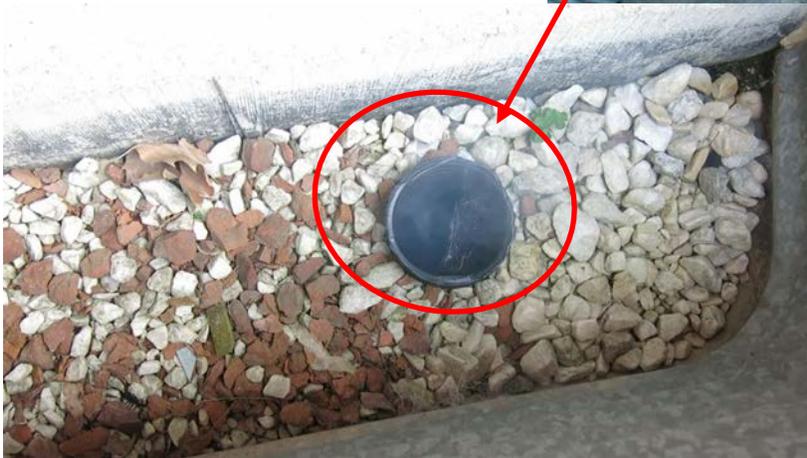
Window Well with connection to the Storm System

Defect Description: Window well connection to the storm sewer was observed. This is evidence of weeping tile (foundation drain) connection to the storm sewer. Ensure positive drainage (grading) away from the house.

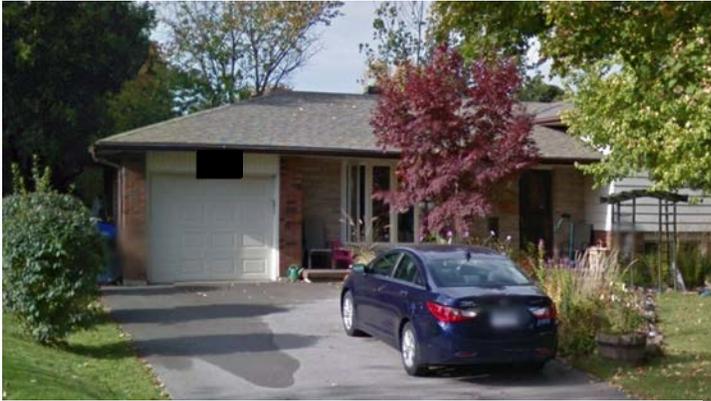
**Sump Pump Pit Connected
to Storm System**

Defect Description: Drains to likely old sump pit that is under concrete.

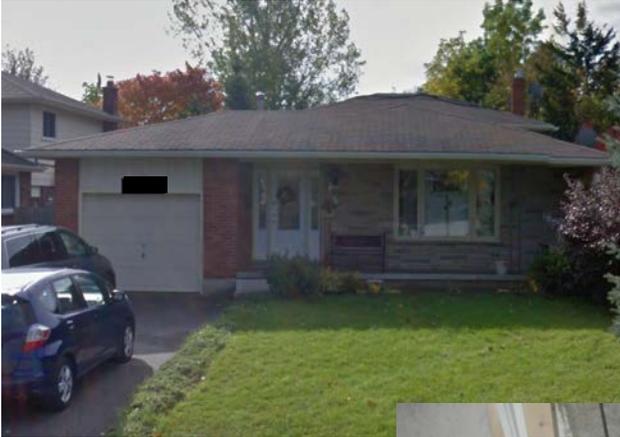
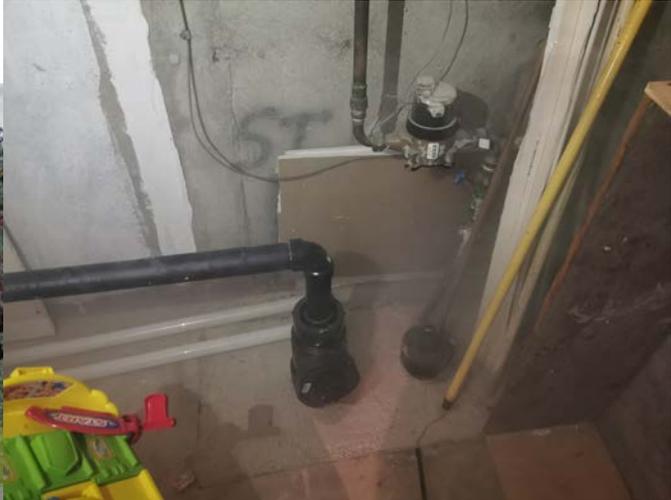
Sump Pit / Clean Out Connected
to Storm System via Lateral

Defect Description: A sump pit in the basement is connected to the storm sewer via the weeping tiles and storm lateral. This smoked during our storm testing filling the basement with smoke. A definite connection to the storm sewer through this source.

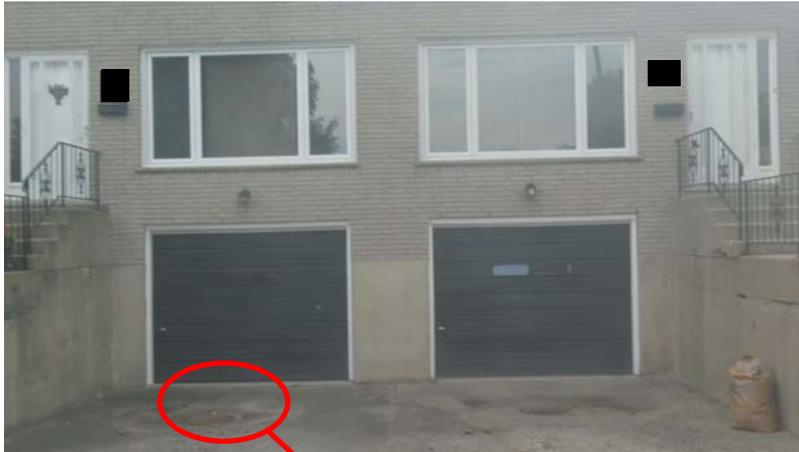
Driveway Drain Connected to Storm System

Defect Description: Reverse grade driveway drain is directly connected to the storm sewer as evidenced by visible smoke at the surface drain in the reverse grade driveway during smoke testing of the storm sewer system.

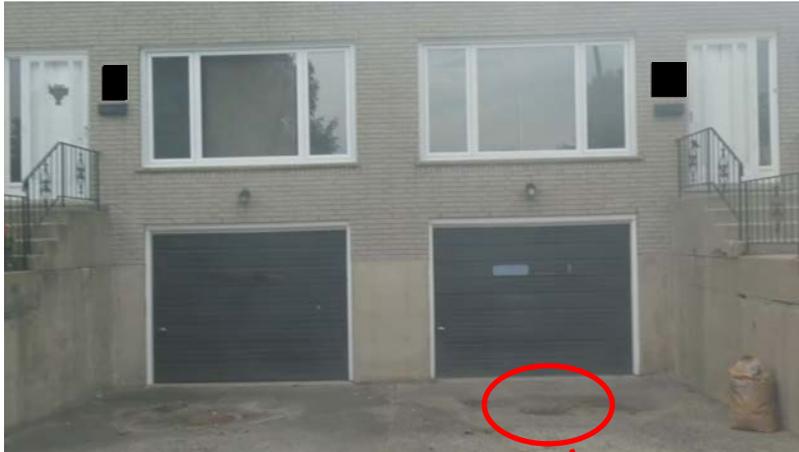
Driveway Drain Connected to Storm System

Defect Description: Reverse grade driveway drain is directly connected to the storm sewer as evidenced by visible smoke at the surface drain in the reverse grade driveway during smoke testing of the storm sewer system.

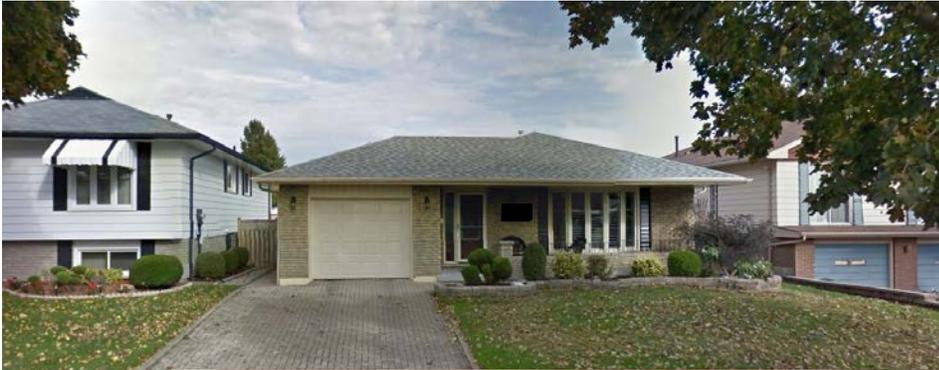
Sump Pump Pit out Connected to Storm System via Lateral

Defect Description: A sump pump pit in the basement is connected to the storm sewer via the weeping tiles and storm lateral. This smoked during our storm testing filling the basement with smoke. A definite connection to the storm sewer through this source.

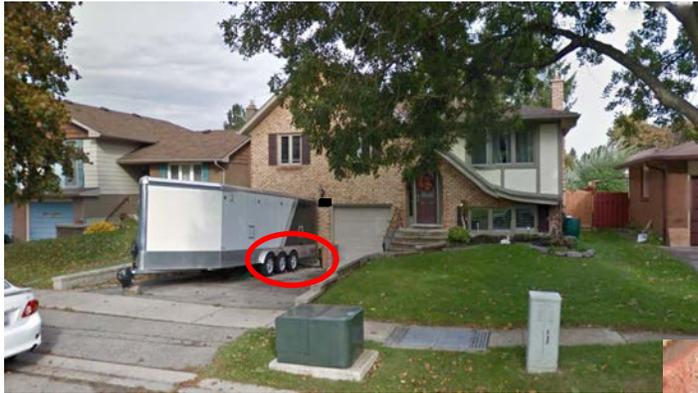
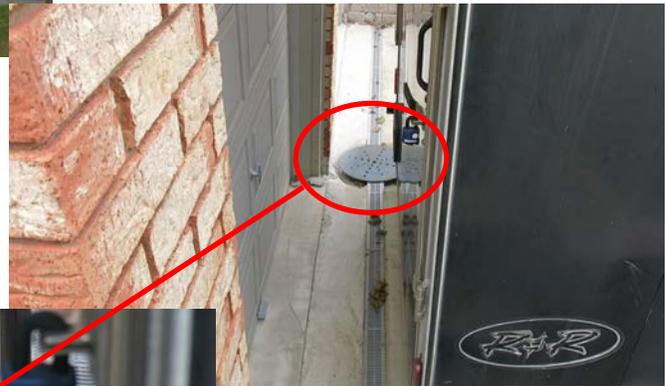
Driveway Drain Connected to Storm System

Defect Description: Reverse grade driveway drain is directly connected to the storm sewer as evidenced by visible smoke at the surface drain in the driveway during smoke testing of the storm sewer system.

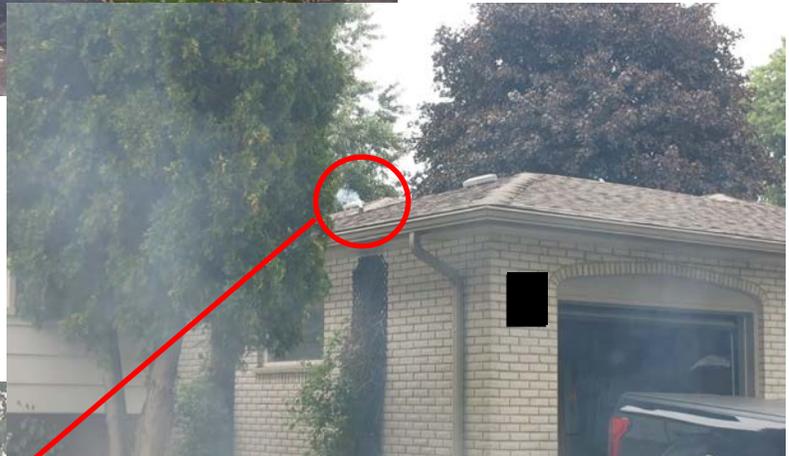
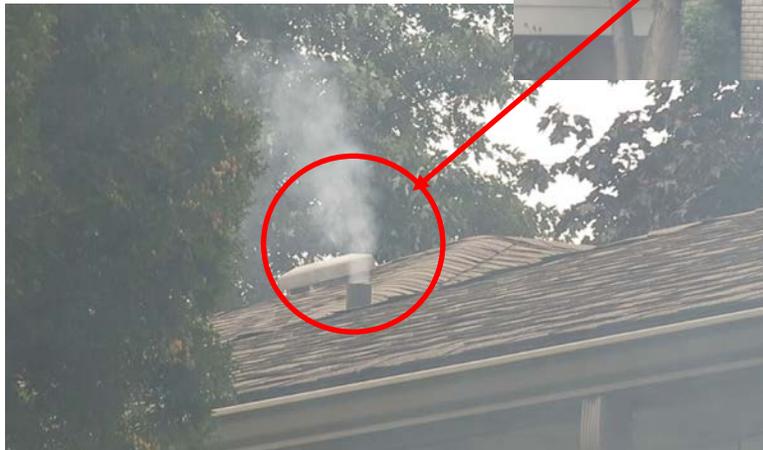
Plumbing Vent Stack with connection to Storm Sewer

Defect Description: Heavy smoke was seen from the plumbing vent during storm smoke testing indicating a connection with the storm sewer system. Sanitary sewer smoke testing or dye testing is recommended to confirm connection of the plumbing to the storm sewer prior to any corrective action.

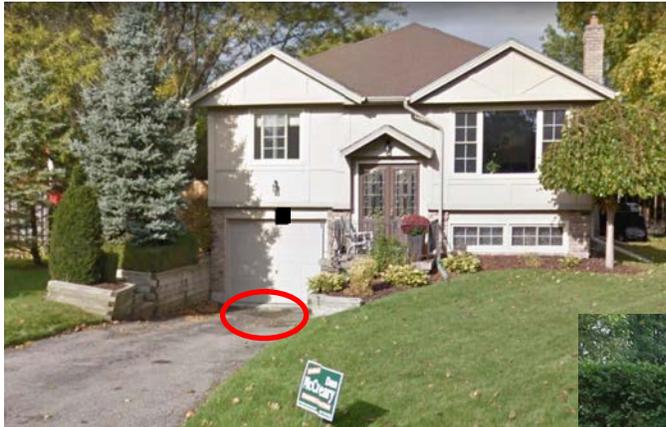
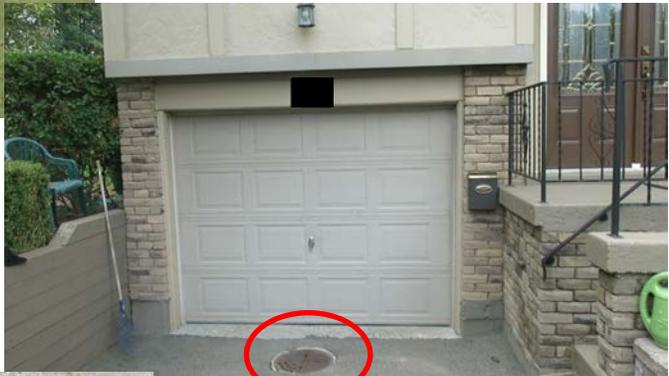
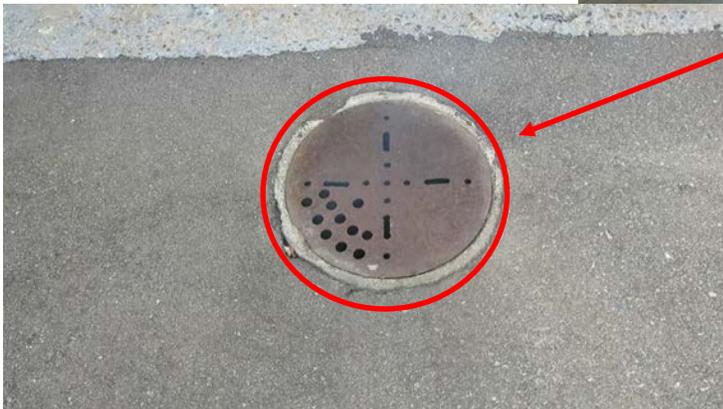
Location: [REDACTED]

Driveway Drain Connected to Storm System

Defect Description: Reverse grade driveway drain is directly connected to the storm sewer as evidenced by visible smoke at the surface drain in the reverse grade driveway during smoke testing of the storm sewer system.

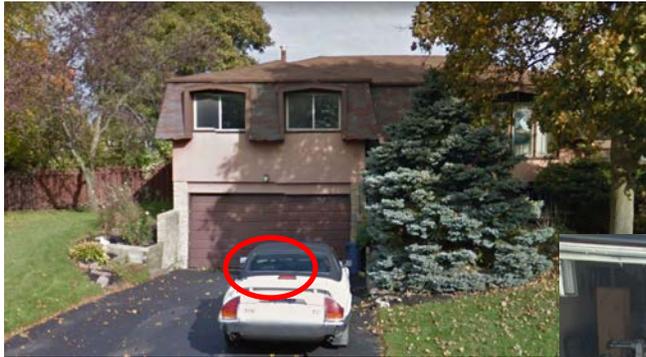
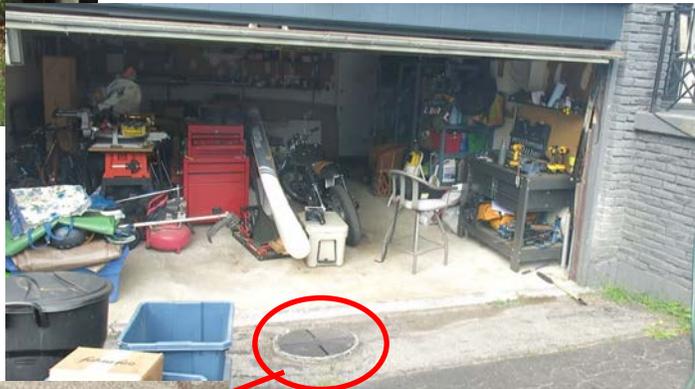
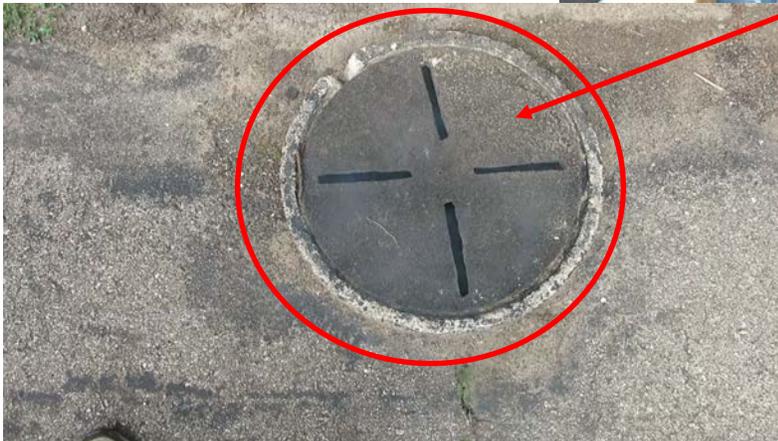
Location: [REDACTED].

Driveway Drain Connected to Storm System

Defect Description: Reverse grade driveway drain is directly connected to the storm sewer as evidenced by visible smoke at the surface drain in the reverse grade driveway during smoke testing of the storm sewer system.

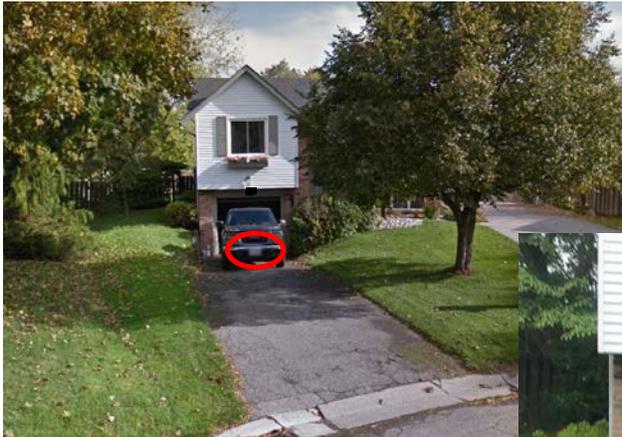
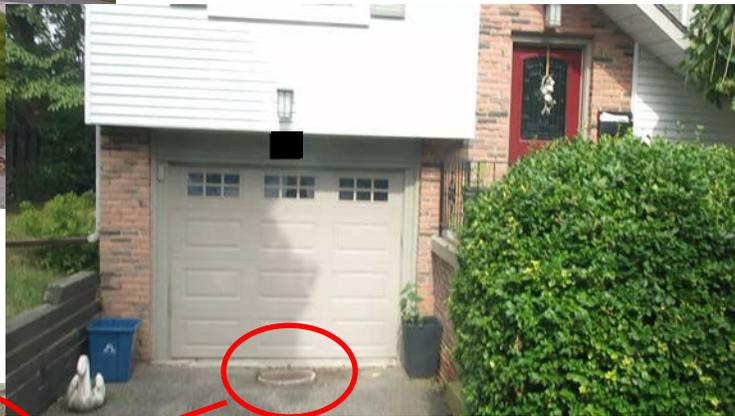
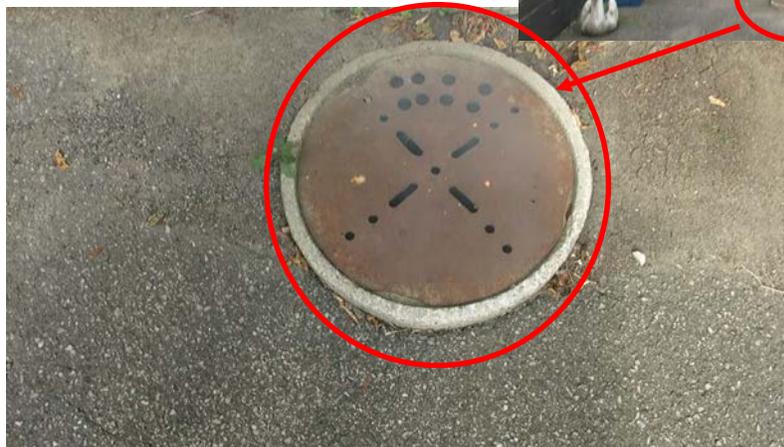
Location: [REDACTED]

Driveway Drain Connected to Storm System

Defect Description: Reverse grade driveway drain is directly connected to the storm sewer as evidenced by visible smoke at the surface drain in the reverse grade driveway during smoke testing of the storm sewer system.
